THE GOVERNMENT OF THE PHILIPPINES
 THE DEPARTMENT OF PUBLIC WORKS AND HIGHWAYS
**The Study on Sabo and Flood Control for
 Western River Basins of Mount Pinatubo
 in the Republic of the Philippines**
 JAPAN INTERNATIONAL COOPERATION AGENCY

Figure 1.2.3
**Investigation Results of Sediment Delivery
 in 2002 in the Marella River**

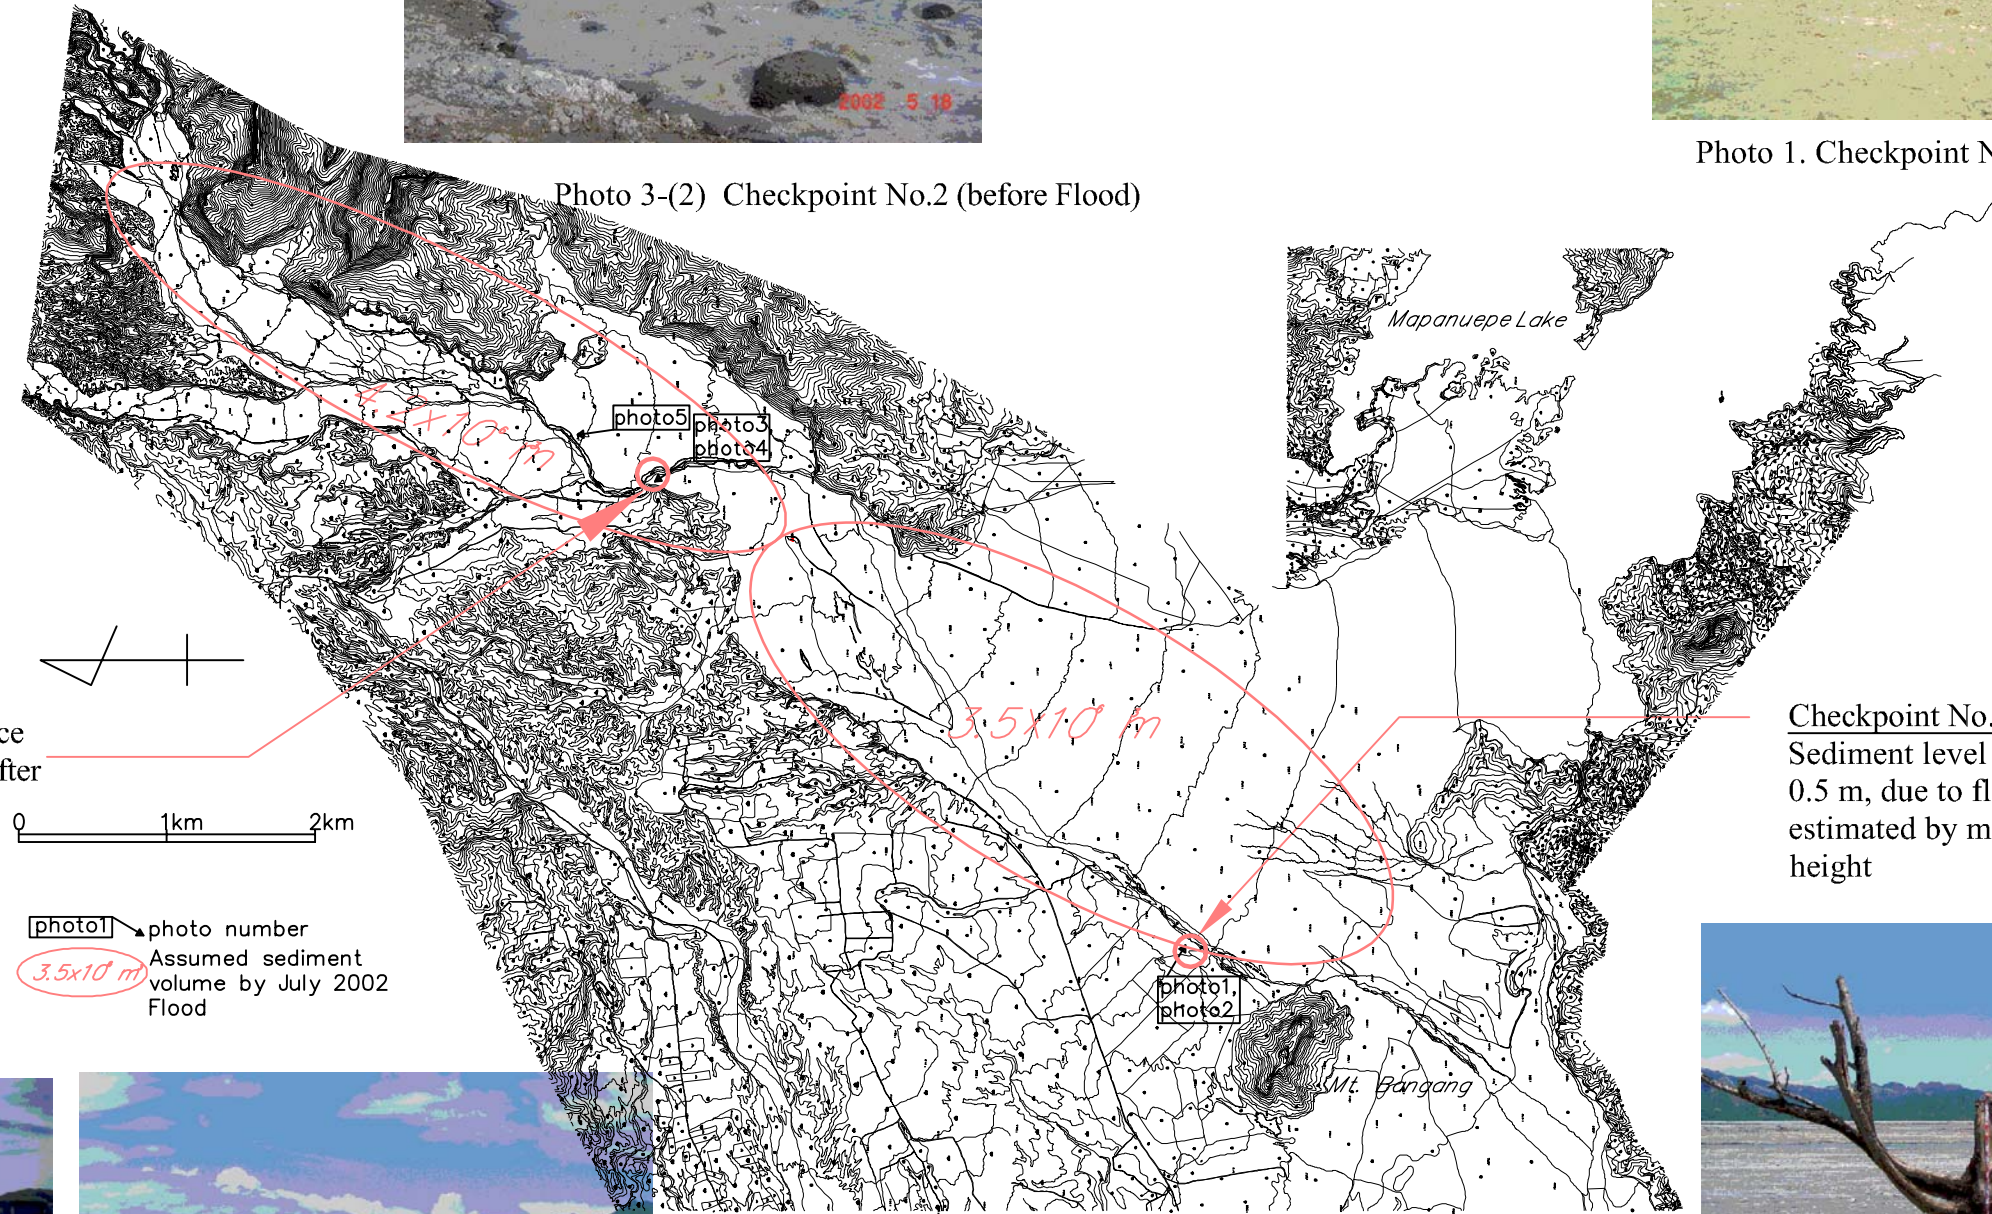
Checkpoint No.2

The river channel with 4 m depth was completely buried and the entire river terrace rose by 0.5 m due to sediment deposition after the flood in July 2002

Checkpoint No.1

Sediment level at river terrace rose by 0.5 m, due to flood in July 2002 estimated by measurement of the tree height

photo1 photo number
 $3.5 \times 10^6 \text{ m}^3$ Assumed sediment volume by July 2002 Flood
