2.3.2 Existing Facilities of the Sewerage system

(1) Sewage Treatment Facility

2) Current Status of STP

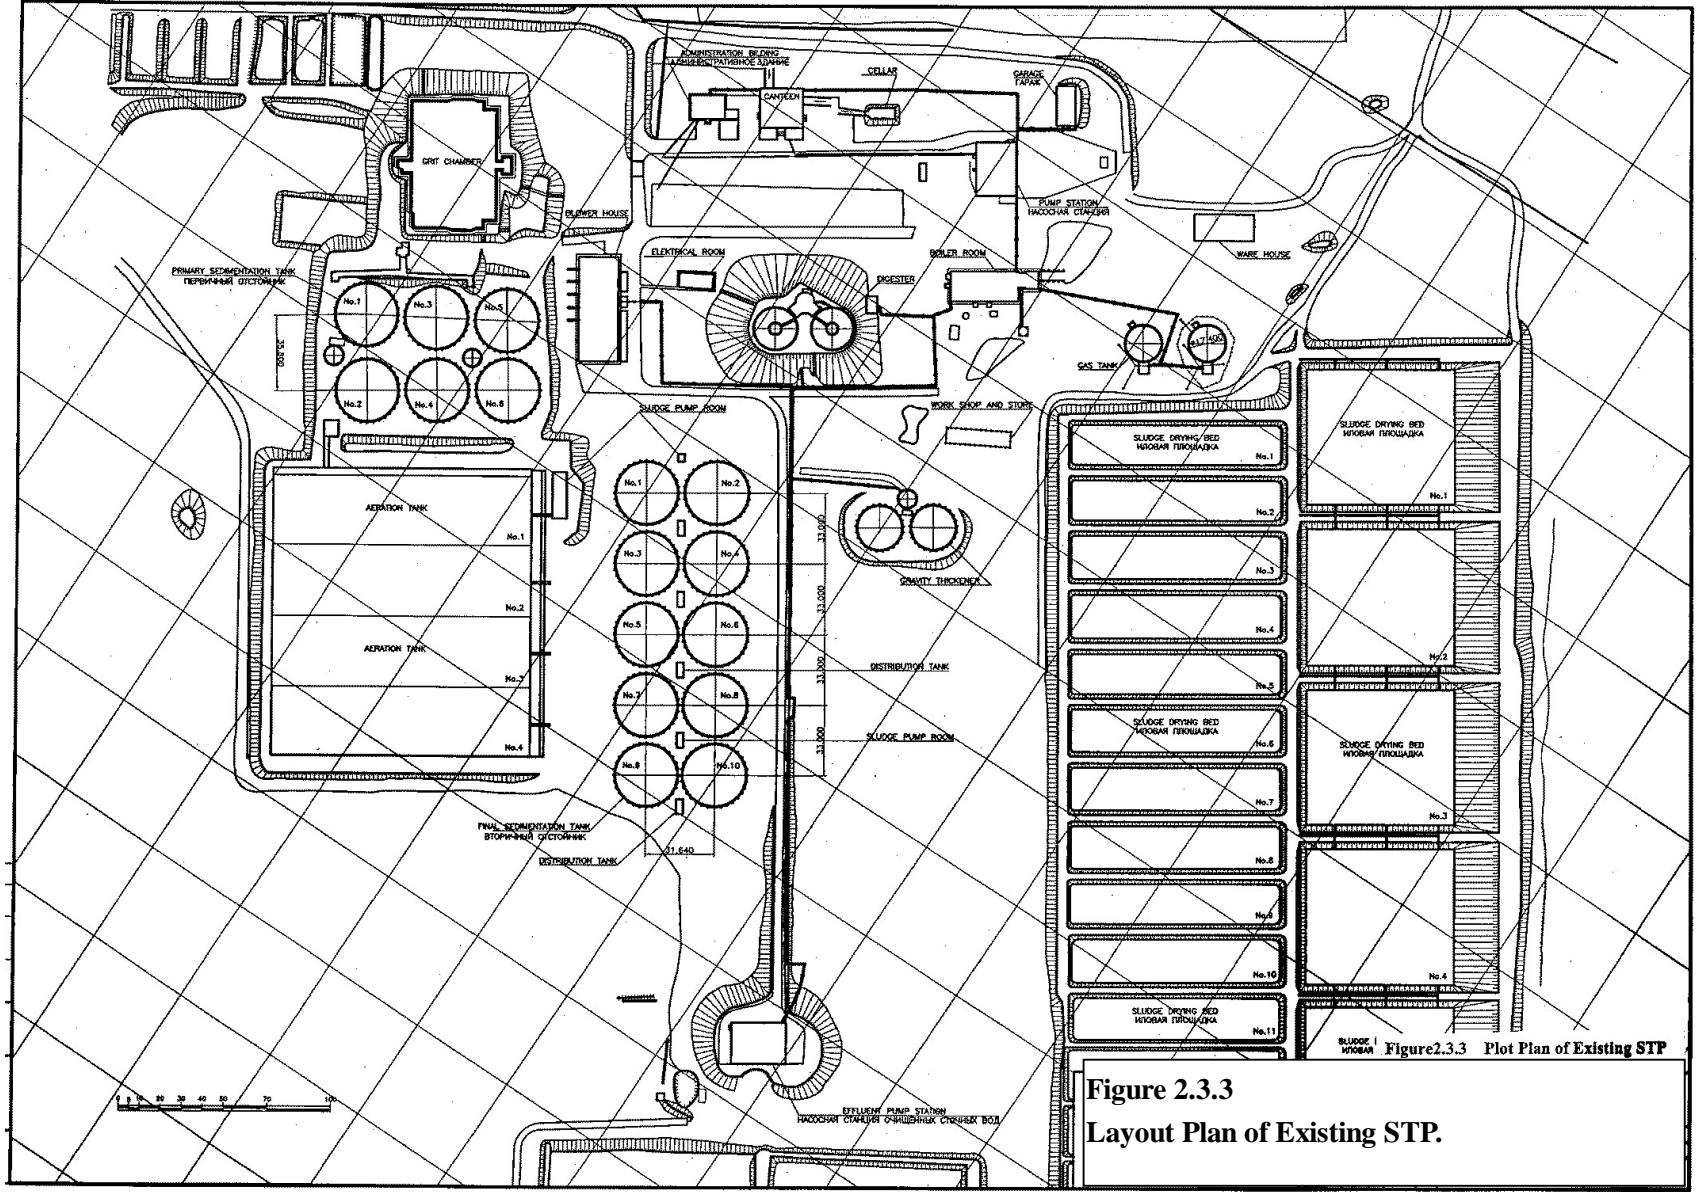
Figure 2.3.3
Layout Plan of Existing STP.

Figure 2.3.3 shows the layout plan of existing STP. The facilities are arranged in accordance with the water flow from the inlet pipe to discharge into the Taldy Kol reservoir. The plant has no definite boundary by structure. Northern part of the site is largely occupied by sludge drying beds. Figure 2.3.4 shows the flow chart diagram of the existing STP.

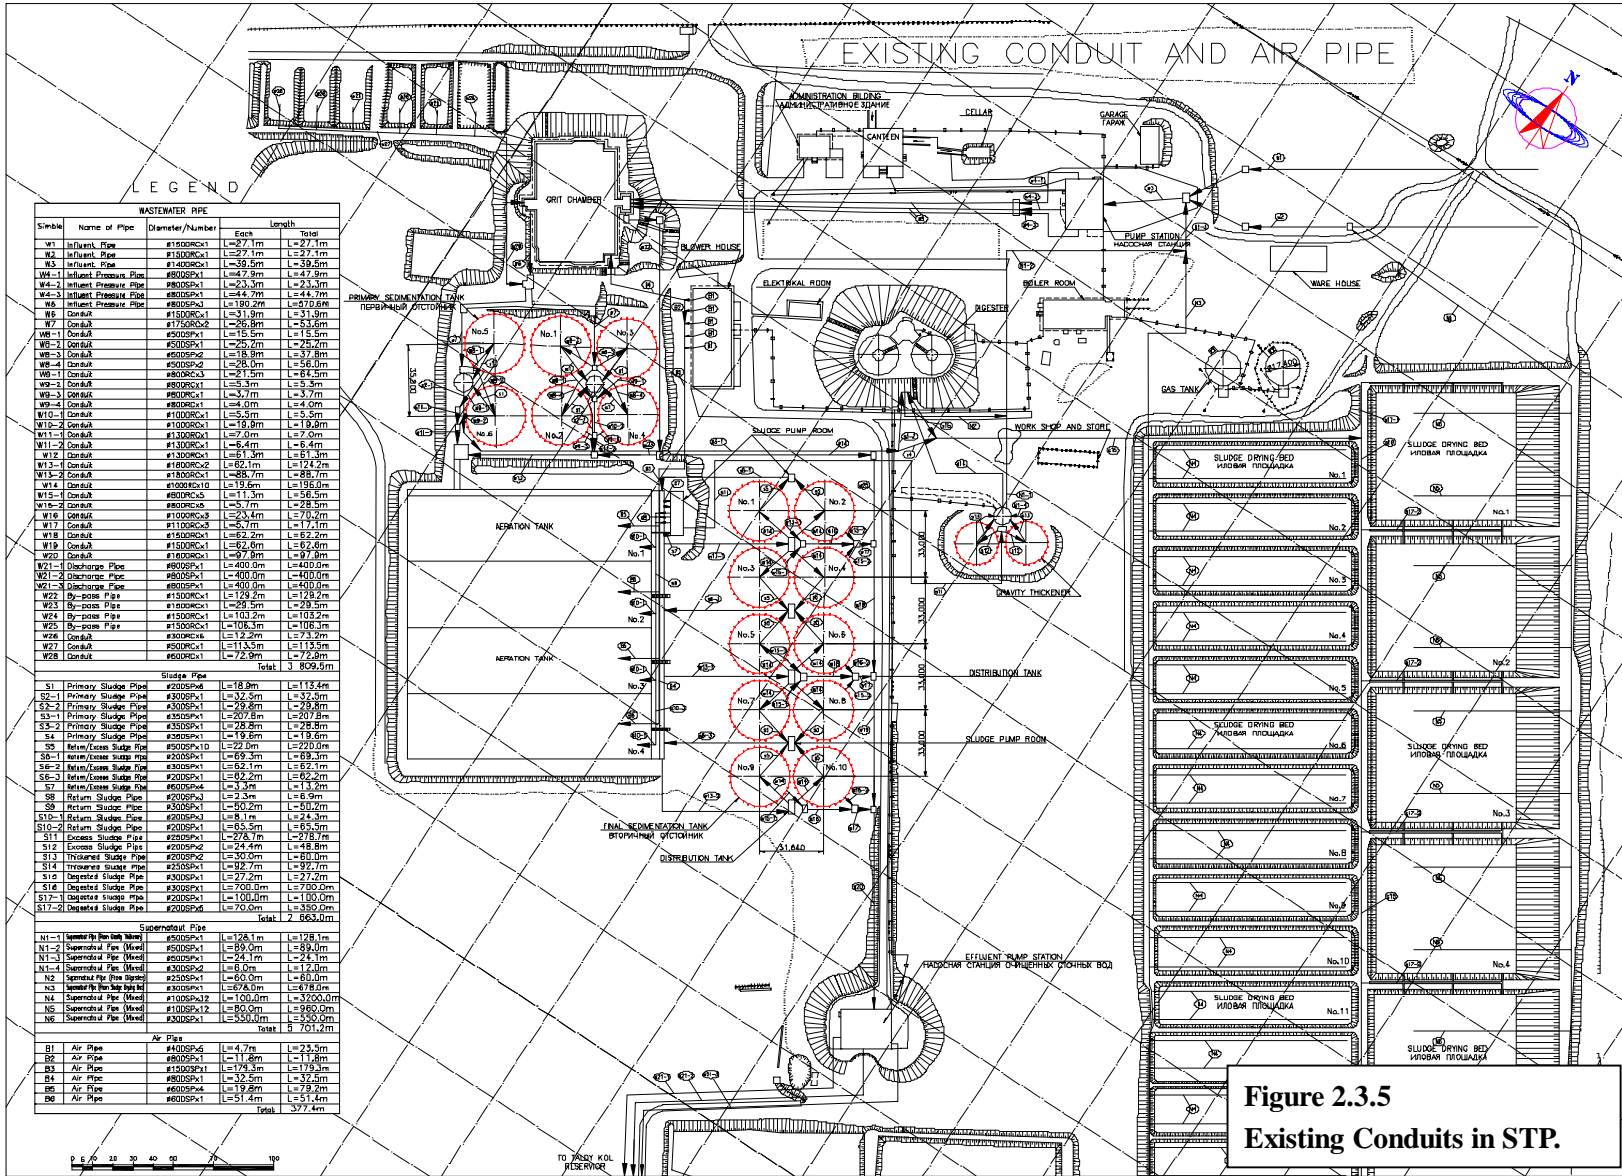
Figure 2.3.5 Existing Conduits in STP.

Effluent pipe is installed on the dike at the discharge point of Taldy Kol. Figure 2.3.5 shows the conduits of the plant. Each facility is stated from item a to item.

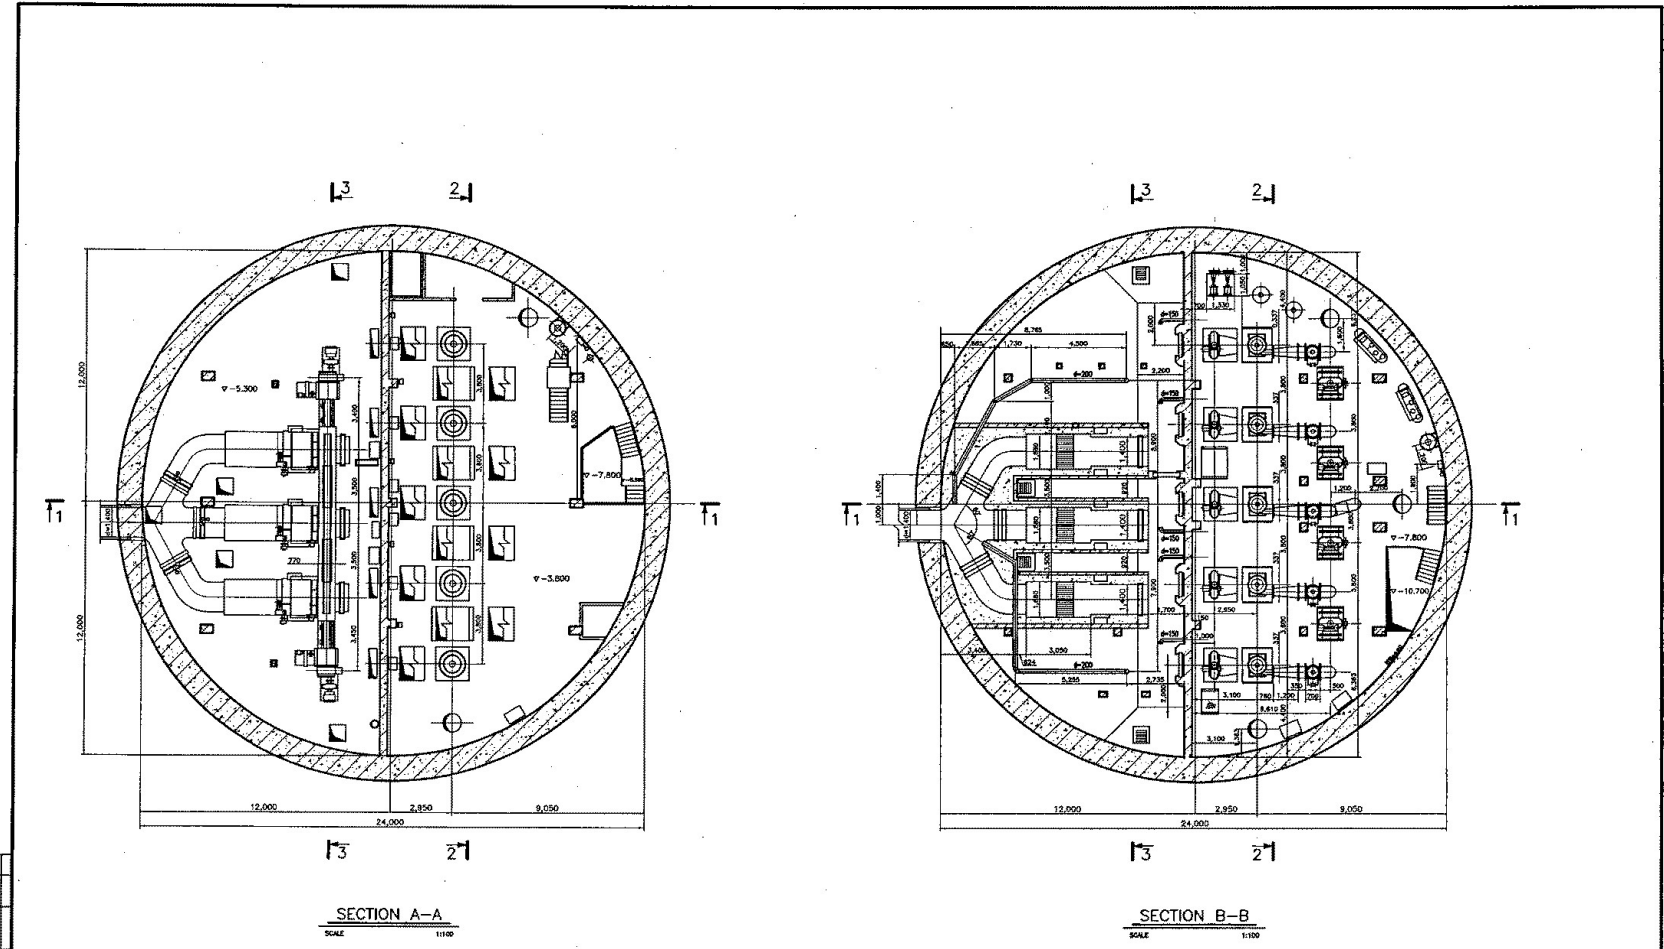
Figure 2.3.8-1
Drawing of Typical Pump Station (Large Size) – 1/3

Scale wise classification of the 34 pump stations was made as shown in Table 2.3.9. From this table, allowance ratio (Safety factor) is mostly beyond 2.0. Typical pump station is shown in Figure 2.3.8.
