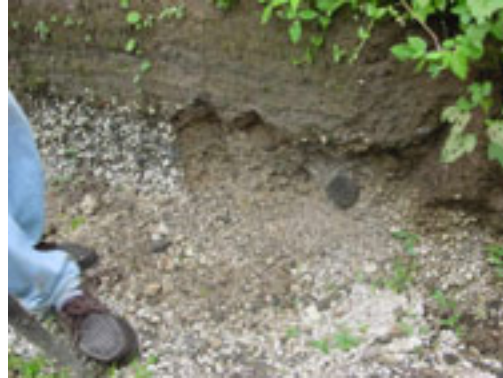
Deposits of this eruption were observed around the rivers Nimá I and Nimá II. The photograph shows the 1902 pumice layer at the point of about 1200m heights between Nimá I and Nimá II. Thickness of the layer is about 30cm and several bombs are included in the layer, and mean diameter of pumice is about 1cm at the place.

Photo 2.3.7-21 Air fall pumice of 1902 Santa María eruption seen at upstream of Nimal

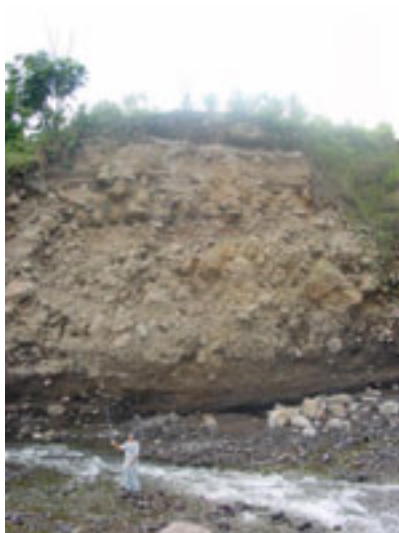
Debris avalanche deposit is observed along the riverbank of Nimá I and Nimá II. Thickness of the deposit at Nimá II near Finca La Florida is about 6m, and ash fall deposited on the debris flow with about 1m thickness. And on those, pumice layer is seen with thickness of about 20cm. Diameter of pumice is about 1-5mm. The pumice layer of

Photo 2.3.7-22 Air fall pumice(bottom) and deposit of debris avalanche (uupper part) of 1902 Santa María eruption at Nimá II river near Finca El Faro

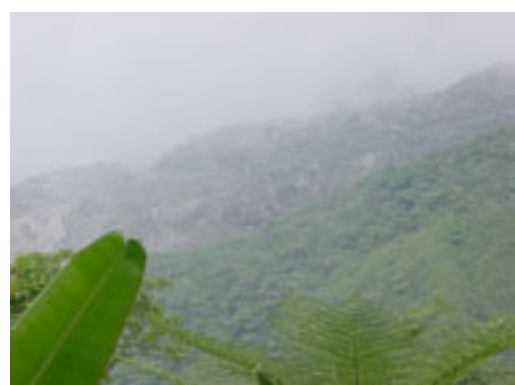
Santiaguito continues extruding lava and the lava flow, which started to flow in 1999, still advances 3-4m per day now. It flows down along the Nimá II river. We observed 1999 lava flow from the east-next ridge at the altitude of about 1400m. This is most wide part of the lava flow. The temperature of the flow is high yet, and vapor rising in the air

Photo 2.3.7-24 1999 lava flow of Santiaguito

was observed. Sounds of collapsing and falling rocks are often heard during the observation. It seems dacite lava flow.

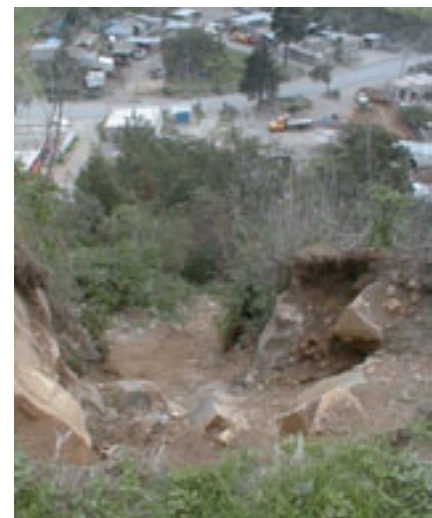
Old lava lobes are observed in the western part of Cerro Quemado. Those are the result of the volcanic activity during Late Holocene. A rhyolite/dacite lava dome, which is called La Pedrera lava flow and lava dome, situates in the northern most part of Cerro Quemado. Rock falls often occur along the edge of this lava dome with earthquakes and heavy rain.

Photo 2.3.7-27 The erosion head seen on the border of La Pedrera lava dome

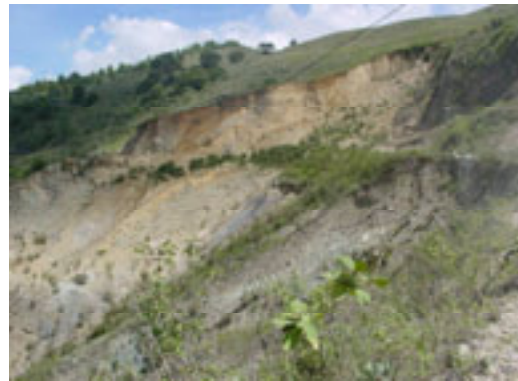
This landslide is located at the left bank of Bucá River about 3km west from Aguacatán on the road to Chiantla. In this area there are large masses of serpentinite, Chochal formation with massive bedded limestones of the Chochal formation (Pc) as well as lithoclastic limestones, dolomites, and dolomite breccia of the Ixcoy limestone (Kis). This area is highly unstable due to its variable geology with so many contacts, folded and cracked rock masses due to ancient and frequent movements of the Chixoy fault which runs just along this area.

Photo2.3.7-49 Landslide at La Barranca

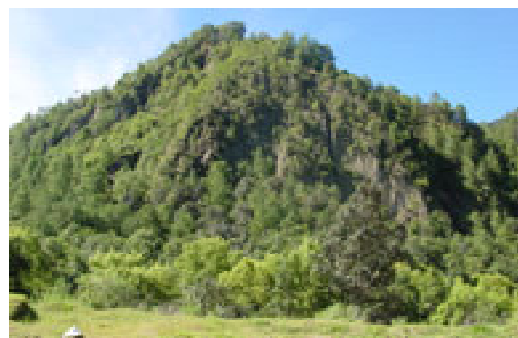
It is located about 15 km from Tecpán, along the south wall of the valley of the Los Chocoyos River. The landslide probably began as a block slide and disintegrated into a debris avalanche that plummeted down the canyon wall to the river and then traveled some 600m downstream before coming to rest. The main scarp has a height of 50 to 60m, and total moved mass was about 1 million m³ of debris derived from Pleistocene pumice deposits.

Photo2.3.7-50 Landslide of Los Chocoyos

This landslide killed 6-7 persons. The landslide blocked the river and formed a lake extending some 300m upstream.

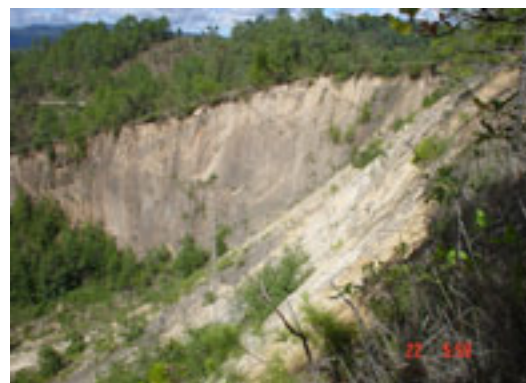
At San Jose Poaquil in the north-west of Tecpan Guatemala, we took a short deviation from the eastern logging road into the valley side to reach the head of this landslide. A huge landslide scarp was found. The upper part of landslide scarp consists of Los Chocoyos pyroclastic flow deposits, which is lightly weathered on the surface to become yellowish brown. The lower part of landslide scarp consists of welded tuff. The huge landslide is more than 400 meters wide and 200 meters high. In the forward of the landslide scarp, there is an outcrop that is lightly inclined toward the landslide scarp side. The outcrop is a remnant of deposits that slipped down from the landslide scarp location and now is found slumped and inclined toward the landslide scarp side. This landslide occurred following the

Photo 2.3.7-53 Large Landslide at San José Poaquil

Guatemala Earthquake in 1976.

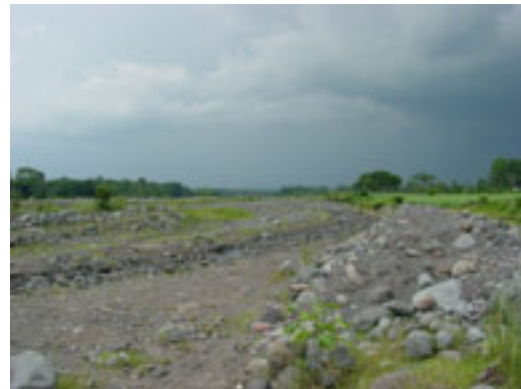
The Nima I River joins the Samalá River in the south of El Palmar. Currently, no flood occurs because the Samalá River in this area flows down a deep valley and no sediments flow in from the Nima II River. The Samalá River joins the Nima I River in the south of San Felipe. Around this location, the river width becomes more than 100m and gravel accumulates on the riverbed. The area around the river is a terrace, posing no danger of flooding. Around the bridge in CA2 in San Sebastián, the Samalá River comes to have a narrow width, causing sediments to accumulate to raise the riverbed. At present, the river path is maintained at this location by excavating the riverbed. On the right bank, gabions are used to form embankment to prevent a flood. On both the banks, the landform changes from a terrace to a lowland area. Floods easily occur in the area downstream from this bridge. Inhabitants here say that, especially on the right bank where there is little difference in height between the riverbed and the lowland area, a flood current flows into the adjacent river, Muluá River. On the riverbank, there are remnants of a gas station washed away by a past flood.

Photo2.3.7-54 Status of the riverbed near CA2

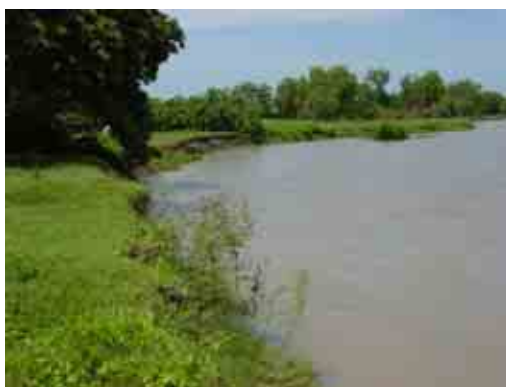
In the lowermost reaches, there is a floodplain three kilometers wide. There is little difference in height between the riverbed and the surrounding lowland area. In some parts, a road was washed away by a flood. When the Hurricane Mitch hit, the water level of the flood was 150 centimeters. At the estuary, there is a beach ridge along the coast, behind which there is a marsh in the background.

Photo2.3.7-55 Status of the lower reaches

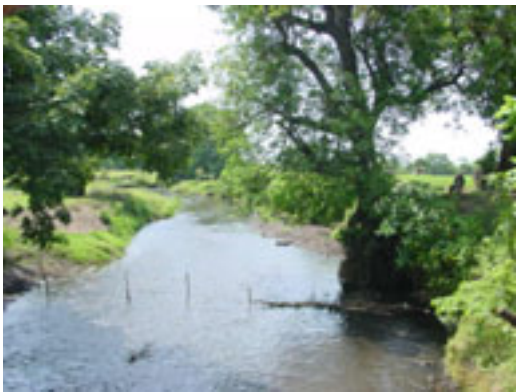
The river meanders through a lowland area near La Gomera and joins the Aguero River in the north of the town. The river is about five meters wide and, since it erodes the lowland area while flowing down, the surrounding lowland area is a terrace about three meters higher than the riverbed. Therefore, land near the Acomé River has been flooded before but the town of La Gomera had scarce flood damage. Even Hurricane Mitch flooded the area near the Acomé River and the entrance of the town at the depth of about 0.5 meters for one night.

Photo2.3.7-57 Aguero River near La Gomera

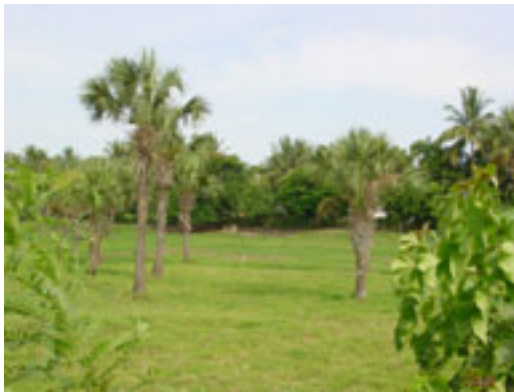
Inland from the dunes, there is a laguna and a marsh (pantano). Despite the dunes extending for about 30 km, there is only one estuary, i.e., that of the Acomé River. Additionally, at the estuary of the Acomé River that flows slowly and meanders, water is not easily discharged due to the sand bar (barra). If the river has a higher water level, therefore, it seems that many of the river streams are dammed to cause a flood in the lowerland area behind the dunes.

Photo2.3.7-59 Marsh and dunes near Sipacate

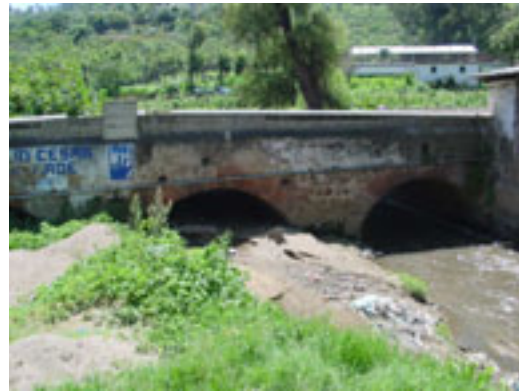
Photo2.3.7.61 Bridge in Postores

If a downpour occurs in the upper reaches, it

is likely that not only the current of the river slows down at such a location but also the bridge dams up the river to cause an inundation. Downstream from this location, gabions were thrown up to prevent erosion on the undercut slope.

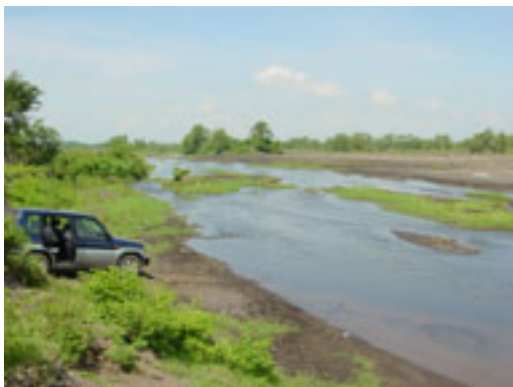
Photo2.3.7-64 Achiguate River near Cuyuta

Guacalate River joins the Achiguate River in the south of Masagua. Downstream from this location, the riverbed becomes more than 300 meters wide, many streams diverge from the river, and the land is prone to flooding. In the south of Masagua, the Achiguate River meanders and erodes the land on the undercut slope. There is a height difference of two to three meters between the surrounding land and the water surface. If it rains heavily such as during Hurricane Mitch, the land may be submerged. In Cuyuta, a flood current that flowed into streams washed away the road and deposited sand around it. If the Achiguate River rises, a flood current may flow into these streams, submerge relatively low land around them, and further expand the flood.

The riverbed deposits in the middle reaches consist mainly of sand and no gravel. In El Pilar on the opposite bank, the diverging streams expanded the flood during Hurricane Mitch, which submerged the town for three days.

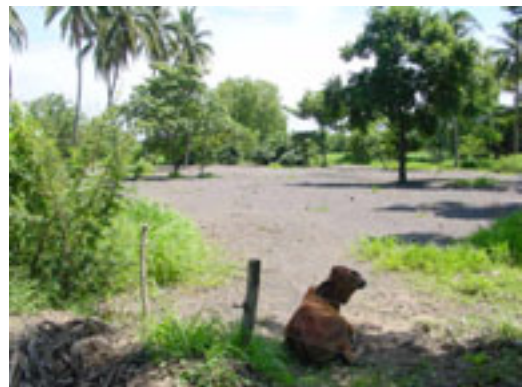
Photo2.3.7-65 Flood-caused deposits near Cuyuta

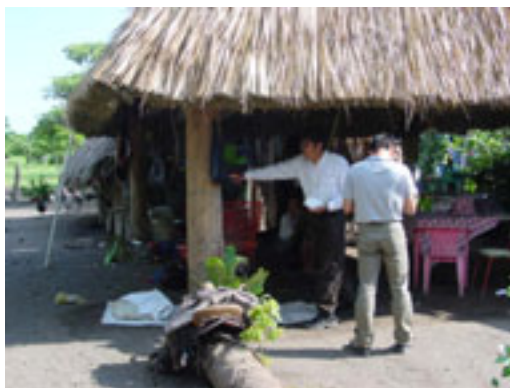
The west side of the Achiguate River is a lowland area like the opposite bank. Hurricane Mitch brought about a flood current through the diverging streams that flooded the area. However, Los Ángeles, five kilometers away from the Achiguate River, was not flooded. What caused this difference could not be identified in the field study because this border has no distinct geomorphological difference around it.

Photo2.3.7-66 Water level of flood in a village in the lower reaches

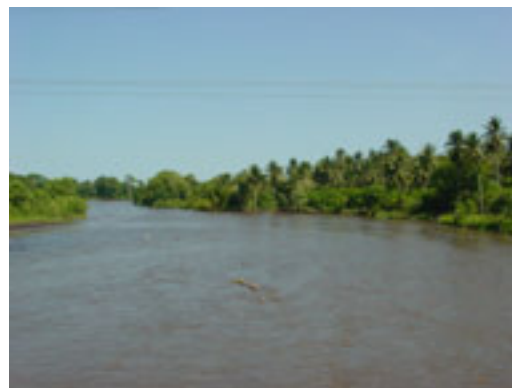
Photo2.3.7-67 Achiguate River near the estuary

Near the estuary, there is little difference in height between the river and the surrounding land and the river is very shallow. The riverbed inclination is very gentle and the speed of the current is low. Thus, a considerable range of land is submerged if the water level rises. La Barrita near the estuary was submerged by Hurricane Mitch for four days.

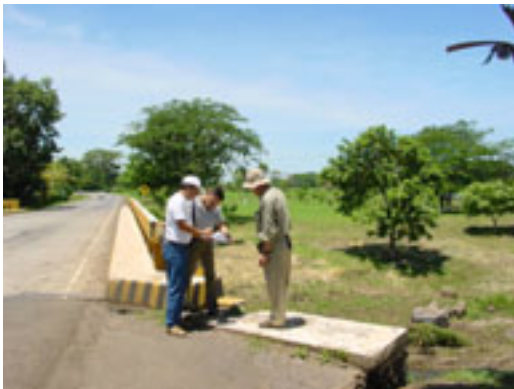
meters or more than the current one to submerge the entire town of Brito. In particular, the bridge piers were eroded on the undercut slope and the road surface was washed away. Currently, they are reinforced with gabions. For houses located lower than others, the water level reached almost the ceiling and one house was washed away. At a curve of a river, water tends to flow slower, the water level rises, and a flood easily occurs. Lateral eroding on an undercut slope may collapse precipices.

Closer to the front is an undercut slope. The discolored part of asphalt is where the road surface is washed away. At the foot of a person on the right is the reinforced section.

Photo2.3.7-70 Water level of flood in Brito

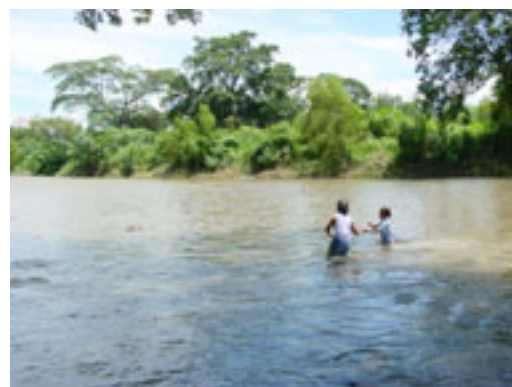
Photo2.3.7-72 María Linda River in Las Flores

In Las Flores, the María Linda River has a riverbed about four meters lower than the surrounding ground surface and precipices on both the banks. The river is about 20 meters wide and 0.5 meters deep and flows very slowly. Here is a water level observatory of INSIVUMEH, which observes the water level twice a day. The observatory uses radio to communicate with INSIVUMEH. Hurricane Mitch raised the water level by five meters and submerged the vicinity to a depth of about one meter. In this area, a flood was caused by the 1969 Hurricane Flancia before Hurricane Mitch but there was no flood inbetween. Since some sections are mounds in CA2 that passes this location, the effect of controlling the expansion of a flood must be considered. The land in this area is used as sugar cane fields and pastures.

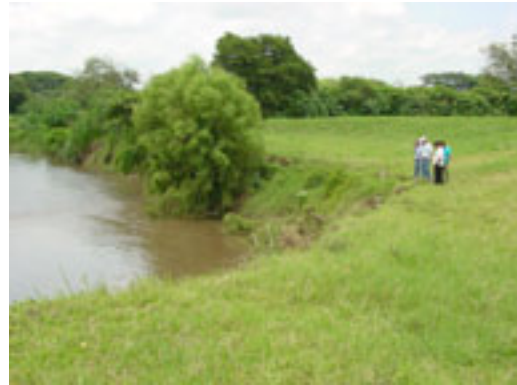
Photo2.3.7-73 Junction between the María Linda River and the Micyatoya River

At the junction of the María Linda River and the Micyatoya River, a flood caused by Hurricane Mitch eroded the undercut slope of the river for about 20 meters. At this location, too, embankment was built after the flood caused by Hurricane Mitch.

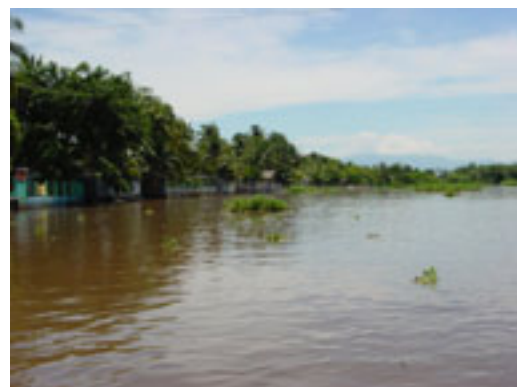
Photo2.3.7-74 María Linda River near Iztapa

The town of Iztapa is located among sand dunes. Sand dunes constitute a land a few meters higher than a lowland area and are generally not prone to flooding. However, Hurricane Mitch raised the water level of lagoons in sand dunes from the María Linda River to Monte Rico and caused the water to overflow the sand dunes to reach the coastline.

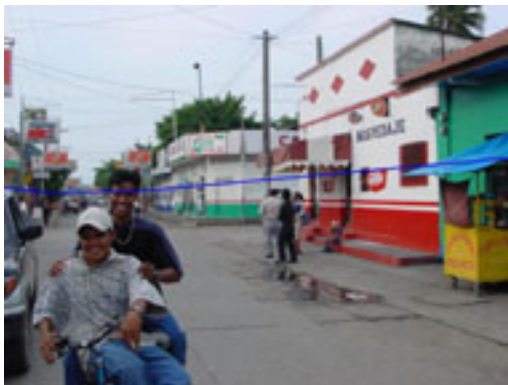
Puerto San José is twelve kilometers away from the María Linda River and tends to be influenced by a flood from the Achiguate River. Most of the town is in a lowland area, where inundation damage occurred many times in the past. Especially, Hurricane Mitch flooded the area to the depth of three to four meters for a few days. In the east part of the town, there is a sand dune zone 600 meters long, 150 meters wide, a few meters higher than the lowland area and not prone to flooding.

Photo2.3.7-75 Puerto San José Hurricane Mitch caused a flood up to the blue line.
