Section 3 Bukhara to Gazachak via dam crossing - Kms 344

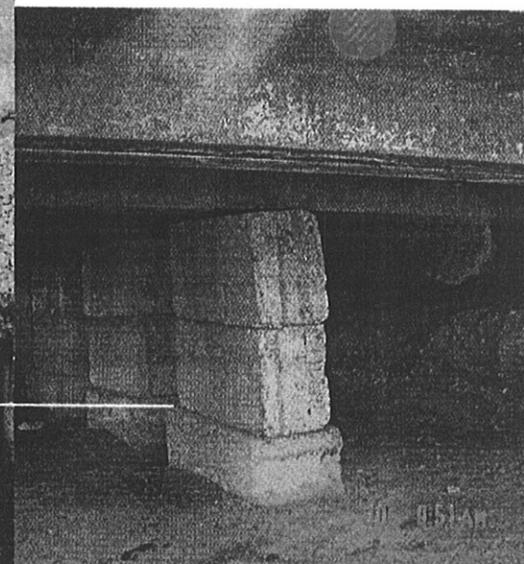
Km 37 Bridge 3 x 9m section
considered suspect as there were concrete block placed under approach and exit sections as reinforcement although not touching.

Km37.0 3 x 9 m の橋。橋入り口及び出口の橋げた
があるため、橋の強度に疑問があり。
