PANALPINA

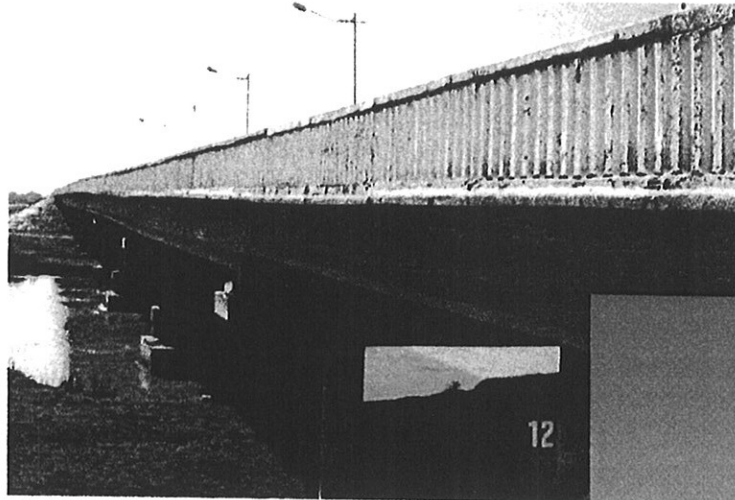
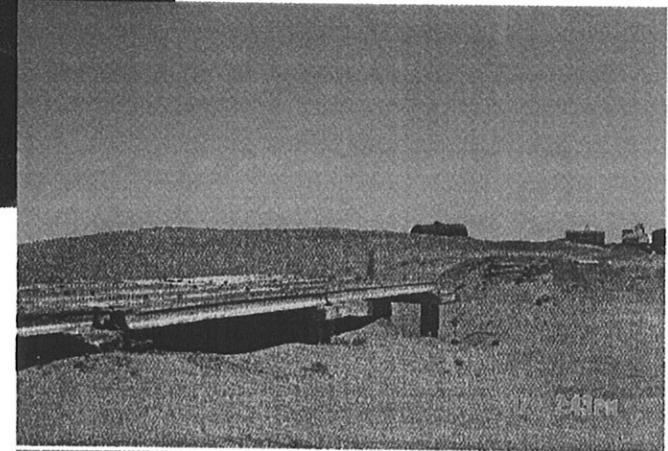
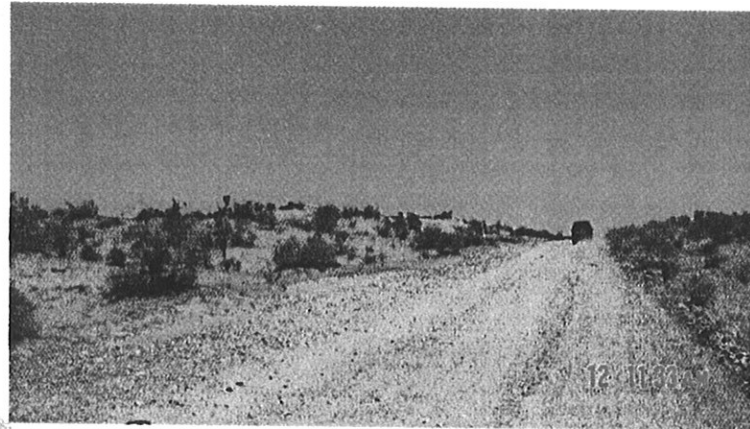
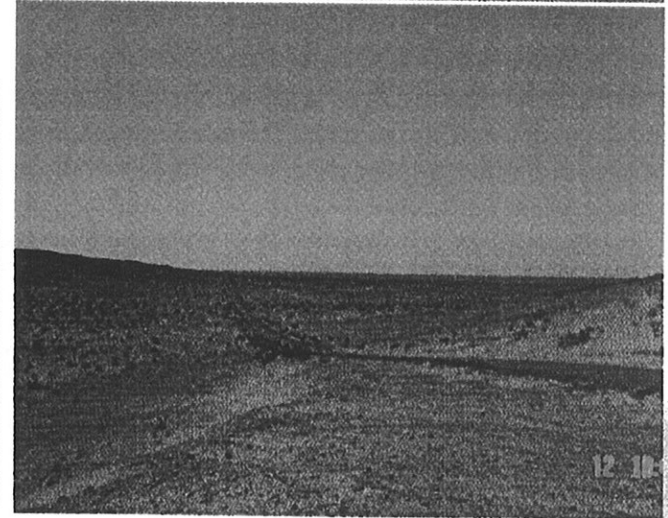
Km 61 Major Bridge
8 x 24m sections and 1 x 33m
Main beams 1.5m depth.
Road width 10m.

Km 66 Bridge 3 x 6m sections.
Km 69 turn left.

Km 73 bridge 2 x 6m section.

Km 187 bridge collapsed. By
pass available which has been
in existence for several years.

KM 339 Road deteriorates to
compacted gravel for 9km but
no problem for transports.
