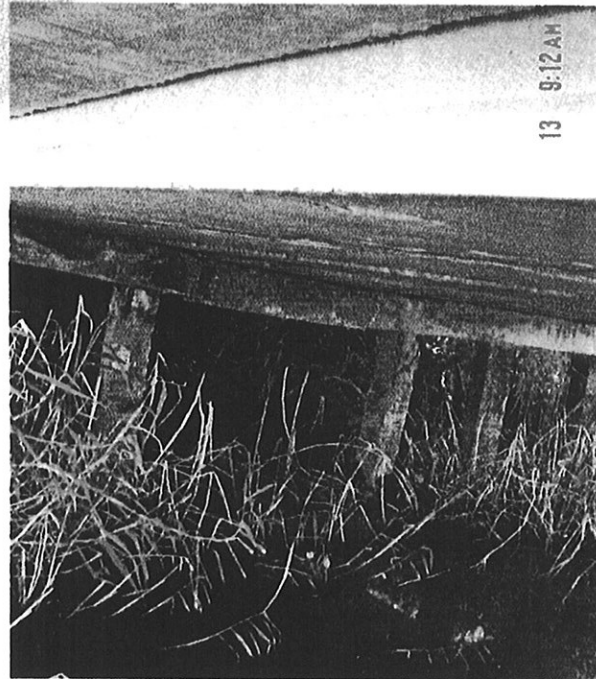
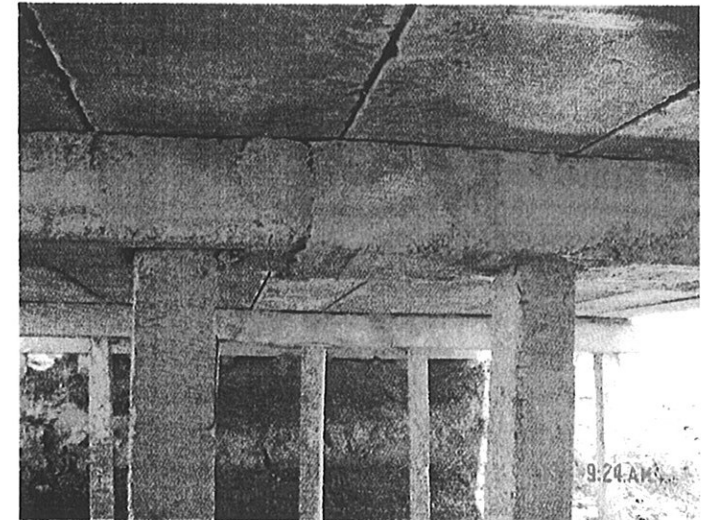
Km 75 Bridge 3 x 9m section
And one 4 x 6m with need of repair due to column deterioration.

Km 84 Bridge 3 x 9m section. Transport to keep to left of centre due to difference in column quality.

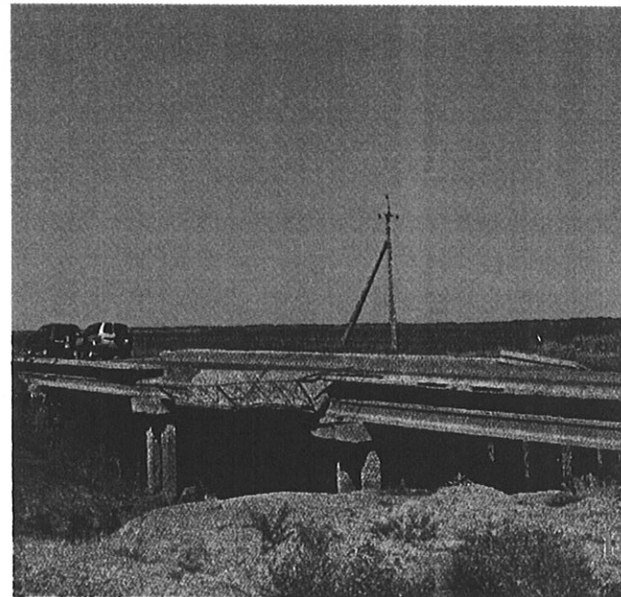
Km 91 Bridge 5 x 9m section
This bridge looks in very bad condition due to collapsed walkways. Deck beams are solid concrete and piers are with double columns support. Top of columns have bad spalling but can be repaired easily.

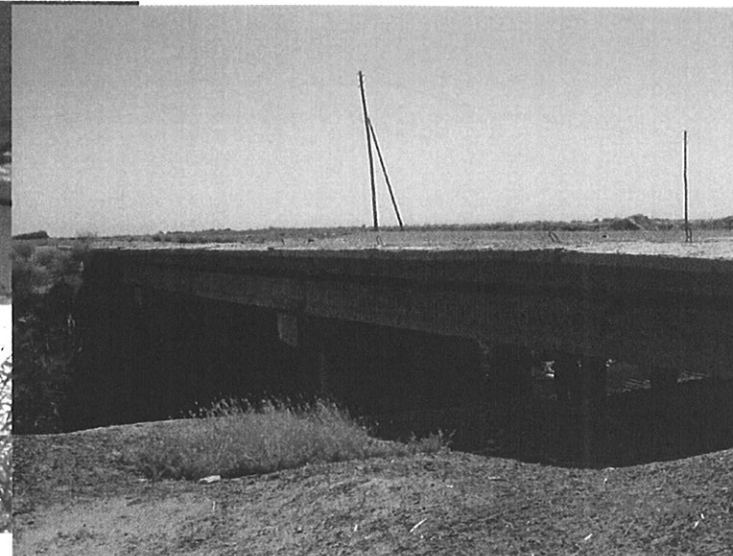
Km 92 Bridge 3 x 9m section
Some column tops to be
repaired.

Km92.0 3 x 9 m の橋。橋げたの上の方は修繕必要。

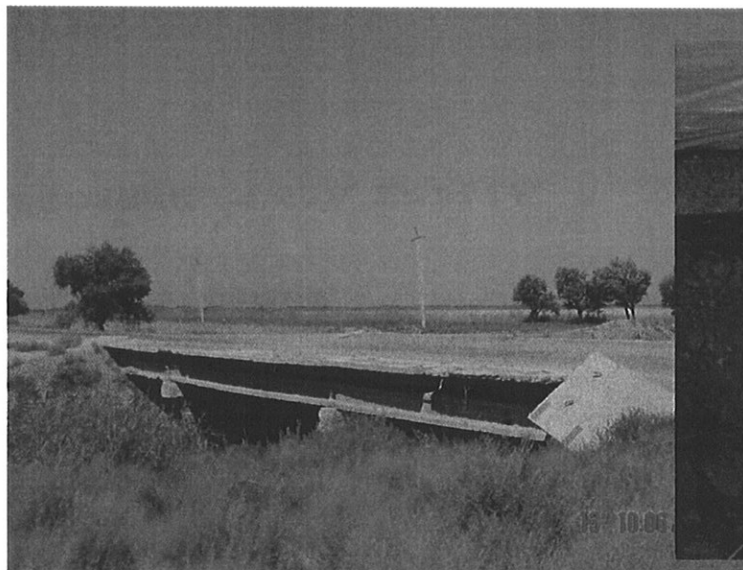
Km 100 Bridge 3 x 9m section
requires some repair to three
column tops.

Km100.0 3 x 9 m の橋。橋げたの上の方は修繕必要。
