Japan International Cooperation Agency (JICA)

**Ministry of Settlement and Regional Infrastructure (MOSRI)
The Republic of Indonesia**

**THE STUDY
ON
COMPREHENSIVE RECOVERY PROGRAM
OF
IRRIGATION AGRICULTURE**

**Priority List
of
Irrigation Schemes
for
Rehabilitation
(North Sumatra Province)**

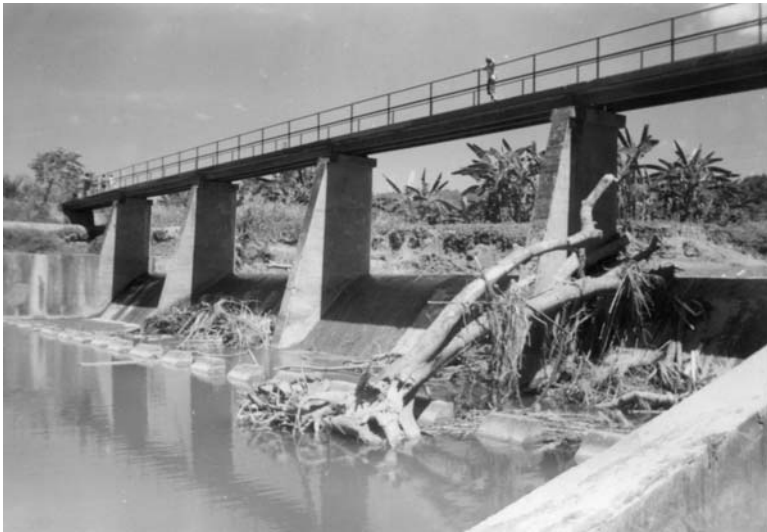
<i>Category</i> Irrigation (Headworks)		
		<i>Structure</i> Weir with Settling Basin in Downstream		
		<i>Condition</i> <input type="checkbox"/> A <input checked="" type="checkbox"/> B <input type="checkbox"/> C <input type="checkbox"/> D		
		<i>Problems</i> Settlement or washed away of stilling basin; fallen down, incline or washed away of retaining wall of weir; sedimentation of sand at upstream of weir.

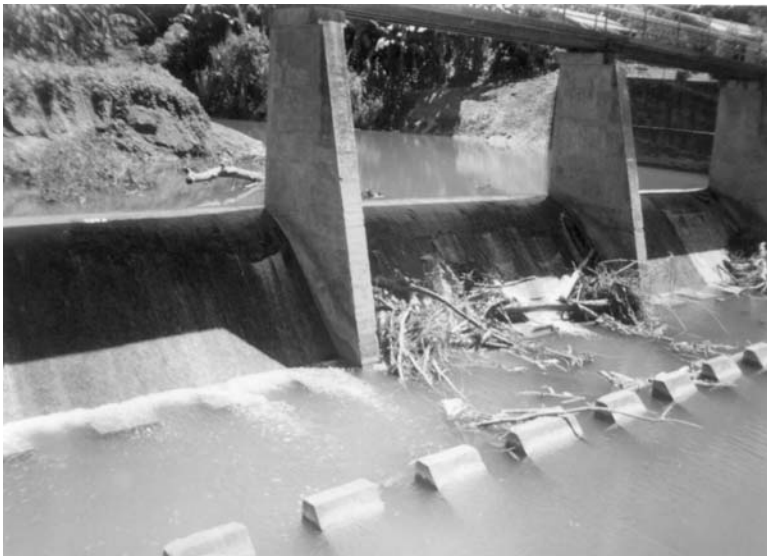
<i>Category</i> Irrigation (Headworks)		
		<i>Structure</i> Fixed Weir		
		<i>Condition</i> <input type="checkbox"/> A <input checked="" type="checkbox"/> B <input type="checkbox"/> C <input type="checkbox"/> D		
		<i>Problems</i> Washed away of ripraps or blocks at downstream of stilling basin

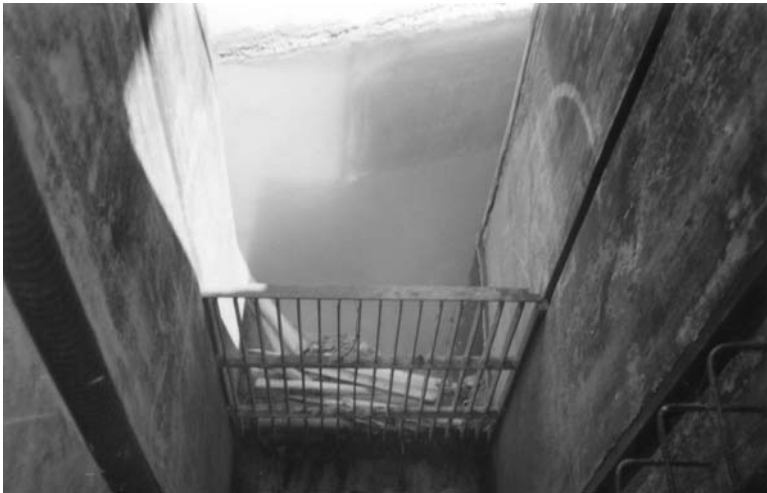
<i>Category</i> Irrigation (Headworks)		
		<i>Structure</i> Intake Gate with Trash Rack

<i>Condition</i> <input type="checkbox"/> A <input checked="" type="checkbox"/> B <input type="checkbox"/> C <input type="checkbox"/> D		
		<i>Problems</i> Leakage from gate leaf, insufficient strength against design load due to rust, decay of steel materials; sediment in front of inlet of intake

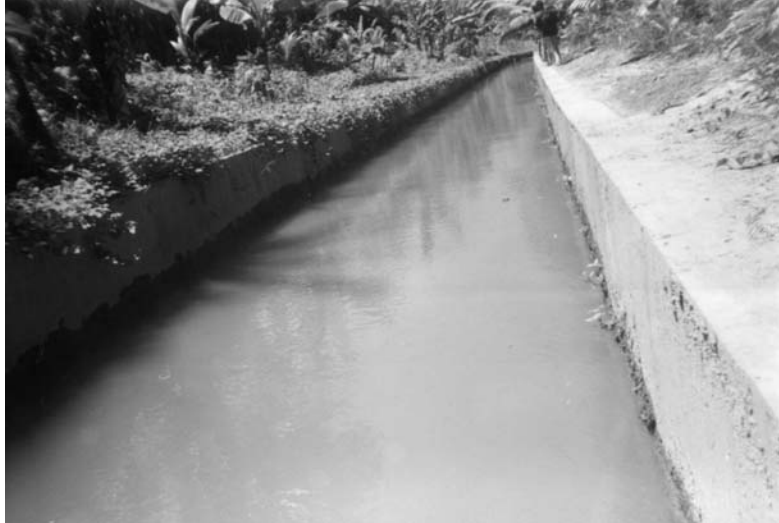
<i>Category</i> Irrigation (Main Canal)			
				<i>Structure</i> Concrete Lined Canal			
				<i>Condition</i> <input type="checkbox"/> A <input type="checkbox"/> B <input type="checkbox"/> C <input checked="" type="checkbox"/> D			
				<i>Problems</i> Lower strength of lined canal; sedimentation; inflow into canal during rain, no inspection road.			
				<i>Category</i>			
				<i>Structure</i>			
				<i>Condition</i> <input type="checkbox"/> A <input type="checkbox"/> B <input type="checkbox"/> C <input type="checkbox"/> D

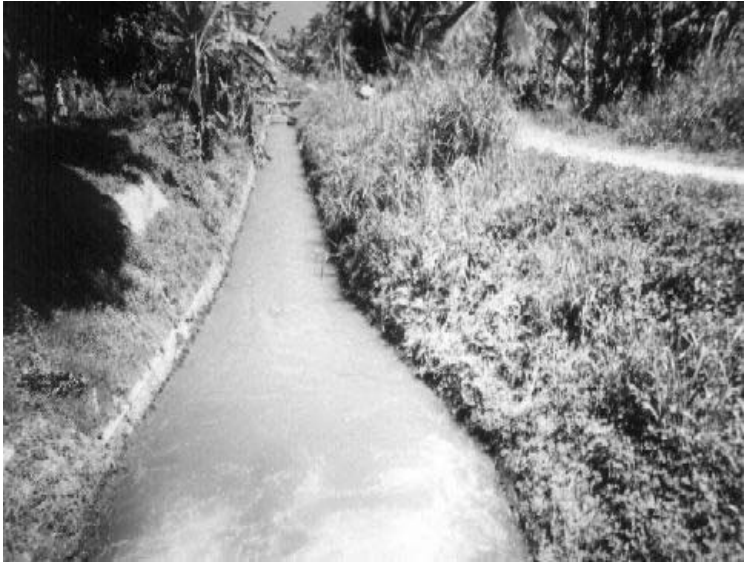
<i>Category</i> Irrigation (Secondary Canal)			
		<i>Structure</i> Masonry Lined Canal			
		<i>Condition</i> <input type="checkbox"/> A <input type="checkbox"/> B <input checked="" type="checkbox"/> C <input type="checkbox"/> D			
		<i>Problems</i> Sediment; no drainage ditch along canal; and no maintenance.

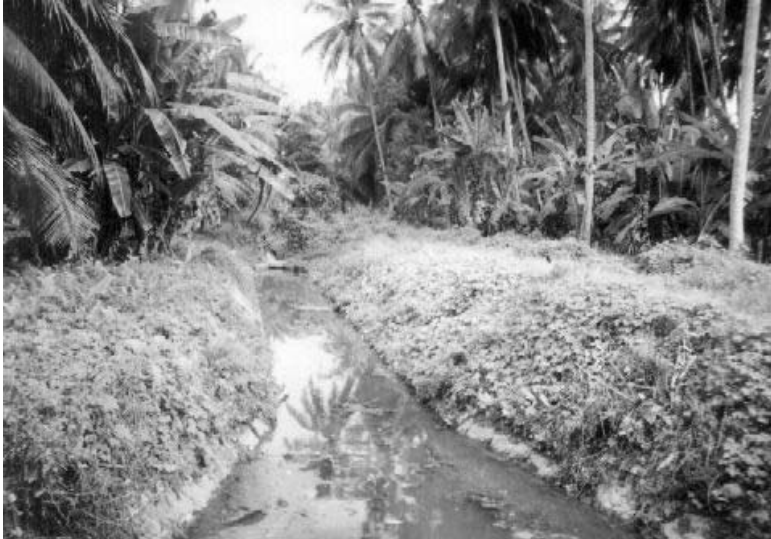
<i>Category</i> Irrigation (Secondary Canal)			
		<i>Structure</i> Canal			
		<i>Condition</i> <input type="checkbox"/> A <input type="checkbox"/> B <input checked="" type="checkbox"/> C <input type="checkbox"/> D			
		<i>Problems</i> Sediment; collapse of canal; and no maintenance.

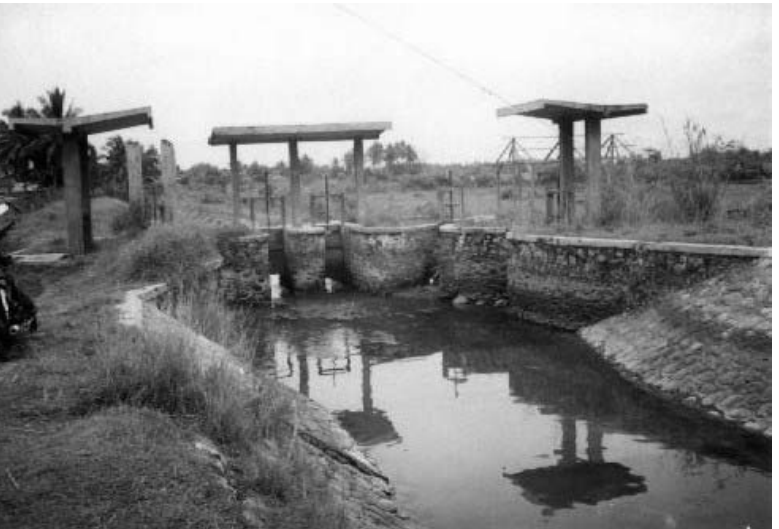
<p><u>Category</u> Irrigation (Main Canal)</p>			
		<p><u>Structure</u> Division Structure</p>			
		<p><u>Condition</u> <input type="checkbox"/> A <input type="checkbox"/> B <input checked="" type="checkbox"/> C <input type="checkbox"/> D</p>			
		<p><u>Problems</u> Washed away of ripraps or blocks at downstream of stilling basin</p>

<p><u>Problems</u> Leakage from gate leaf; problem on management due to lack of periodically maintenance.</p>			
		<p><u>Problems</u> Lower function of division structure due to sedimentation in front of gate; physical operation problem on division structure due to O&M problem and structure damage.</p>

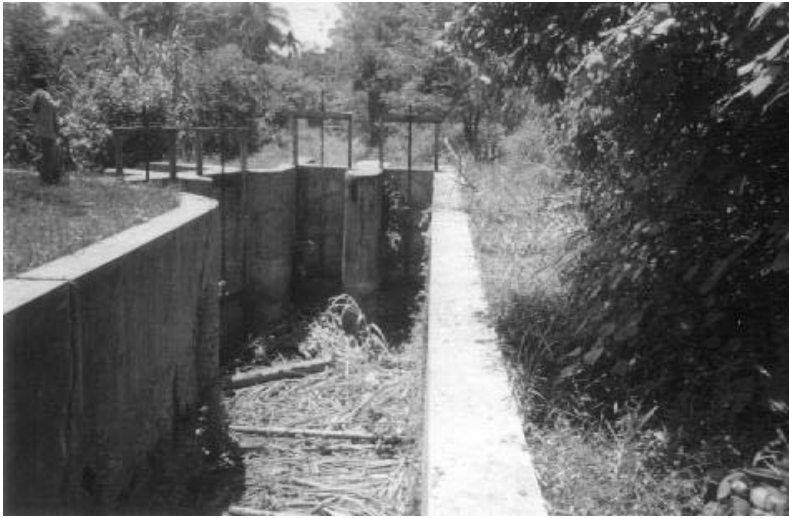
<p><u>Category</u> Irrigation (Headworks)</p>			
		<p>Irrigation (Headworks) Intake and Spillway Gate</p>			
		<p><u>Condition</u> <input type="checkbox"/> A <input type="checkbox"/> B <input type="checkbox"/> C <input checked="" type="checkbox"/> D</p>

<p><u>Problems</u> Out of function.</p>

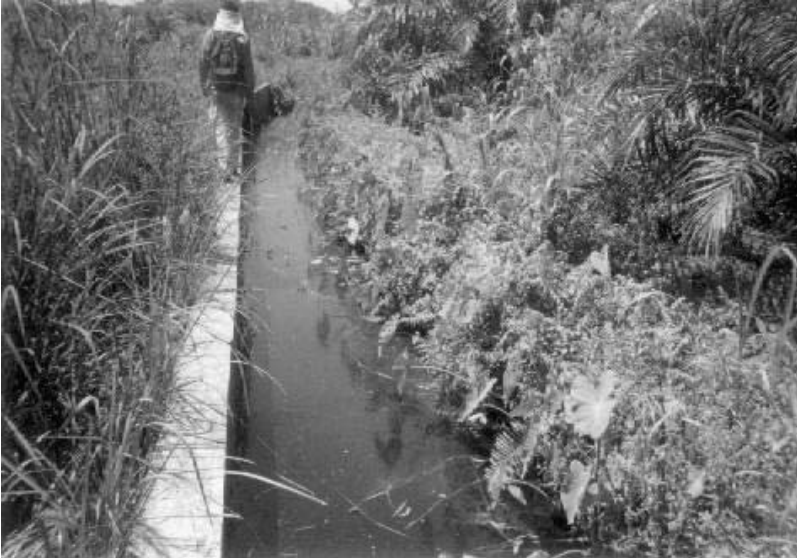
<u>Category</u> Irrigation (Main Canal)		
		<u>Structure</u> Concrete Lined Canal		
		<u>Condition</u> <input type="checkbox"/> A <input type="checkbox"/> B <input type="checkbox"/> C <input checked="" type="checkbox"/> D		
		<u>Problems</u> Sedimentation; leakage from lined canal; crack or damage on lined canal; and no inspection road.		
		<u>Category</u>		
		<u>Structure</u>		
		<u>Condition</u> <input type="checkbox"/> A <input type="checkbox"/> B <input type="checkbox"/> C <input type="checkbox"/> D		
		<u>Problems</u>

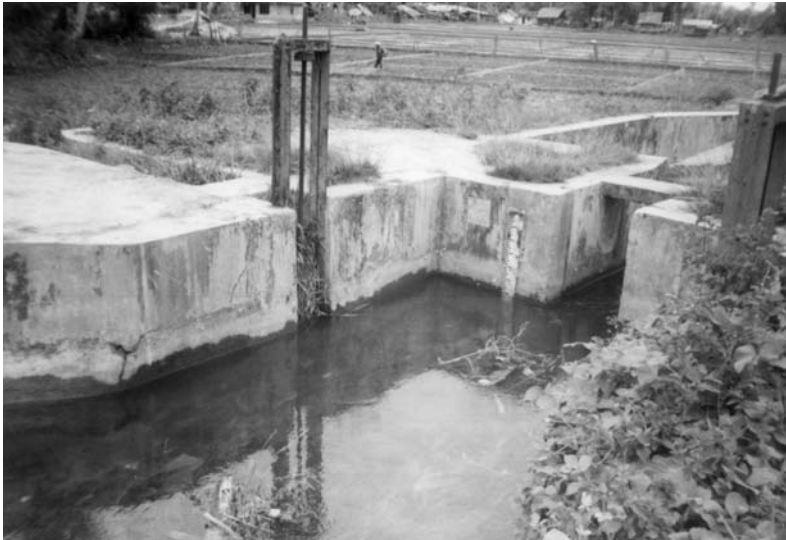
<p><u>Category</u> Irrigation (Main Canal)</p>		
		<p><u>Structure</u> Division Structure</p>		
		<p><u>Condition</u> <input type="checkbox"/> A <input type="checkbox"/> B <input type="checkbox"/> C <input checked="" type="checkbox"/> D</p>		
		<p><u>Problems</u> Lower function on division structure; physical operation problem due to less or no function of steel gates.</p>

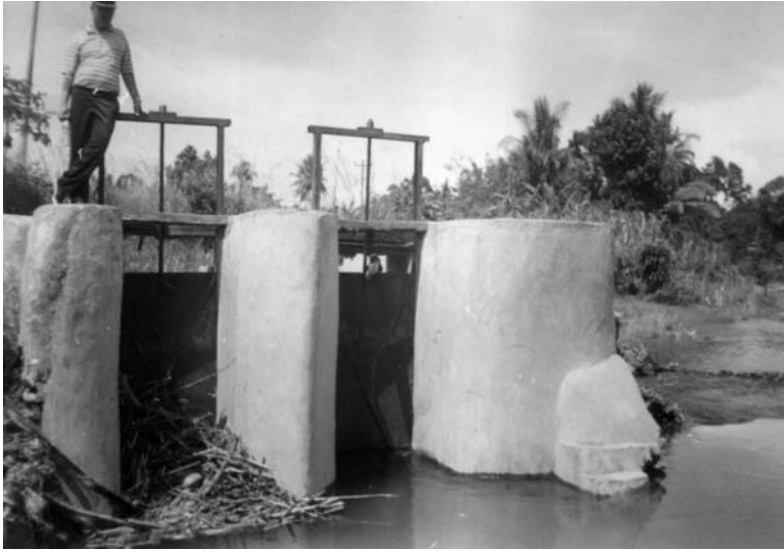
<p><u>Category</u> Irrigation (Free Intake)</p>		
		<p><u>Structure</u> Masonry Construction</p>		
		<p><u>Condition</u> <input type="checkbox"/> A <input type="checkbox"/> B <input type="checkbox"/> C <input checked="" type="checkbox"/> D</p>

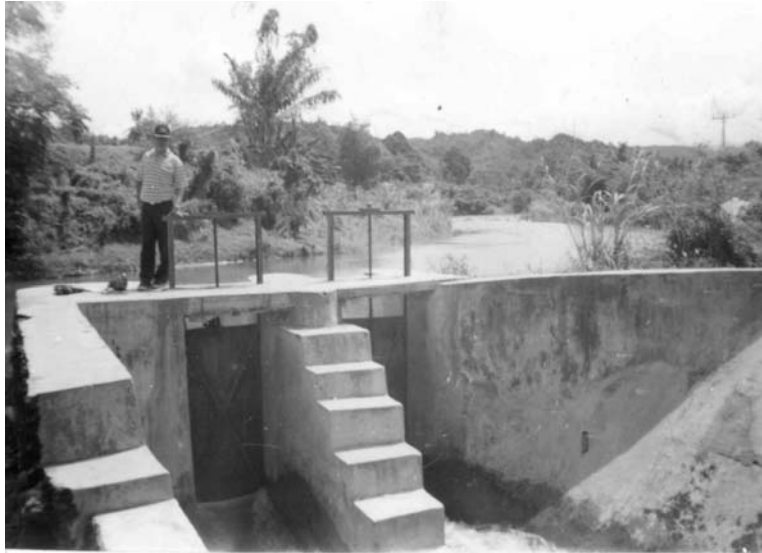
<p><u>Category</u> Irrigation (Free Intake)</p>		
		<p><u>Structure</u> Intake Gate</p>		
		<p><u>Condition</u> <input type="checkbox"/> A <input type="checkbox"/> B <input type="checkbox"/> C <input checked="" type="checkbox"/> D</p>

<p><u>Problems</u> Leakage from intake gate; insufficient strength against design load due to rust, decay of steel materials; physical operational problems due to trouble; problem on management due to lack of periodically maintenance.</p>

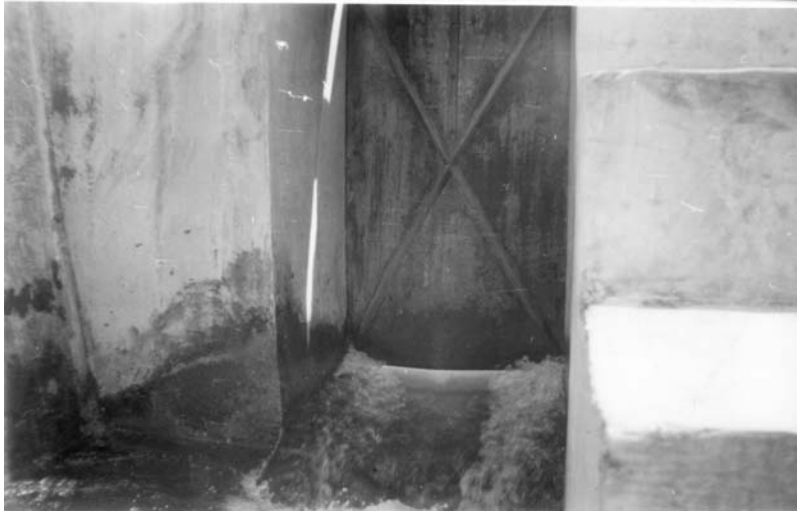
<p><u>Category</u> Irrigation (Free Intake)</p>		
		<p><u>Structure</u> Intake Gate</p>		
		<p><u>Condition</u> <input type="checkbox"/> A <input type="checkbox"/> B <input type="checkbox"/> C <input checked="" type="checkbox"/> D</p>		
<p><u>Problems</u> Insufficient diversion water due to river bed degradation; insufficient diversion water due to sedimentation in front of intake; settlement of intake structure; and washed away of wing wall.</p>		<p><u>Problems</u> Insufficient diversion water due to river bed degradation; insufficient diversion water due to sedimentation in front of intake; settlement of intake structure; and deterioration of steel gates.</p>

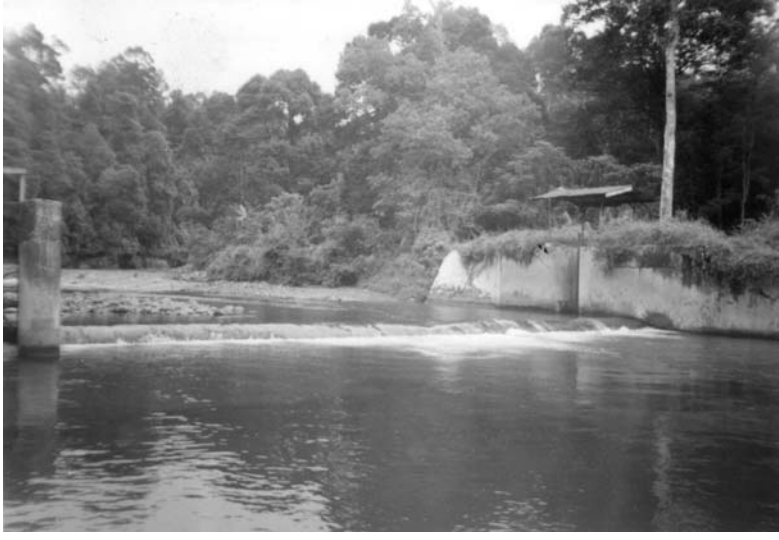
<p><u>Category</u> Irrigation (Headworks)</p>		
		<p><u>Structure</u> Fixed Weir</p>		
		<p><u>Condition</u> <input type="checkbox"/> A <input type="checkbox"/> B <input type="checkbox"/> C <input checked="" type="checkbox"/> D</p>		
		<p><u>Problems</u> Crack or damage on weir crest; settlement of weir body; sedimentation at weir; settlement or breakage of apron</p>

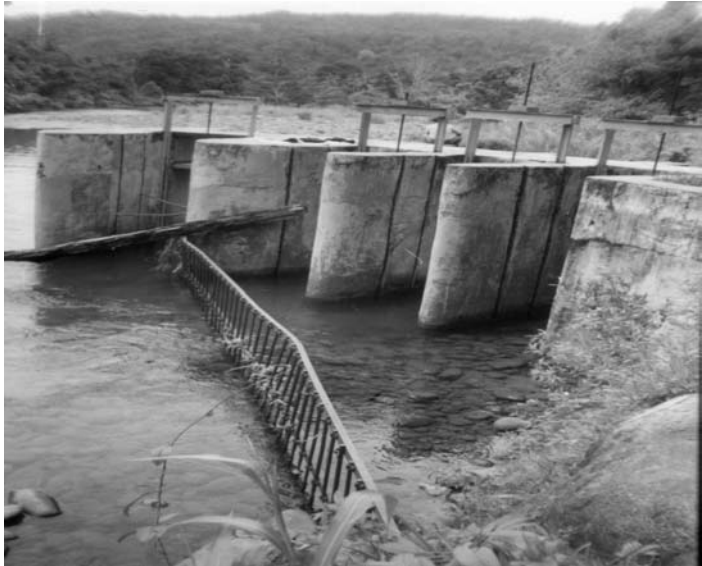
<p><u>Category</u> Irrigation (Headworks)</p>		
		<p><u>Structure</u> Intake with Trash Rack</p>		
		<p><u>Condition</u> <input type="checkbox"/> A <input type="checkbox"/> B <input type="checkbox"/> C <input checked="" type="checkbox"/> D</p>		
		<p><u>Problems</u> Insufficient diversion water due to sedimentation in front of intake; problem on management due to lack of periodically maintenance; leakage from gate leaf, insufficient strength against design load due to rust, decay of steel material</p>

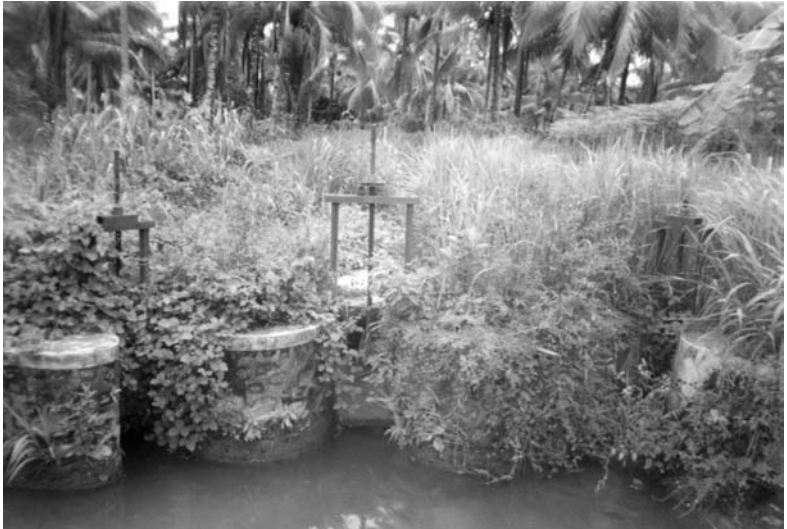
<p><u>Category</u> Irrigation (Main Canal)</p>		
		<p><u>Structure</u> Off-take Structure</p>		
		<p><u>Condition</u> <input type="checkbox"/> A <input type="checkbox"/> B <input type="checkbox"/> C <input checked="" type="checkbox"/> D</p>		
		<p><u>Problems</u> Lower function of turn out structure; physical operation problem on turn out structure due to sedimentation; and deterioration of steel gates.</p>

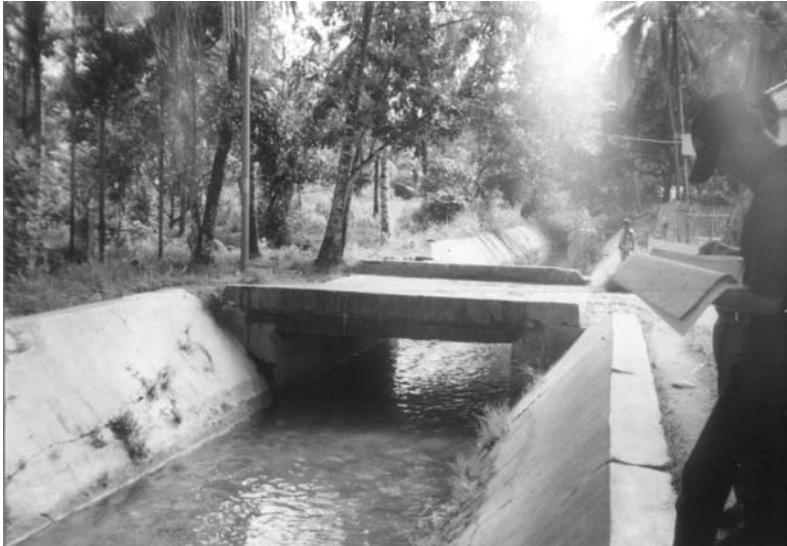
<p><u>Category</u> Irrigation (Main Canal)</p>			
		<p><u>Structure</u> Lined Main Canal</p>			
		<p><u>Condition</u> <input type="checkbox"/> A <input type="checkbox"/> B <input type="checkbox"/> C <input checked="" type="checkbox"/> D</p>			
		<p><u>Problems</u> Sedimentation; crack or damage on lined canal; leakage from lined canal; deflection of lining toward inside of canal; and no inspection road.</p>

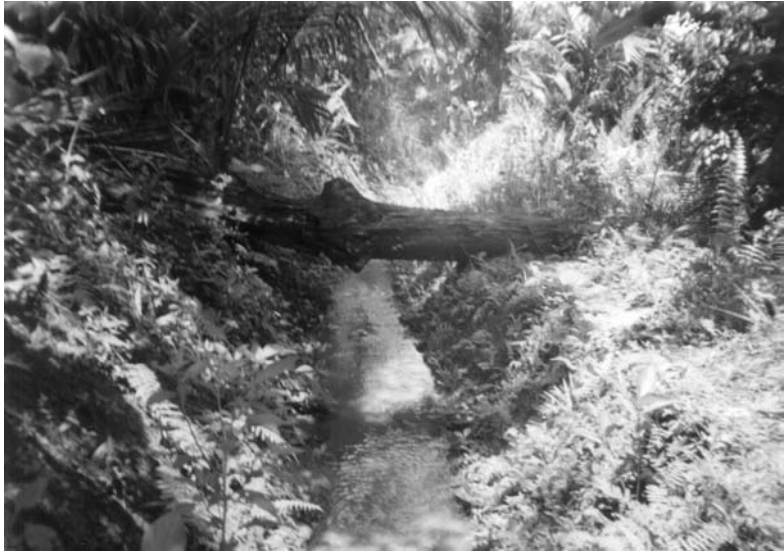
<u>Category</u> Irrigation (Secondary Canal)			
		<u>Structure</u> Earth Canal			
		<u>Condition</u> <input type="checkbox"/> A <input type="checkbox"/> B <input type="checkbox"/> C <input checked="" type="checkbox"/> D			
		<u>Problems</u> Sedimentation; leakage from canal; collapse on canal; difficulty on maintenance of earth canal; and no inspection road.			
		<u>Category</u>			
		<u>Structure</u>			
		<u>Condition</u> <input type="checkbox"/> A <input type="checkbox"/> B <input type="checkbox"/> C <input type="checkbox"/> D			
		<u>Problems</u>			
		<u>Category</u>			
		<u>Structure</u>			
		<u>Condition</u> <input type="checkbox"/> A <input type="checkbox"/> B <input type="checkbox"/> C <input type="checkbox"/> D			
		<u>Problems</u>

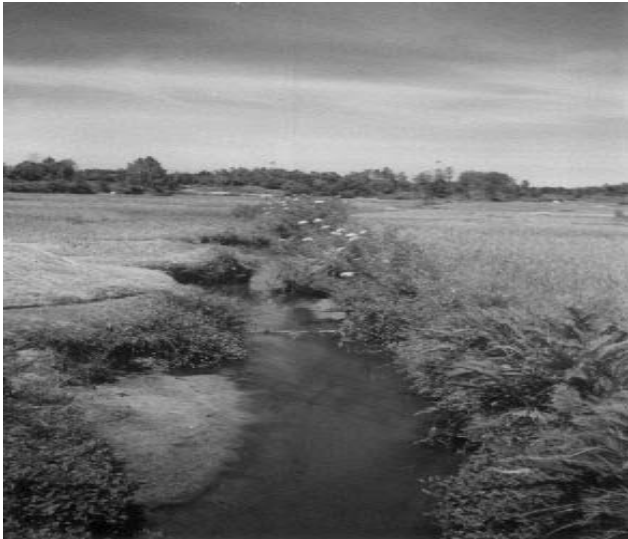
<p><u>Category</u> Irrigation (Secondary Canal)</p>		
		<p><u>Structure</u> Earth Canal</p>

<p><u>Condition</u> <input type="checkbox"/> A <input type="checkbox"/> B <input type="checkbox"/> C <input checked="" type="checkbox"/> D</p>		
		<p><u>Problems</u> Sedimentation or obstruction of water flow; leakage from canal; collapse of canal; difficulty on maintenance of earth canal; and no inspection road.</p>

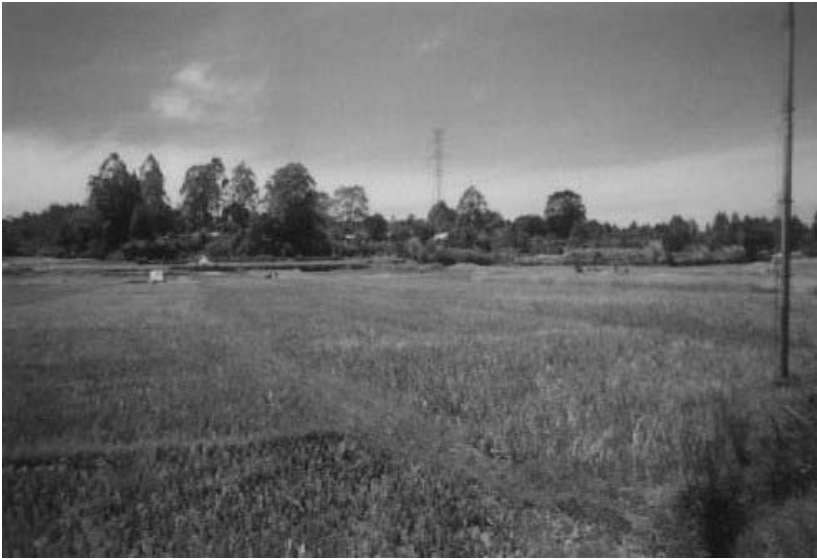
<u>Category</u> Agriculture, On-Farm		
		<u>Activity</u> Paddy Cultivation		
		<u>Condition</u> <input type="checkbox"/> A <input type="checkbox"/> B <input type="checkbox"/> C <input checked="" type="checkbox"/> D		
		<u>Problems</u> Low density of on-farm canal and farm roads.		
		<u>Category</u>		
		<u>Structure</u>		
		<u>Condition</u> <input type="checkbox"/> A <input type="checkbox"/> B <input type="checkbox"/> C <input type="checkbox"/> D		
		<u>Problems</u>		
		<u>Category</u>		
		<u>Structure</u>		
		<u>Condition</u> <input type="checkbox"/> A <input type="checkbox"/> B <input type="checkbox"/> C <input type="checkbox"/> D		
		<u>Problems</u>

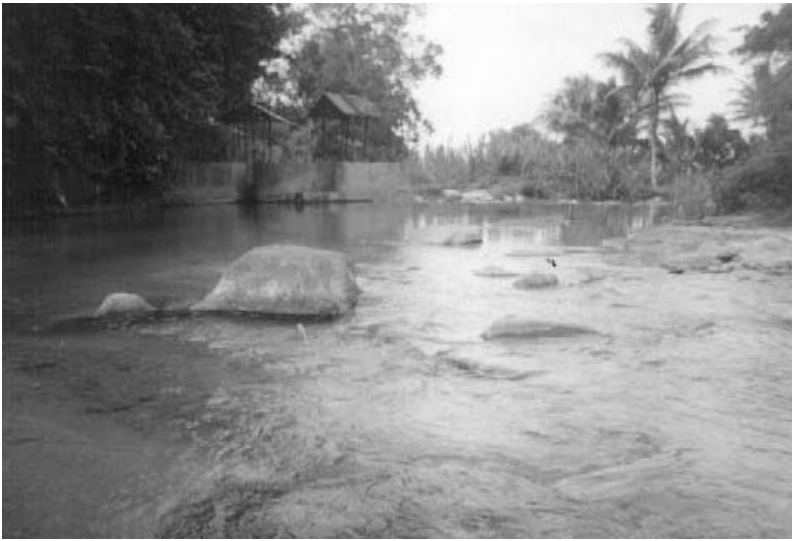
<i>Category</i> Irrigation (Headworks)		
		<i>Structure</i> Fixed Weir		
		<i>Condition</i> <input type="checkbox"/> A <input type="checkbox"/> B <input checked="" type="checkbox"/> C <input type="checkbox"/> D		
		<i>Problems</i> Crack or damage on weir crest; settlement of weir body; sedimentation in front of intake.

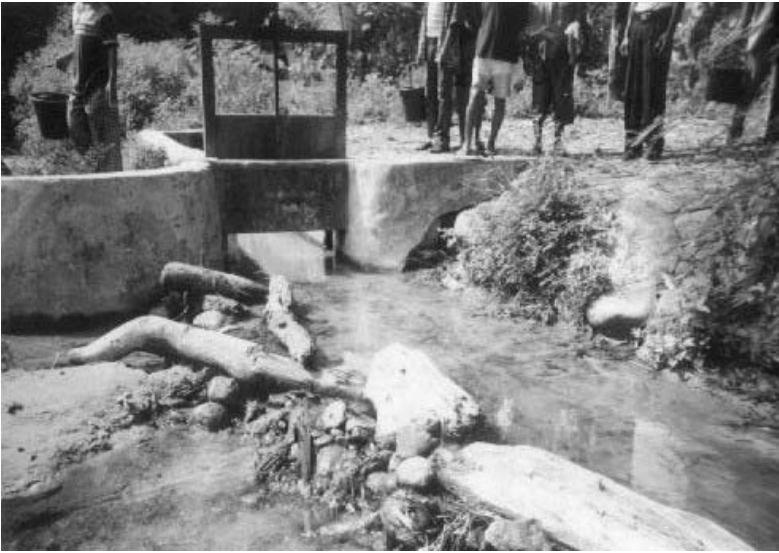
<i>Category</i> Irrigation (Headworks)		
		<i>Structure</i> Intake and Intake Gate		
		<i>Condition</i> <input type="checkbox"/> A <input type="checkbox"/> B <input type="checkbox"/> C <input checked="" type="checkbox"/> D		
		<i>Problems</i> Less function and urgent measures are needed.

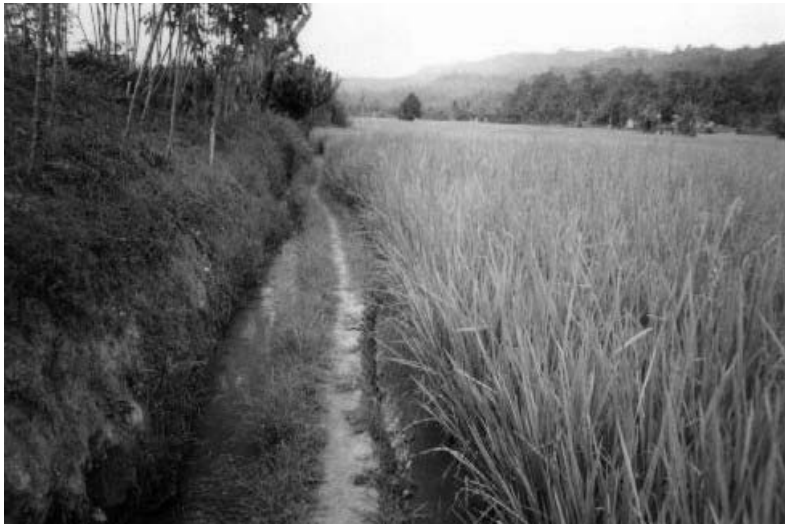
<i>Category</i> Irrigation (Main Canal)		
		<i>Structure</i> Canal		
		<i>Condition</i> <input type="checkbox"/> A <input type="checkbox"/> B <input type="checkbox"/> C <input checked="" type="checkbox"/> D

<i>Problems</i> Sedimentation; leakage from canal; collapse of canal; difficulty on maintenance of earth canal; and less related structure.

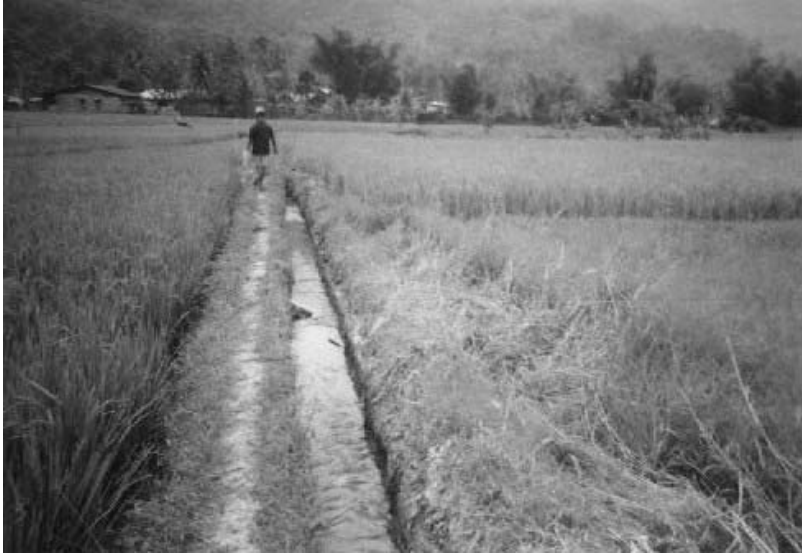
<u>Category</u> Irrigation (Secondary Canal)		
		<u>Structure</u> Earth Canal		
		<u>Condition</u> <input type="checkbox"/> A <input type="checkbox"/> B <input type="checkbox"/> C <input checked="" type="checkbox"/> D		
		<u>Problems</u> Sedimentation; leakage from canal; collapse of canal; difficulty on maintenance of earth canal; and less related structure.		
		<u>Category</u>		
		<u>Structure</u>		
		<u>Condition</u> <input type="checkbox"/> A <input type="checkbox"/> B <input type="checkbox"/> C <input type="checkbox"/> D		
		<u>Problems</u>		
		<u>Category</u>		
		<u>Structure</u>		
		<u>Condition</u> <input type="checkbox"/> A <input type="checkbox"/> B <input type="checkbox"/> C <input type="checkbox"/> D		
		<u>Problems</u>

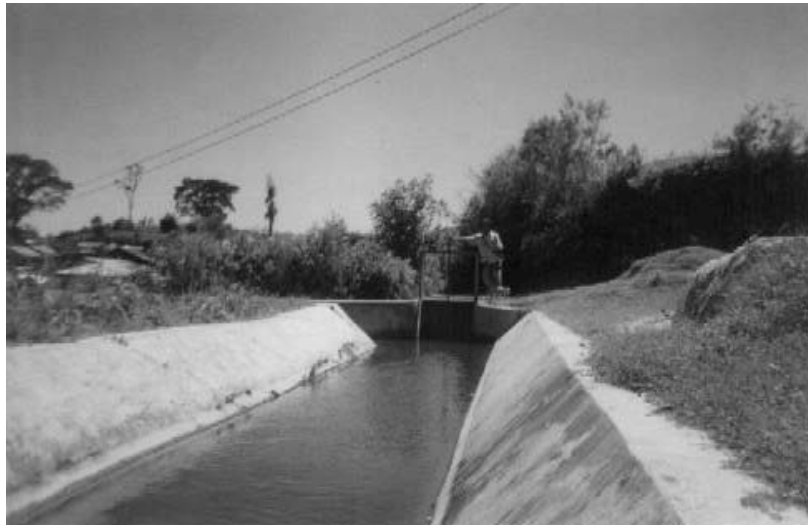
<p><u>Category</u> Irrigation (Main Canal)</p>		
		<p><u>Structure</u> Masonry Lined Canal</p>		
		<p><u>Condition</u> <input type="checkbox"/> A <input type="checkbox"/> B <input checked="" type="checkbox"/> C <input type="checkbox"/> D</p>		
		<p><u>Problems</u> Sedimentation; crack on lined canal; leakage from lined canal; deflection of lining toward inside of canal; and no inspection road.</p>

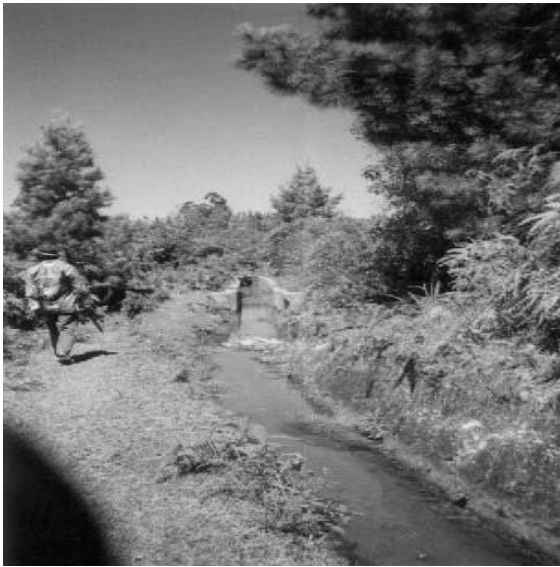
<p><u>Category</u> Irrigation (Secondary Canal)</p>		
		<p><u>Structure</u> Earth Canal</p>		
		<p><u>Condition</u> <input type="checkbox"/> A <input type="checkbox"/> B <input checked="" type="checkbox"/> C <input type="checkbox"/> D</p>		
		<p><u>Problems</u> Sedimentation; collapse of canal; leakage from canal, crack or damage on lined canal; and less function of inspection road.</p>

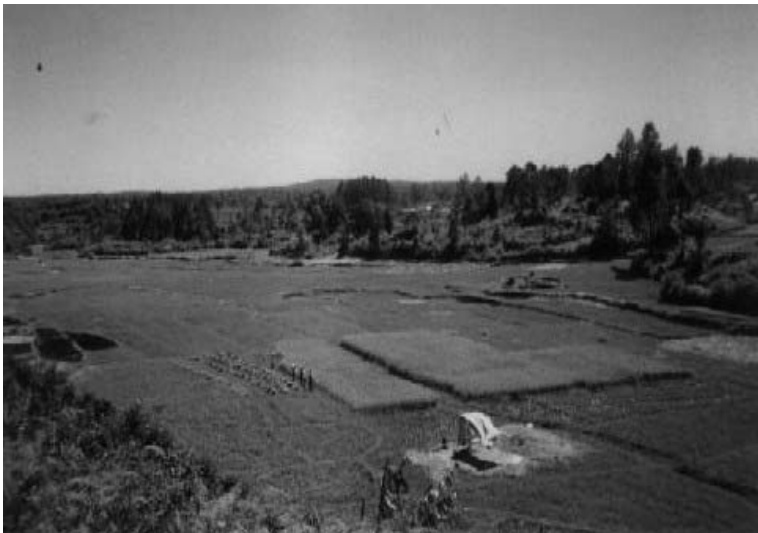
<p><u>Category</u> Agriculture, On-Farm</p>		
		<p><u>Type</u> Paddy Cultivation</p>

<p><u>Condition</u> <input type="checkbox"/> A <input type="checkbox"/> B <input type="checkbox"/> C <input checked="" type="checkbox"/> D</p>		
		<p><u>Problems</u> Low density of on-farm canal and farm roads.</p>

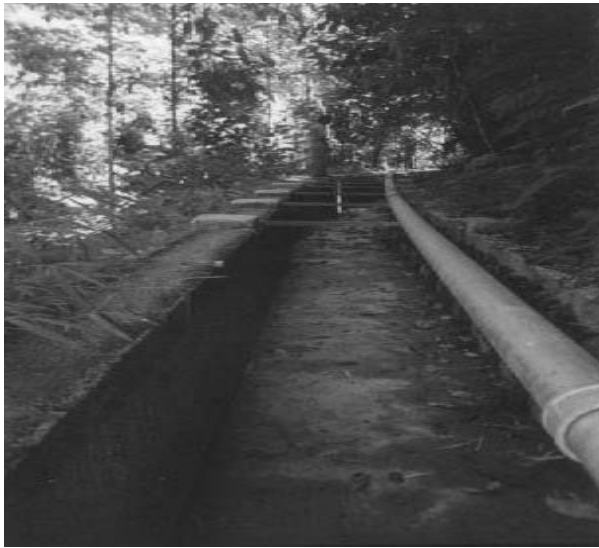
<u>Category</u> Irrigation (Secondary Canal)		
		<u>Structure</u> Masonry Lined Canal		
		<u>Condition</u> <input type="checkbox"/> A <input type="checkbox"/> B <input type="checkbox"/> C <input checked="" type="checkbox"/> D		
		<u>Problems</u> Sedimentation; crack or damage on lined canal; leakage from lined canal; deflection of lining toward inside of canal; and no inspection road.

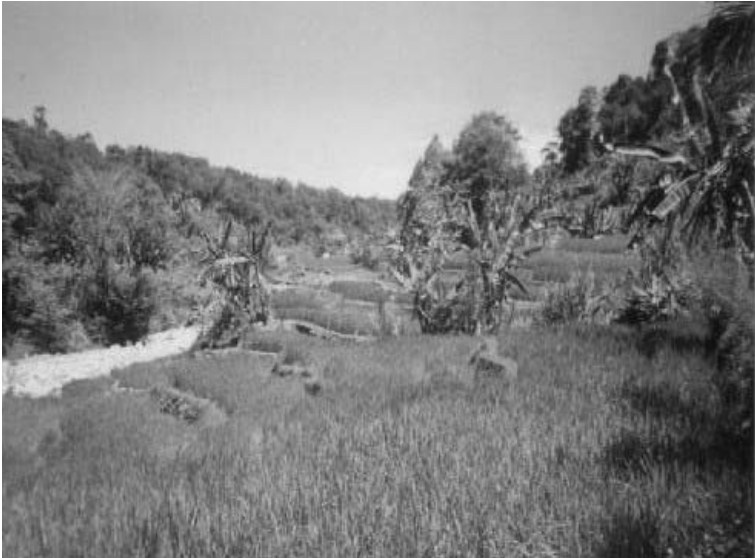
<u>Category</u> Agriculture, On-Farm		
		<u>Activity</u> Paddy Cultivation		
		<u>Condition</u> <input type="checkbox"/> A <input type="checkbox"/> B <input type="checkbox"/> C <input checked="" type="checkbox"/> D		
		<u>Problems</u> Low density of on-farm canal and farm roads.		
		<u>Category</u>		
		<u>Activity</u>		
		<u>Condition</u> <input type="checkbox"/> A <input type="checkbox"/> B <input type="checkbox"/> C <input type="checkbox"/> D

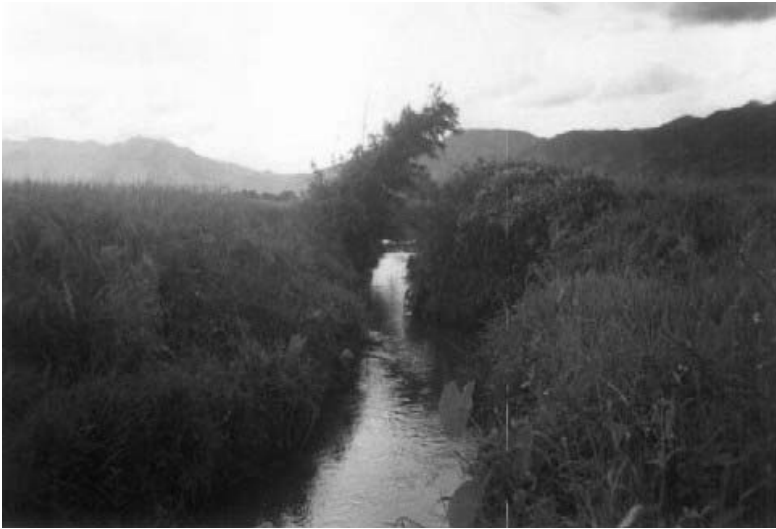
<p><u>Category</u> Irrigation (Main Canal)</p>		
		<p><u>Structure</u> Earth Canal</p>		
		<p><u>Condition</u> <input type="checkbox"/> A <input checked="" type="checkbox"/> B <input type="checkbox"/> C <input type="checkbox"/> D</p>

<p><u>Problems</u> Sedimentation ; leakage from canal; collapse on canal; difficulty on maintenance of earth canal; no maintenance; and no inspection road.</p>

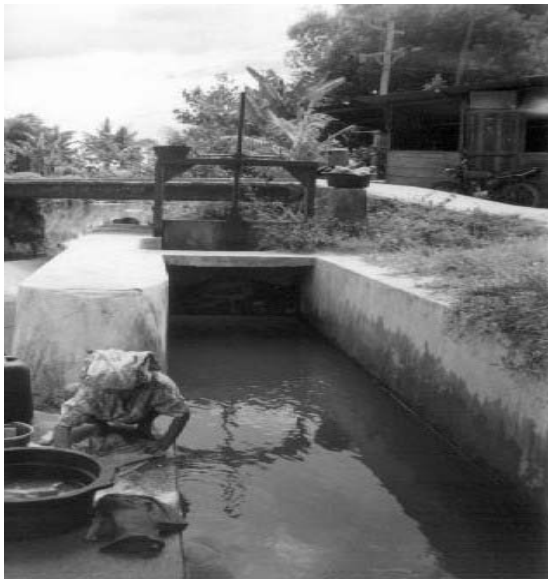
<u>Category</u> Irrigation (Secondary Canal)		
		<u>Structure</u> Concrete Lined Canal		
		<u>Condition</u> <input type="checkbox"/> A <input type="checkbox"/> B <input type="checkbox"/> C <input checked="" type="checkbox"/> D		
		<u>Problems</u> Sedimentation; crack or damage on lined canal; leakage from lined canal; deflection of lining toward inside of canal

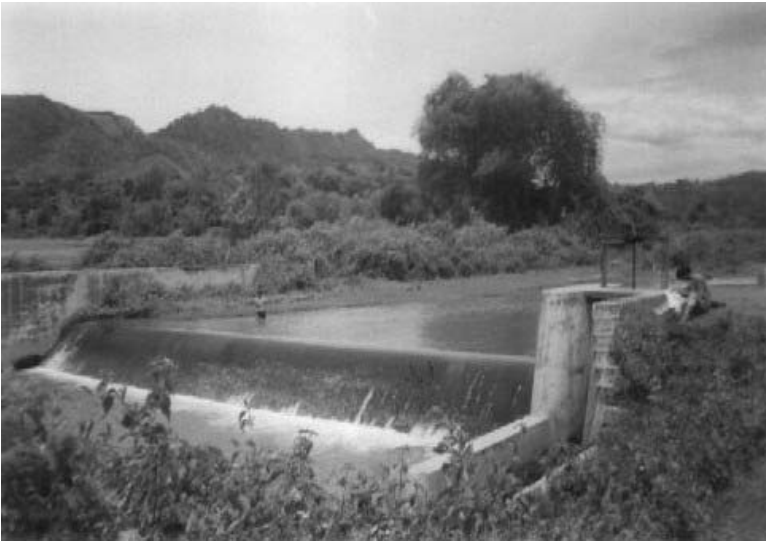
<p><u>Category</u> Irrigation (Headworks)</p>			
		<p><u>Structure</u> Fixed Weir</p>			
		<p><u>Condition</u> <input type="checkbox"/> A <input type="checkbox"/> B <input checked="" type="checkbox"/> C <input type="checkbox"/> D</p>			
		<p><u>Problems</u> Washed away of stilling basin and retaining wall; sediment in front of intake.</p>

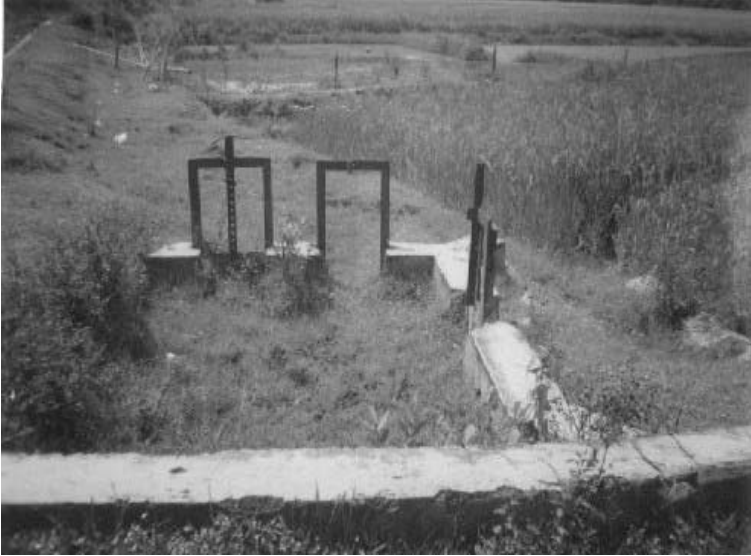
<p><u>Category</u> Irrigation (Main Canal)</p>			
		<p><u>Structure</u> Division structure</p>			
		<p><u>Condition</u> <input type="checkbox"/> A <input type="checkbox"/> B <input type="checkbox"/> C <input checked="" type="checkbox"/> D</p>			
		<p><u>Problems</u> Lower function of division structure; damage of division structure; physical operation problem on division structure on canal (no use).</p>

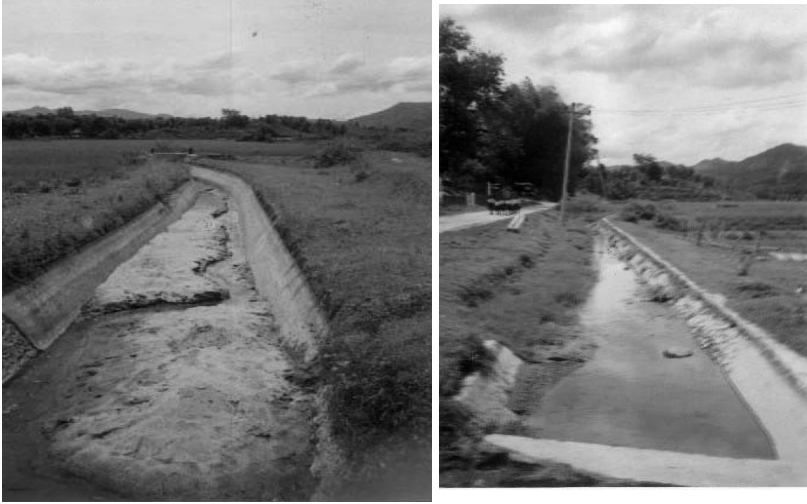
<p><u>Category</u> Irrigation (Main Canal)</p>

<p><u>Structure</u> Masonry Lined Canal</p>			
		<p><u>Condition</u> <input type="checkbox"/> A <input type="checkbox"/> B <input checked="" type="checkbox"/> C <input type="checkbox"/> D</p>			
		<p><u>Problems</u> Sedimentation; crack or damage on lined canal; leakage from lined canal; deflection of lining toward inside of canal; and no inspection road.</p>

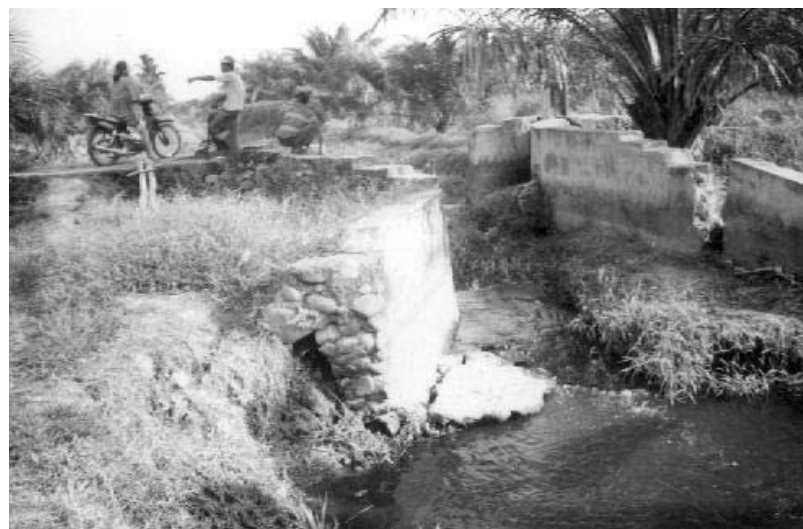
<i>Category</i> Irrigation (Main Canal)

<i>Structure</i> Off-take Structure		
		<i>Condition</i> <input type="checkbox"/> A <input type="checkbox"/> B <input type="checkbox"/> C <input checked="" type="checkbox"/> D		
		<i>Problems</i> Lower function of off-take structure; settlement or damage on off-take structure; physical operation problem on off-take structure.

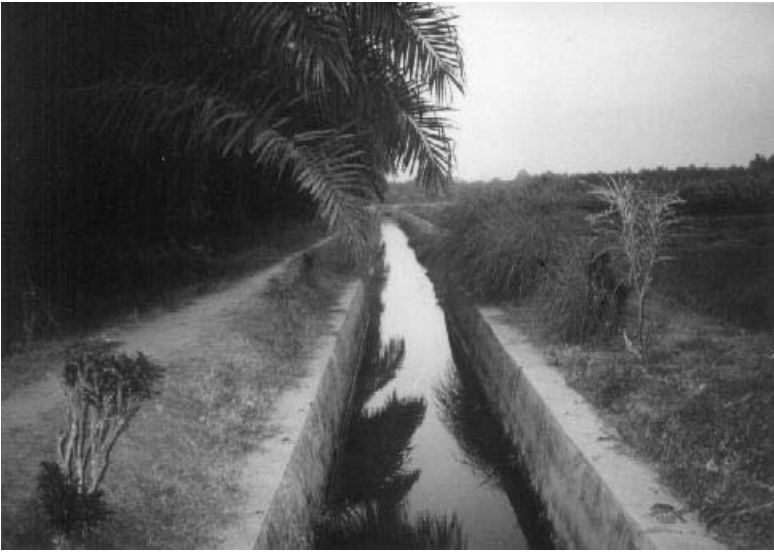
<p><u>Category</u> Irrigation (Main Canal)</p>			
		<p><u>Structure</u> Masonry Lined Canal</p>			
		<p><u>Condition</u> <input type="checkbox"/> A <input type="checkbox"/> B <input type="checkbox"/> C <input checked="" type="checkbox"/> D</p>			
		<p><u>Problems</u> Sedimentation, crack or damage on lined canal; leakage from lined canal; deflection of lining toward inside of canal</p>

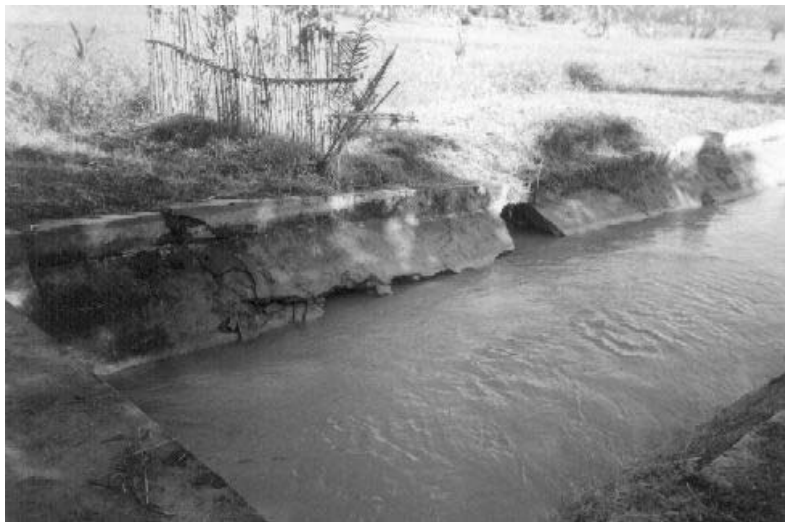
<i>Category</i> Irrigation (Secondary Canal)		
		<i>Structure</i> Masonry Lined Canal

<i>Condition</i> <input type="checkbox"/> A <input type="checkbox"/> B <input checked="" type="checkbox"/> C <input type="checkbox"/> D		
		<i>Problems</i> Sedimentation; crack or damage on lined canal; leakage from lined canal; deflection of lining toward inside of canal;

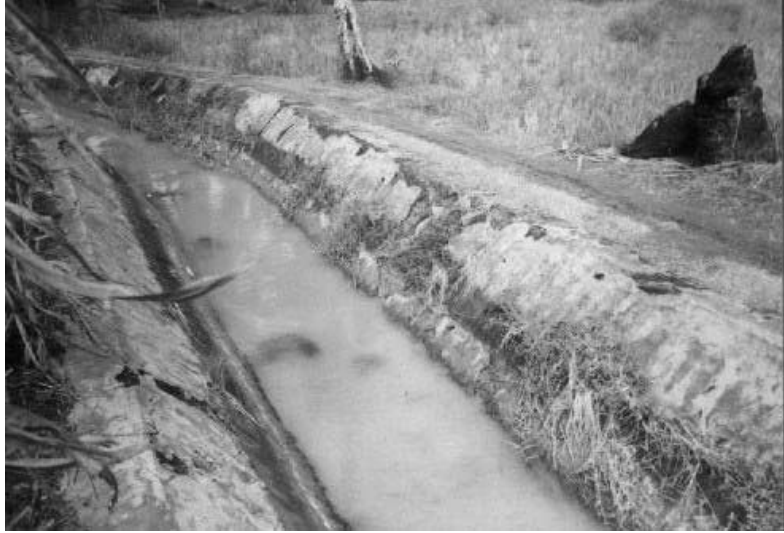
<i>Category</i> Irrigation (Main Canal)		
		<i>Structure</i> Masonry Lined Canal

<i>Condition</i> <input type="checkbox"/> A <input type="checkbox"/> B <input type="checkbox"/> C <input checked="" type="checkbox"/> D		
		<i>Problems</i> Sedimentation; crack or damage on lined canal; leakage from lined canal; deflection of lining toward inside of canal; no inspection road; and less maintenance.

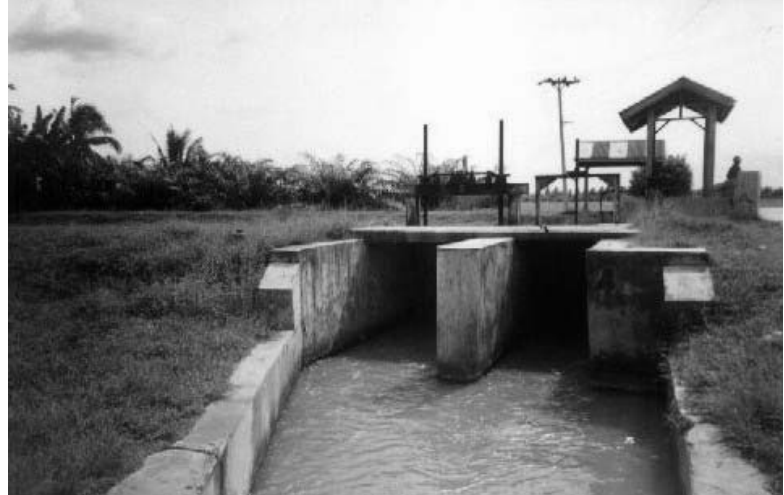
<p><u>Category</u> Irrigation (Headworks)</p>		
		<p><u>Structure</u> Intake and Intake Gate</p>		
		<p><u>Condition</u> <input type="checkbox"/> A <input type="checkbox"/> B <input checked="" type="checkbox"/> C <input type="checkbox"/> D</p>		
		<p><u>Problems</u> Leakage from gate leaf; insufficient strength against design load due to rust, decay of steel material; insufficient diversion water due to sedimentation in front of intake</p>

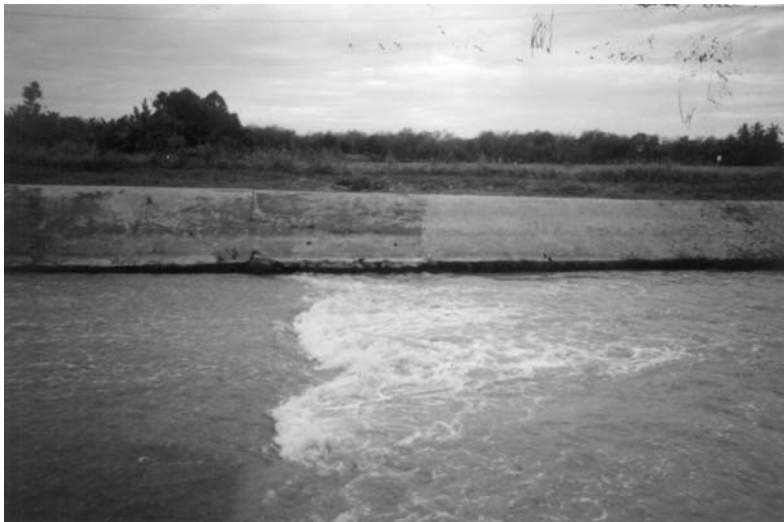
<i>Category</i> Irrigation (Headworks)		
		<i>Structure</i> Retaining Wall		
		<i>Condition</i> <input type="checkbox"/> A <input type="checkbox"/> B <input checked="" type="checkbox"/> C <input type="checkbox"/> D

<i>Problems</i> Fallen down, incline or washed away of retaining wall of weir.

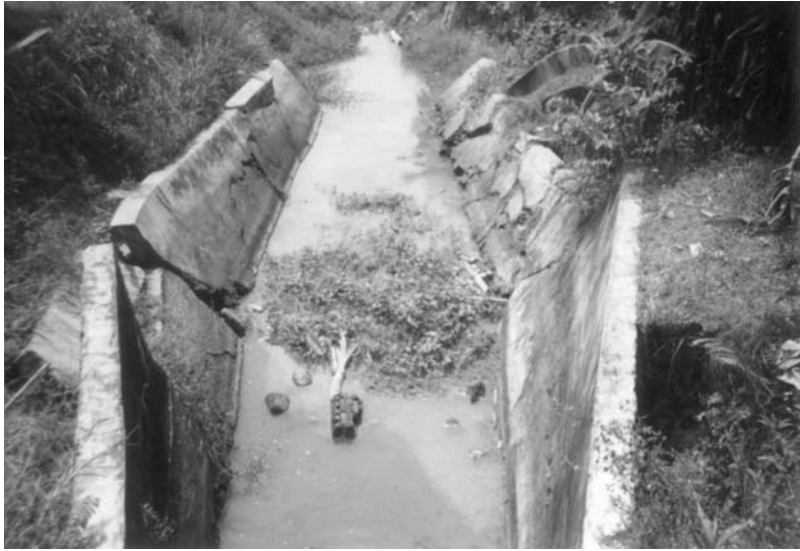
<p><u>Category</u> Irrigation (Main Canal)</p>		
		<p><u>Structure</u> Concrete Lined Canal</p>		
		<p><u>Condition</u> <input type="checkbox"/> A <input type="checkbox"/> B <input checked="" type="checkbox"/> C <input type="checkbox"/> D</p>		
		<p><u>Problems</u> Sedimentation; leakage from lined canal; crack or damage on lined canal; deflection of lining toward inside of canal; and no function of inspection road.</p>

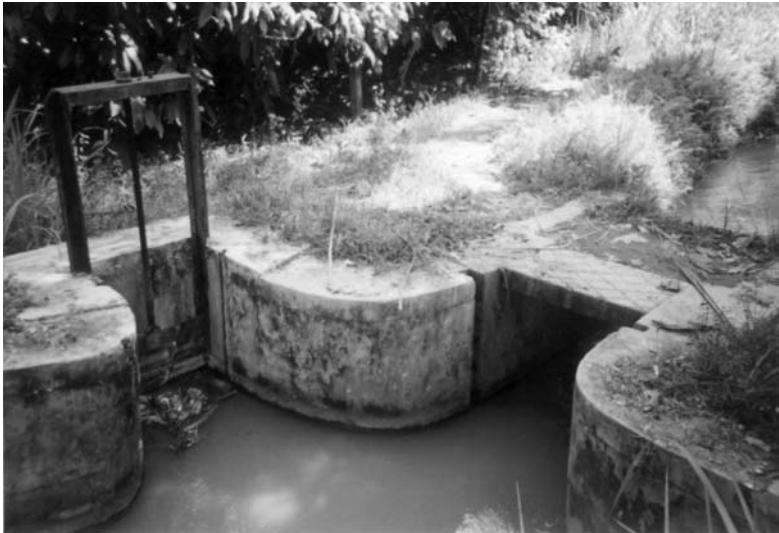
<p><u>Category</u> Irrigation (Secondary Canal)</p>

<p><u>Structure</u> Division structure</p>		
		<p><u>Condition</u> <input type="checkbox"/> A <input type="checkbox"/> B <input type="checkbox"/> C <input checked="" type="checkbox"/> D</p>		
		<p><u>Problems</u> Lower function of division structure; physical operation problem due to gate problem.</p>

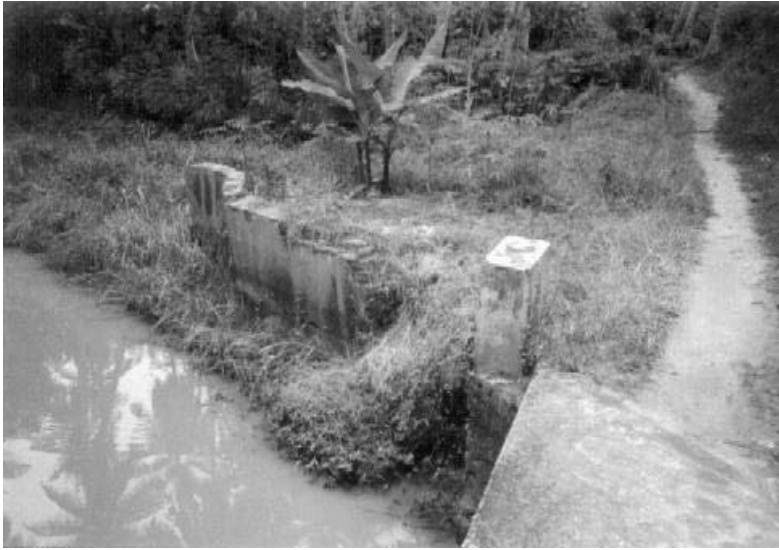
<u>Category</u> Irrigation (Free Intake)		
		<u>Structure</u> Intake		
		<u>Condition</u> <input type="checkbox"/> A <input type="checkbox"/> B <input type="checkbox"/> C <input checked="" type="checkbox"/> D		
		<u>Problems</u> Total damage on intake structure; no functional facility is provided.
