Japan International Cooperation Agency (JICA)

**Ministry of Settlement and Regional Infrastructure (MOSRI)
The Republic of Indonesia**

**THE STUDY
ON
COMPREHENSIVE RECOVERY PROGRAM
OF
IRRIGATION AGRICULTURE**

**Priority List
of
Irrigation Schemes
for
Rehabilitation
(North Sumatra Province)**

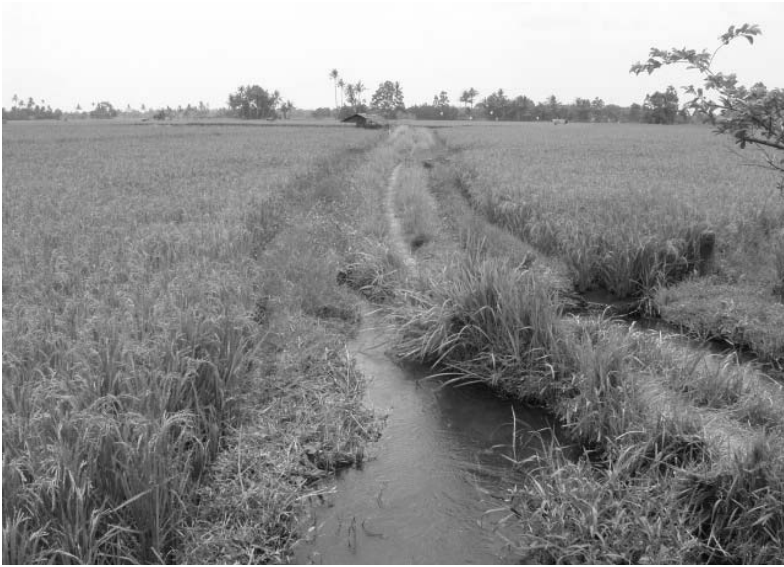
<u>Category</u> Irrigation (Main Canal)		
		<u>Structure</u> Earth Canal		
		<u>Condition</u> <input type="checkbox"/> A <input type="checkbox"/> B <input type="checkbox"/> C <input checked="" type="checkbox"/> D		
		<u>Problems</u> Sedimentation; leakage from canal; collapse of canal; less maintenance; no inspection road.

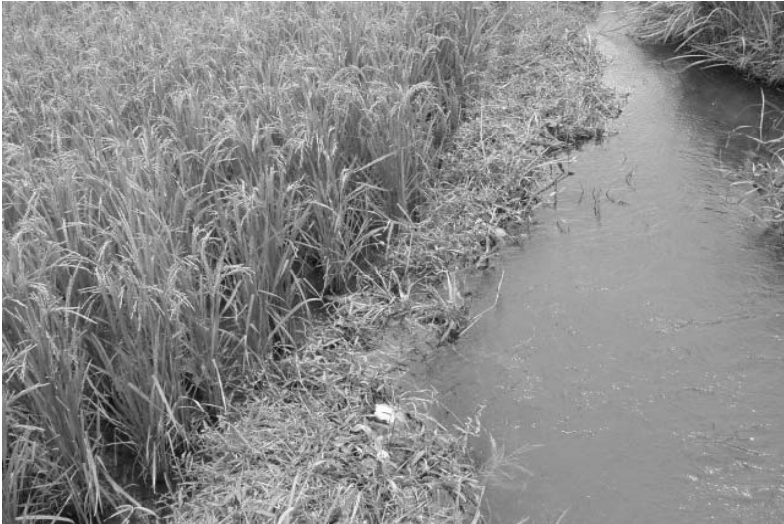
<u>Category</u> Irrigation (Secondary Canal)		
		<u>Structure</u> Earth Canal		
		<u>Condition</u> <input type="checkbox"/> A <input type="checkbox"/> B <input type="checkbox"/> C <input checked="" type="checkbox"/> D

<u>Problems</u> Sedimentation; leakage from canal; collapse of canal; less maintenance; no inspection road.

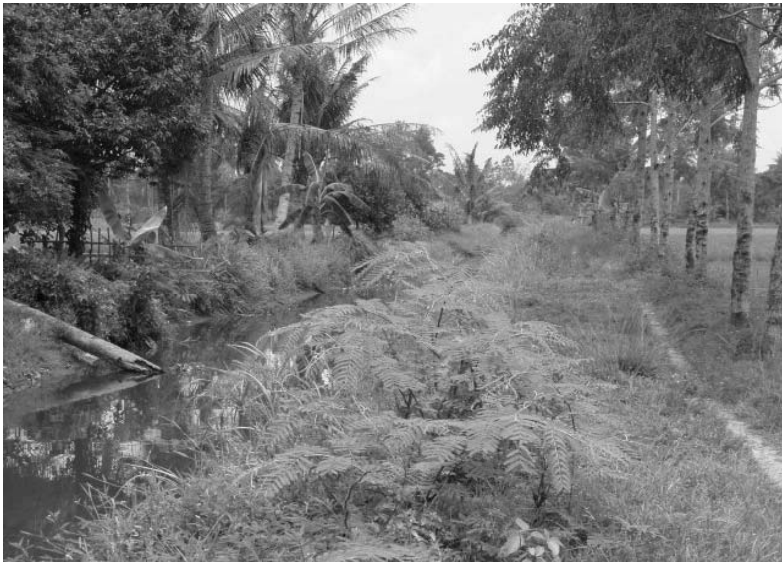
<u>Category</u> Irrigation (Secondary Canal)		
		<u>Structure</u> Earth Canal		
		<u>Condition</u> <input type="checkbox"/> A <input type="checkbox"/> B <input type="checkbox"/> C <input checked="" type="checkbox"/> D		
		<u>Problems</u> Sedimentation; leakage from canal; collapse of canal; less maintenance; no inspection road.		
		<u>Category</u>		
		<u>Structure</u>		
		<u>Condition</u> <input type="checkbox"/> A <input type="checkbox"/> B <input type="checkbox"/> C <input type="checkbox"/> D		
		<u>Problems</u>		
		<u>Category</u>		
		<u>Structure</u>		
		<u>Condition</u> <input type="checkbox"/> A <input type="checkbox"/> B <input type="checkbox"/> C <input type="checkbox"/> D		
		<u>Problems</u>

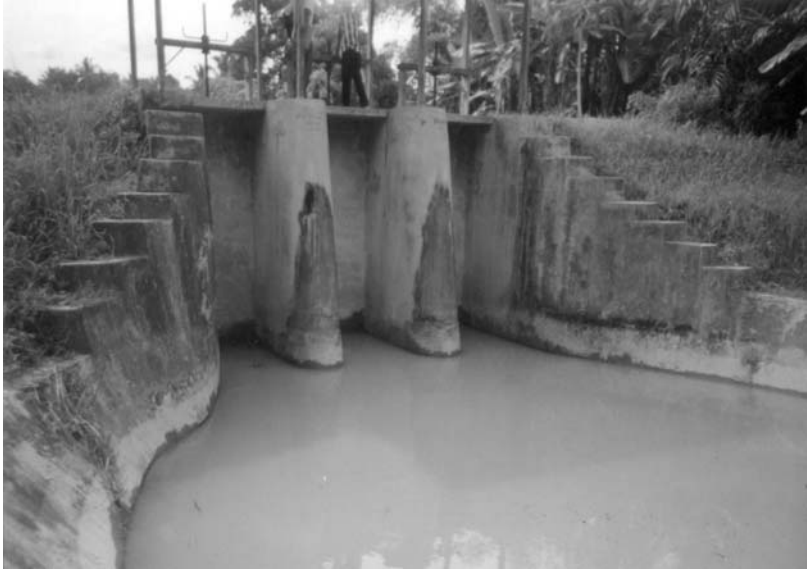
<i>Category</i> Irrigation (Free Intake)		
		<i>Structure</i> Intake Gate		
		<i>Condition</i> <input type="checkbox"/> A <input type="checkbox"/> B <input type="checkbox"/> C <input checked="" type="checkbox"/> D		
		<i>Problems</i> Insufficient diversion water due to sedimentation in front of intake; Leakage from gate leaf; insufficient strength against design load due to rust, decay of steel material (two of three gates are damaged)

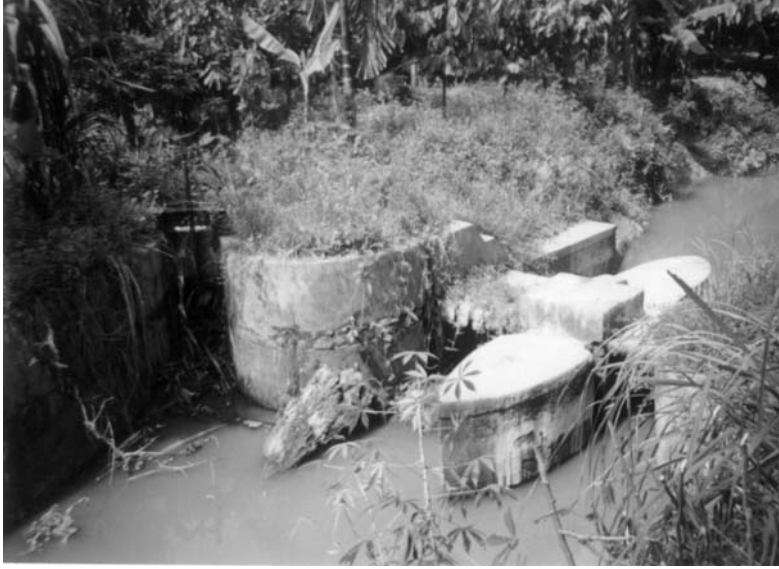
<i>Category</i> Irrigation (Main Canal)		
		<i>Structure</i> Division structure		
		<i>Condition</i> <input type="checkbox"/> A <input type="checkbox"/> B <input type="checkbox"/> C <input checked="" type="checkbox"/> D		
		<i>Problems</i> Lower function of division structure on canal; damage of division structure; and no inspection road.

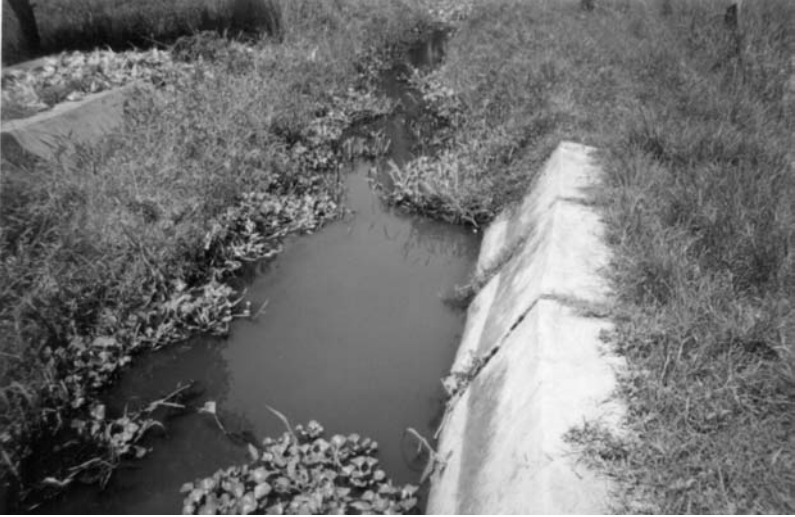
<i>Category</i> Irrigation (Main Canal)		
		<i>Structure</i> Masonry Lined Canal		
		<i>Condition</i> <input type="checkbox"/> A <input type="checkbox"/> B <input type="checkbox"/> C <input checked="" type="checkbox"/> D		
		<i>Problems</i> Sedimentation; leakage from canal; crack or damage on canal; less maintenance; and no inspection road.

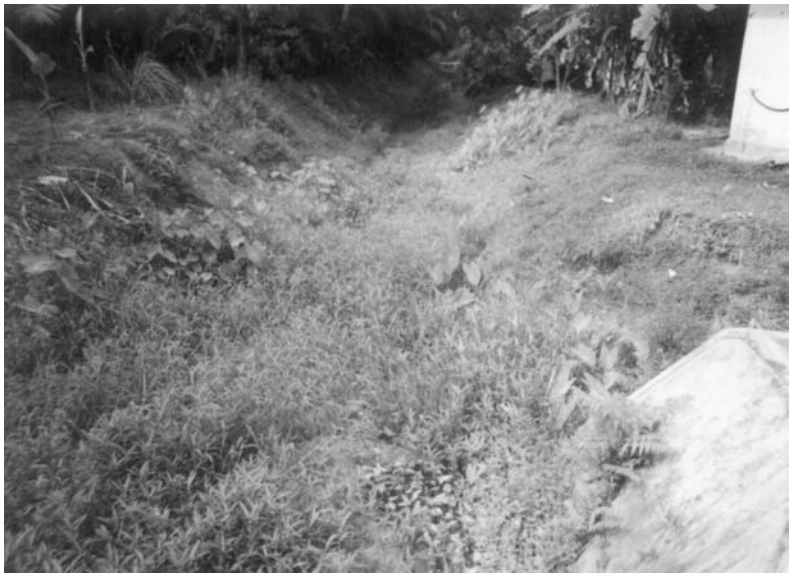
<u>Category</u> Irrigation (Secondary Canal)		
		<u>Structure</u> Canal		
		<u>Condition</u> <input type="checkbox"/> A <input type="checkbox"/> B <input type="checkbox"/> C <input checked="" type="checkbox"/> D		
		<u>Problems</u> Sedimentation (canal is covered by grass); leakage from canal; collapse of canal, difficulty on maintenance of earth canal; and no inspection road.		
		<u>Category</u>		
		<u>Structure</u>		
		<u>Condition</u> <input type="checkbox"/> A <input type="checkbox"/> B <input type="checkbox"/> C <input type="checkbox"/> D		
		<u>Problems</u>		
		<u>Category</u>		
		<u>Structure</u>		
		<u>Condition</u> <input type="checkbox"/> A <input type="checkbox"/> B <input type="checkbox"/> C <input type="checkbox"/> D		
		<u>Problems</u>

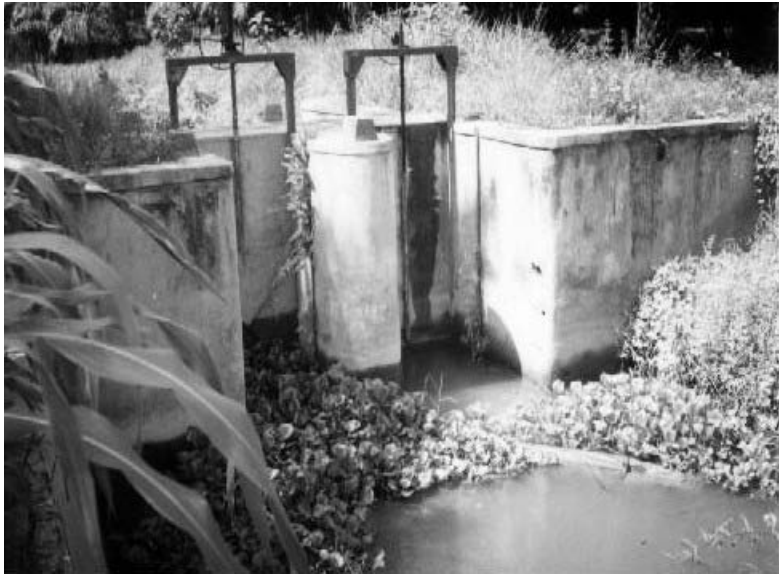
<i>Category</i> Irrigation (Free Intake)		
		<i>Structure</i> Intake Gate		
		<i>Condition</i> <input type="checkbox"/> A <input type="checkbox"/> B <input type="checkbox"/> C <input checked="" type="checkbox"/> D		
		<i>Problems</i> Insufficient diversion water due to sedimentation in front of intake; and deterioration of gates.

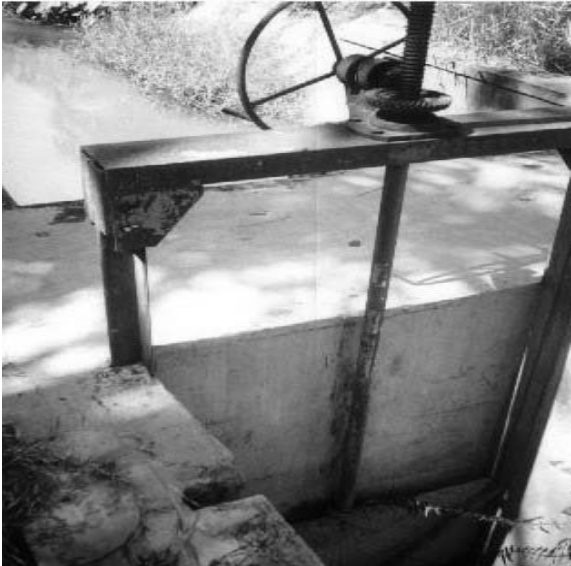
<i>Category</i> Irrigation (Free Intake)		
		<i>Structure</i> Intake Gate, Steel Gate		
		<i>Condition</i> <input type="checkbox"/> A <input type="checkbox"/> B <input type="checkbox"/> C <input checked="" type="checkbox"/> D		
		<i>Problems</i> Leakage from gate leaf; insufficient strength against design load due to rust, decay of steel material; physical operation problem due to deflection/trouble; problem on management due to lack of periodically maintenance

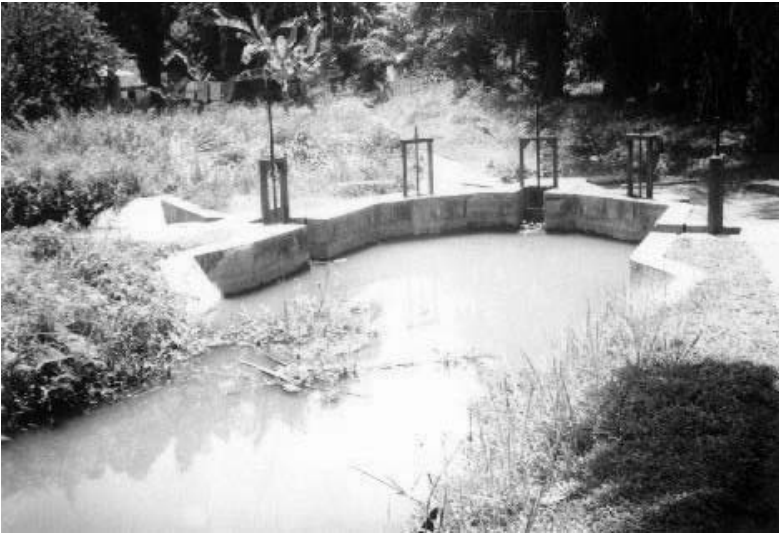
<i>Category</i> Irrigation (Main Canal)		
		<i>Structure</i> Division structure		
		<i>Condition</i> <input type="checkbox"/> A <input type="checkbox"/> B <input type="checkbox"/> C <input checked="" type="checkbox"/> D		
		<i>Problems</i> Lower function of division structure on canal; damage of division structure; physical operation problem on diversion gate; sedimentation in canal.

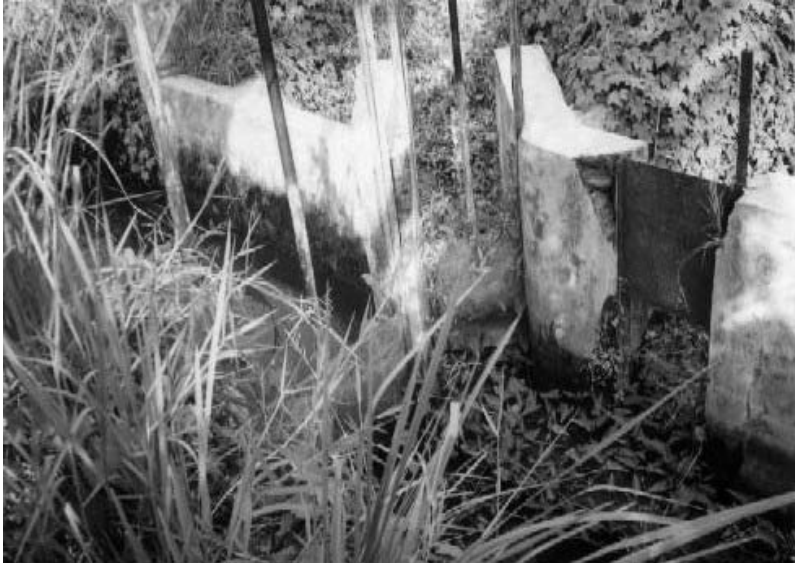
<p><u>Category</u> Irrigation (Main Canal)</p>		
		<p><u>Structure</u> Off-take Structure</p>		
		<p><u>Condition</u> <input type="checkbox"/> A <input type="checkbox"/> B <input type="checkbox"/> C <input checked="" type="checkbox"/> D</p>		
		<p><u>Problems</u> Lower function of off-take structure on canal; damage of off-take structure; physical operation problem on off-take gate; and no maintenance of canal and structure.</p>		
		<p><u>Category</u></p>		
		<p><u>Structure</u></p>		
		<p><u>Condition</u> <input type="checkbox"/> A <input type="checkbox"/> B <input type="checkbox"/> C <input type="checkbox"/> D</p>		
		<p><u>Problems</u></p>		
		<p><u>Category</u></p>		
		<p><u>Structure</u></p>		
		<p><u>Condition</u> <input type="checkbox"/> A <input type="checkbox"/> B <input type="checkbox"/> C <input type="checkbox"/> D</p>

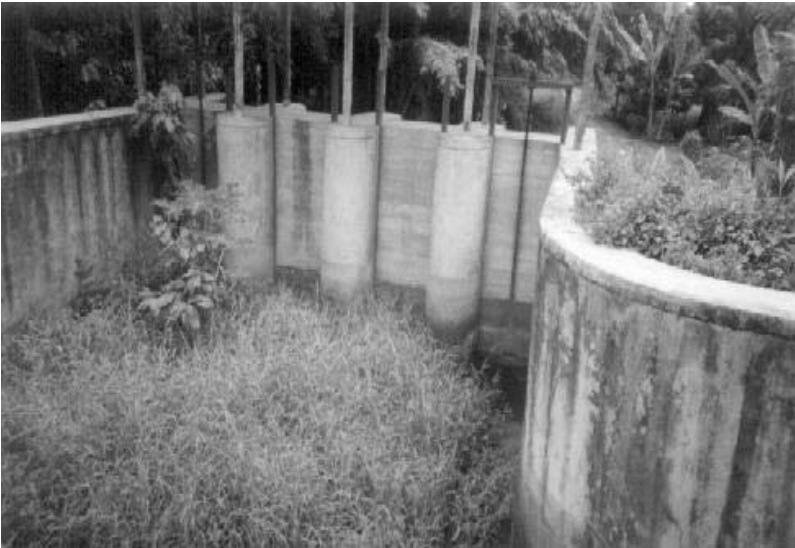
<p><u>Category</u> Irrigation (Free Intake)</p>		
		<p><u>Structure</u> Free Intake, Upstream View</p>		
		<p><u>Condition</u></p> <p><input type="checkbox"/> A <input type="checkbox"/> B <input type="checkbox"/> C <input checked="" type="checkbox"/> D</p>		
		<p><u>Problems</u> Insufficient diversion water due to sedimentation in front of intake; deflection of intake structure</p>

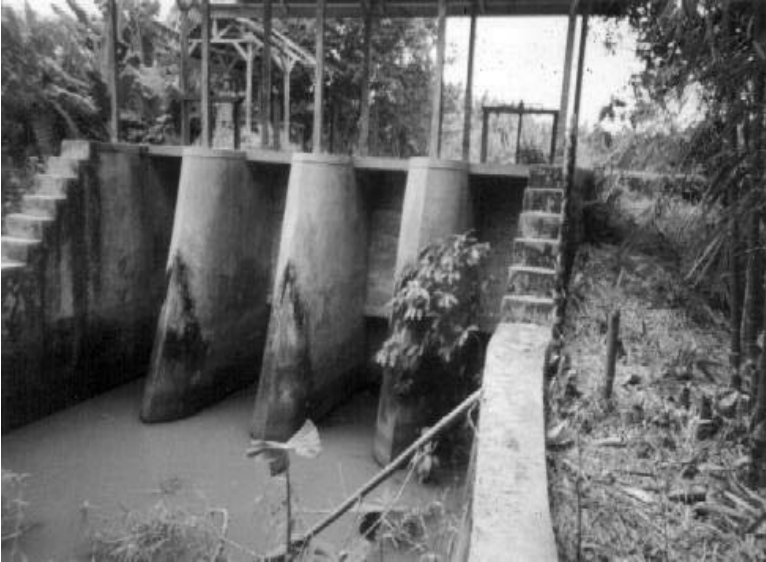
<p><u>Category</u> Irrigation (Free Intake)</p>		
		<p><u>Structure</u> Free Intake, Downstream View</p>		
		<p><u>Condition</u></p> <p><input type="checkbox"/> A <input type="checkbox"/> B <input type="checkbox"/> C <input checked="" type="checkbox"/> D</p>		
		<p><u>Problems</u> Insufficient diversion water due to sedimentation in front of intake; deflection of intake structure</p>

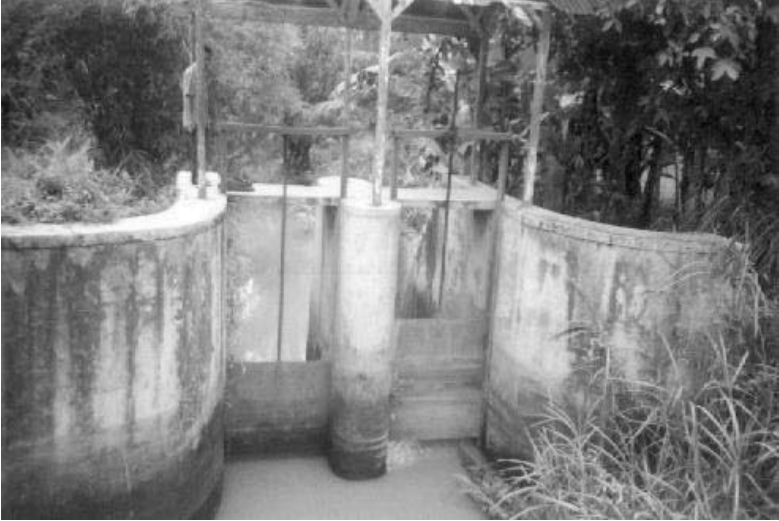
<p><u>Category</u> Irrigation (Free Intake)</p>

<p><u>Structure</u> Spillway</p>		
		<p><u>Condition</u></p> <p><input type="checkbox"/> A <input type="checkbox"/> B <input type="checkbox"/> C <input checked="" type="checkbox"/> D</p>		
		<p><u>Problems</u> Leakage from gate leaf; insufficient strength against design load due to rust, decay of steel materials; physical operation problem due to deflection; and no stability due to less back fill at back side of retaining wall.</p>

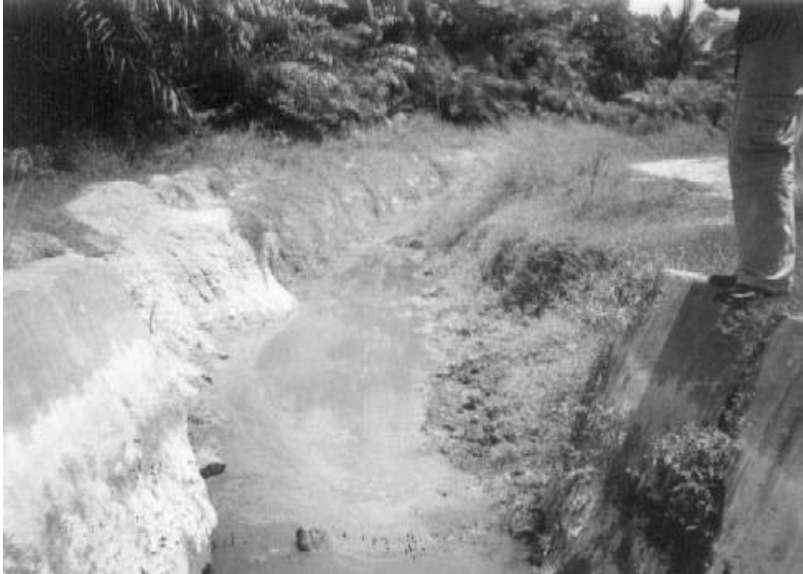
<i>Category</i> Irrigation (Main Canal)		
		<i>Structure</i> Masonry Lined Canal		
		<i>Condition</i> <input type="checkbox"/> A <input type="checkbox"/> B <input type="checkbox"/> C <input checked="" type="checkbox"/> D		
		<i>Problems</i> Sedimentation; leakage from lined canal; crack or damage on lined canal; deflection of lining toward inside of canal; and no function of inspection road.

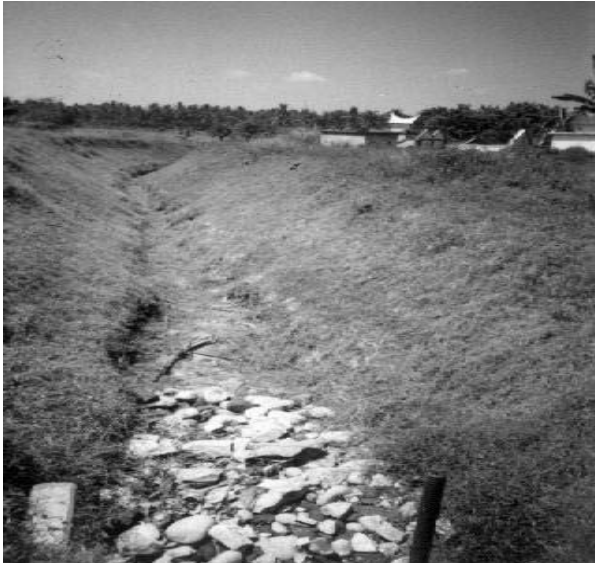
<i>Category</i> Irrigation (Secondary Canal)		
		<i>Structure</i> Earth Canal		
		<i>Condition</i> <input type="checkbox"/> A <input type="checkbox"/> B <input type="checkbox"/> C <input checked="" type="checkbox"/> D		
		<i>Problems</i> Not in use
