**THE STUDY  
ON  
COMPREHENSIVE RECOVERY PROGRAM  
OF  
IRRIGATION AGRICULTURE**

**Priority List  
of  
Irrigation Schemes  
for  
Rehabilitation  
(Central Java Province)**

**February 2004**

**Nippon Koei Co., Ltd.**

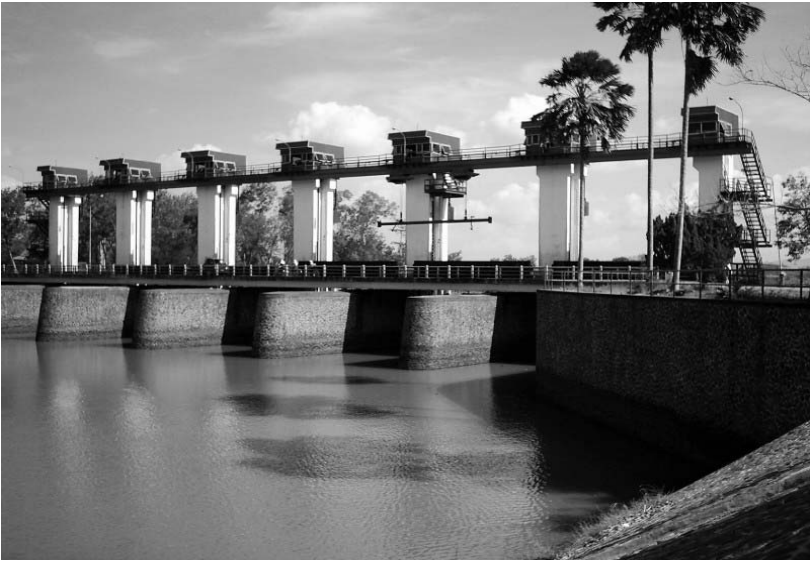
| Scheme | Mangganti | District | Cilacap |
|---|---|---|---|
| | | <u>Category</u><br>Irrigation (Headworks) | |
| | | <u>Structure</u><br>Movable Weir | |
| | | <u>Condition</u><br><input checked="" type="checkbox"/> A <input type="checkbox"/> B <input type="checkbox"/> C <input type="checkbox"/> D | |
| | | <u>Problems</u><br>In good condition | |

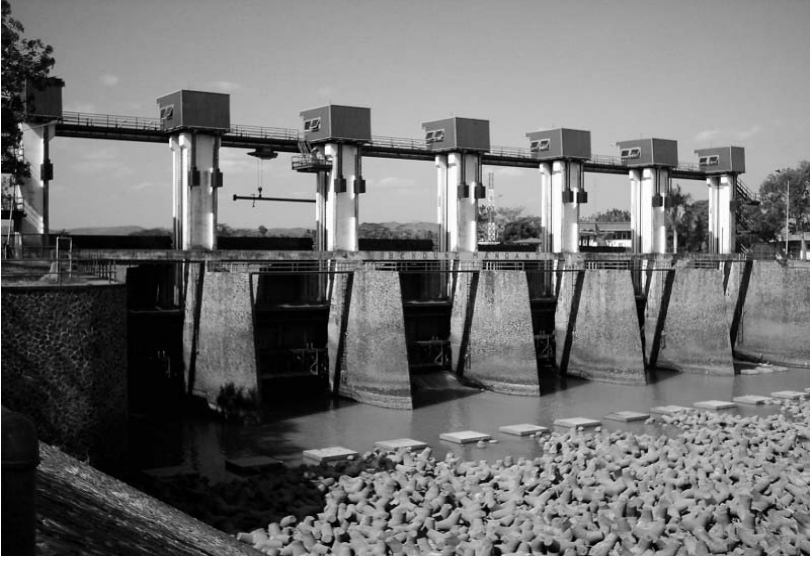
| Scheme | Mangganti | District | Cilacap |
|---|---|---|---|
| | | <u>Category</u><br>Irrigation (Headworks) | |
| | | <u>Structure</u><br>Movable Weir | |
| | | <u>Condition</u><br><input checked="" type="checkbox"/> A <input type="checkbox"/> B <input type="checkbox"/> C <input type="checkbox"/> D | |
| | | <u>Problems</u><br>In good condition | |

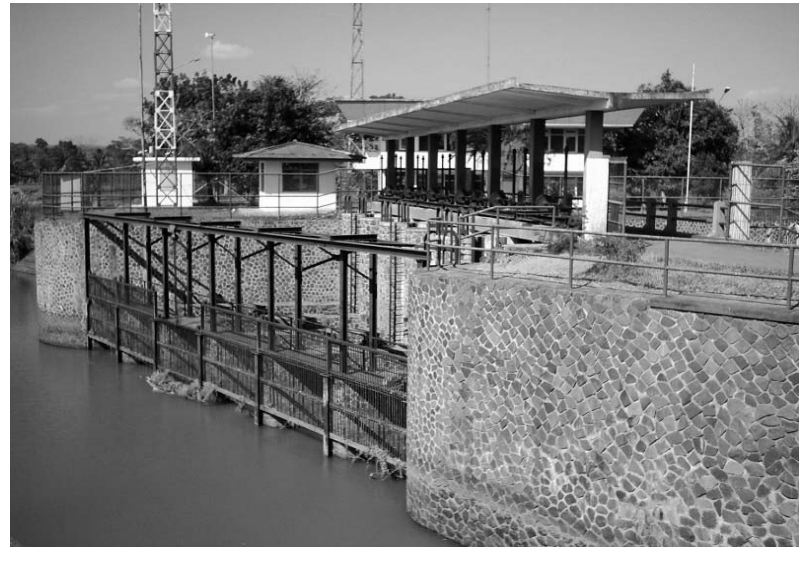
| Scheme | Mangganti | District | Cilacap |
|---|---|---|---|
| | | <u>Category</u><br>Irrigation (Headworks) | |
| | | <u>Structure</u><br>Intake | |
| | | <u>Condition</u><br><input checked="" type="checkbox"/> A <input type="checkbox"/> B <input type="checkbox"/> C <input type="checkbox"/> D | |

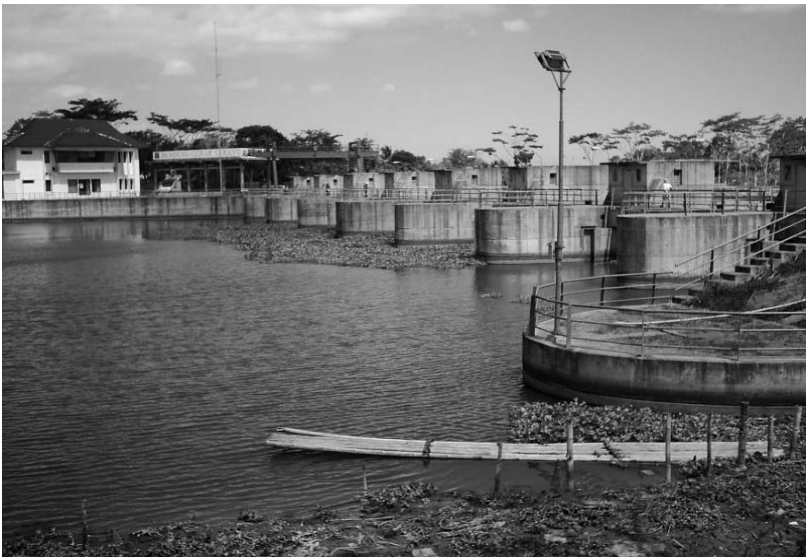
| Scheme | Serayu | District | Cilacap |
|---|---|---|---|
| | | <u>Category</u><br>Irrigation (Headworks) | |
| | | <u>Structure</u><br>Movable Weir | |
| | | <u>Condition</u><br><input checked="" type="checkbox"/> A <input type="checkbox"/> B <input type="checkbox"/> C <input type="checkbox"/> D | |
| | | <u>Problems</u><br>In good condition | |

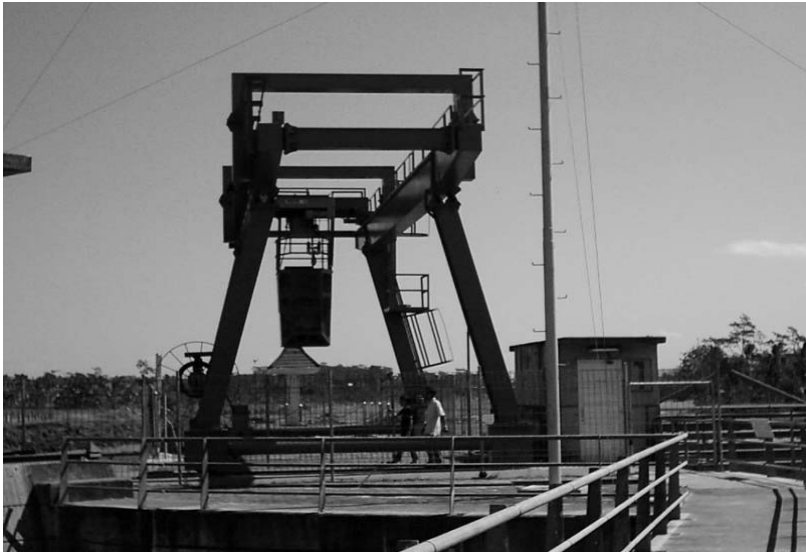
| Scheme | Serayu | District | Cilacap |
|---|---|---|---|
| | | <u>Category</u><br>Irrigation (Headworks) | |
| | | <u>Structure</u><br>Intake, Gantry Crane | |
| | | <u>Condition</u><br><input checked="" type="checkbox"/> A <input type="checkbox"/> B <input type="checkbox"/> C <input type="checkbox"/> D | |
| | | <u>Problems</u><br>In good condition | |

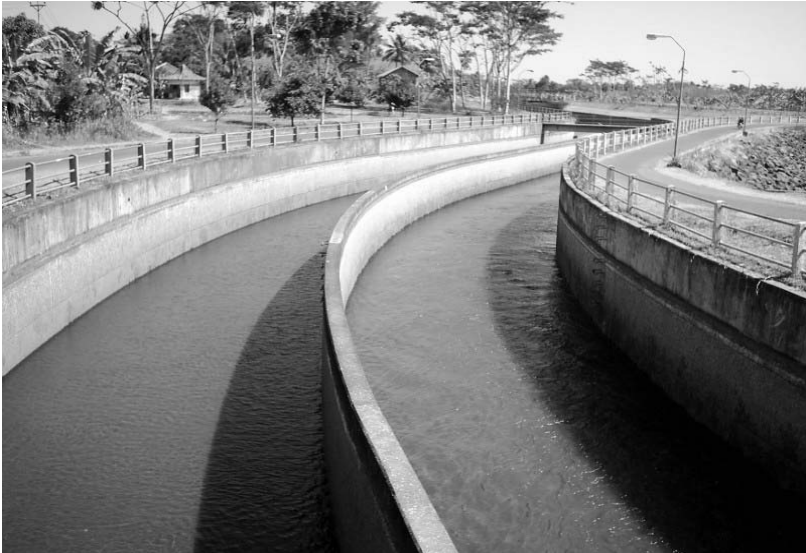
| Scheme | Serayu | District | Cilacap |
|---|---|---|---|
| | | <u>Category</u><br>Irrigation (Headworks) | |
| | | <u>Structure</u><br>Settling Basin | |
| | | <u>Condition</u><br><input checked="" type="checkbox"/> A <input type="checkbox"/> B <input type="checkbox"/> C <input type="checkbox"/> D | |

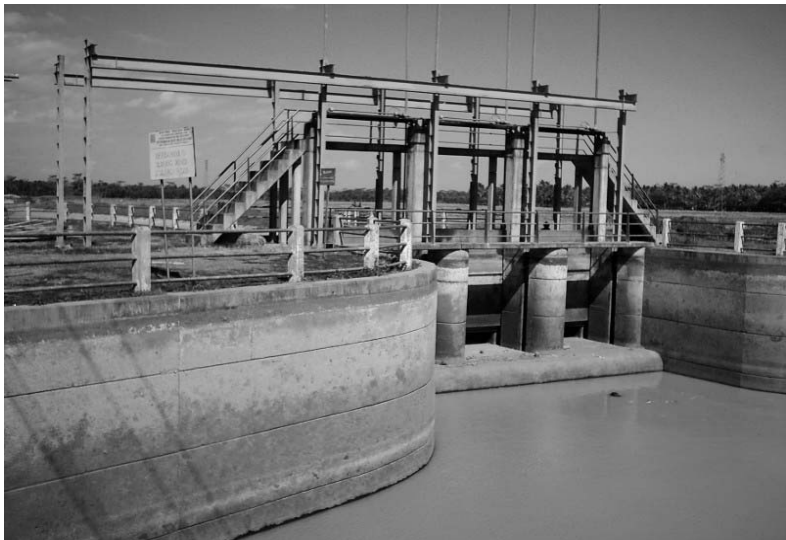
| Scheme | Serayu | District | Cilacap |
|---|---|---|---|
| | | <u>Category</u><br>Irrigation (Main Canal) | |
| | | <u>Structure</u><br>Division structure | |
| | | <u>Condition</u><br><input checked="" type="checkbox"/> A <input type="checkbox"/> B <input type="checkbox"/> C <input type="checkbox"/> D | |

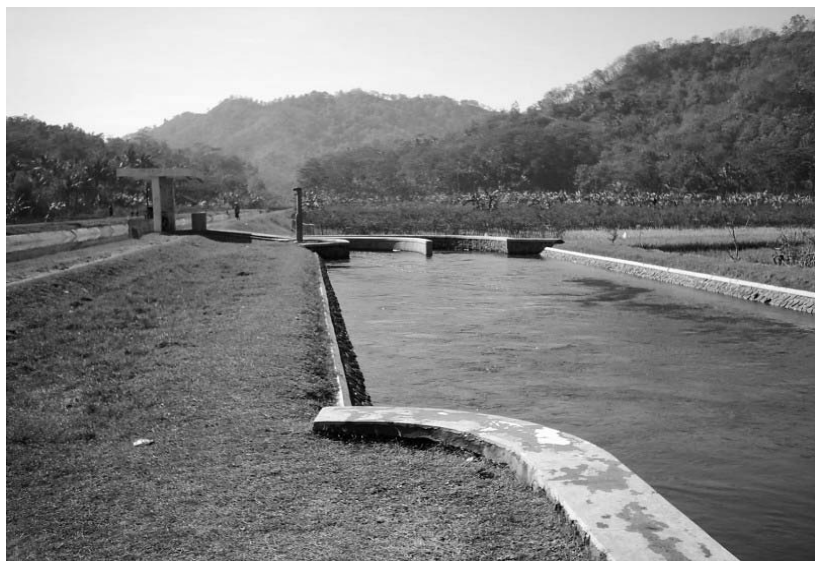
| Scheme | Kaligending | District | Kebumen |
|---|---|---|---|
| | | <u>Category</u><br>Irrigation (Main Canal) | |
| | | <u>Structure</u><br>Division Structure and Canal | |
| | | <u>Condition</u><br><input checked="" type="checkbox"/> A <input type="checkbox"/> B <input type="checkbox"/> C <input type="checkbox"/> D | |

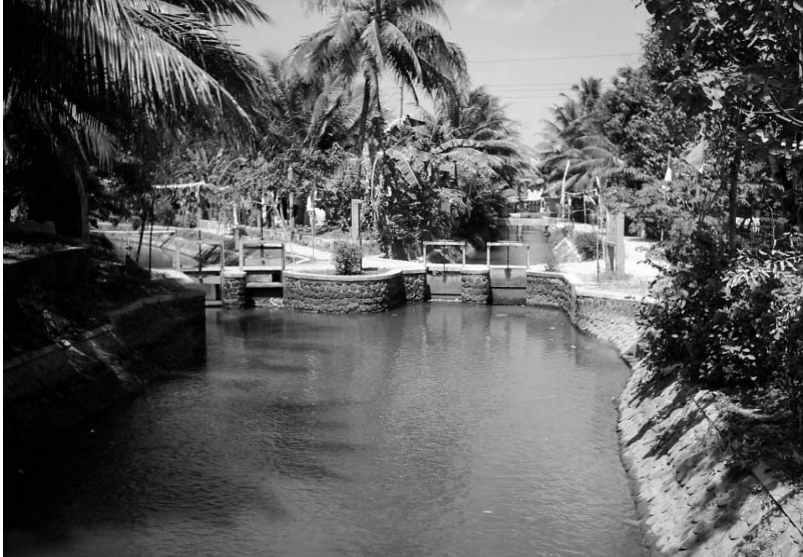
| Scheme | Pesucen | District | Kebumen |
|---|---|---|---|
| | | <u>Category</u><br>Irrigation (Main Canal) | |
| | | <u>Structure</u><br>Division Structure | |
| | | <u>Condition</u><br><input type="checkbox"/> A <input checked="" type="checkbox"/> B <input type="checkbox"/> C <input type="checkbox"/> D | |

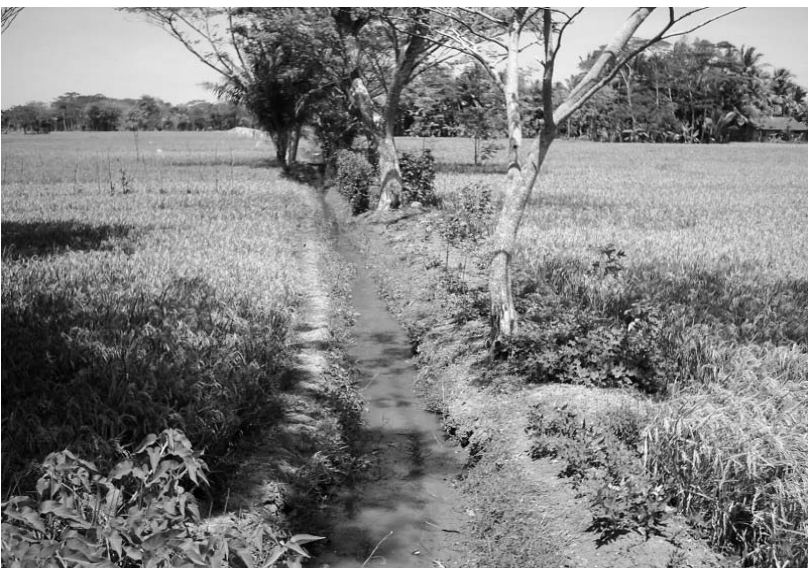
| Scheme | Pesucen | District | Kebumen |
|---|---|---|---|
| | | <u>Category</u><br>Irrigation (Paddy Field) | |
| | | <u>Structure</u><br>Tertiary Canal and Paddy Field | |
| | | <u>Condition</u><br><input type="checkbox"/> A <input type="checkbox"/> B <input checked="" type="checkbox"/> C <input type="checkbox"/> D | |

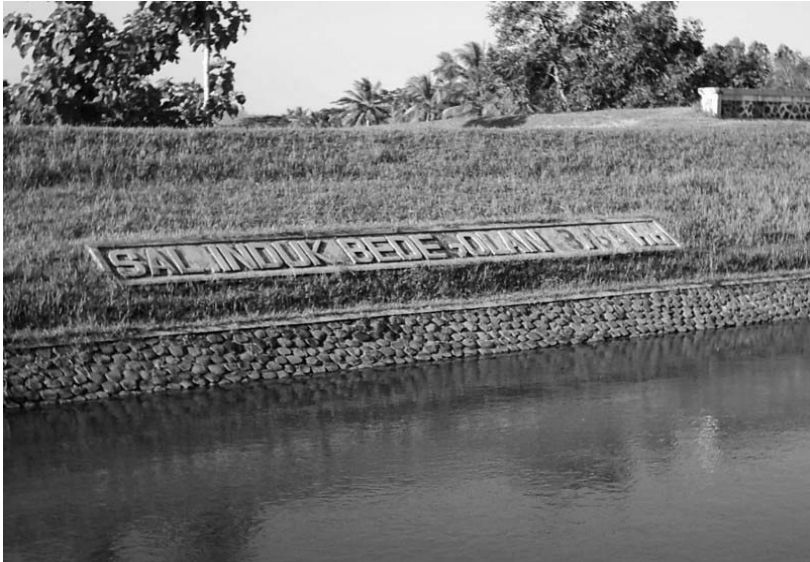
| Scheme | Bedegolan | District | Kebumen | | |
|---|---|---|---|---|---|
| | | <u>Category</u><br>Irrigation (Main Canal) | | | |
| | | <u>Structure</u><br>Lined Canal | | | |
| | | <u>Condition</u><br><input type="checkbox"/> A <input checked="" type="checkbox"/> B <input type="checkbox"/> C <input type="checkbox"/> D | | | |

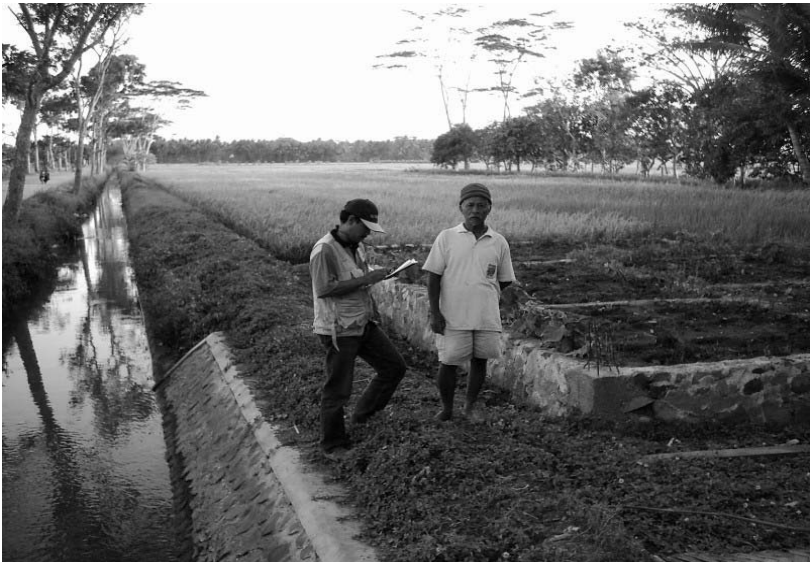
| Scheme | Bedegolan | District | Kebumen | | |
|---|---|---|---|---|---|
| | | <u>Category</u><br>Irrigation (Secondary Canal) | | | |
| | | <u>Structure</u><br>Earth Canal | | | |
| | | <u>Condition</u><br><input type="checkbox"/> A <input type="checkbox"/> B <input type="checkbox"/> C <input checked="" type="checkbox"/> D | | | |
