The Study on Comprehensive Recovery Program
of Irrigation Agriculture

Japan International Cooperation Agency

**Location Map of Irrigation Schemes
in Purworejo District**

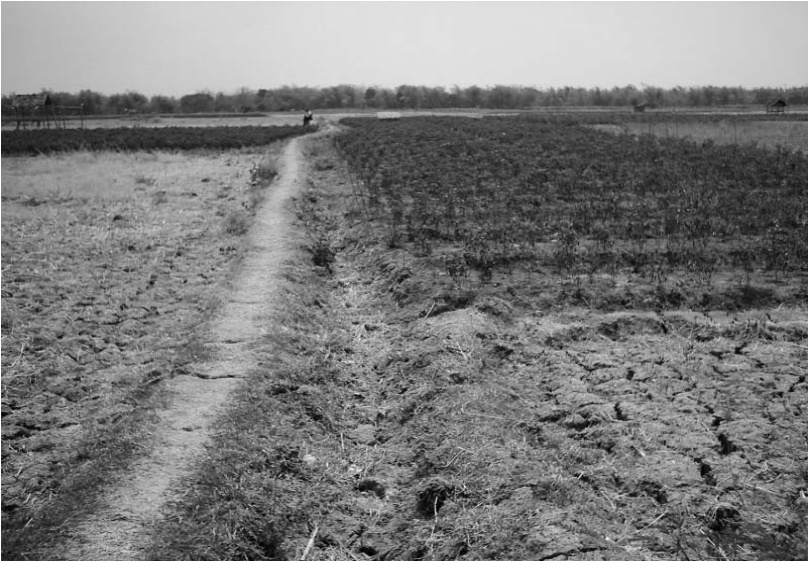
<i>Category</i> Irrigation (Paddy Field)			
		<i>Structure</i> Tertiary Canal and Paddy Field			
		<i>Condition</i> <input type="checkbox"/> A <input type="checkbox"/> B <input type="checkbox"/> C <input checked="" type="checkbox"/> D

<i>Problems</i> Require farm ditch and road
