I. PROJECT FUNDAMENTALS									
I.1 General									
(1) Code Number	: 33010020-22			(7) Number of Farmers	: 10,638				
(2) Name of Irrigation Scheme	: Jragung			(8) Water Resource River	: Jragung

Scheme	Jragung	District	Demak
Technical Level	Technical	Registered Area	4,597 ha

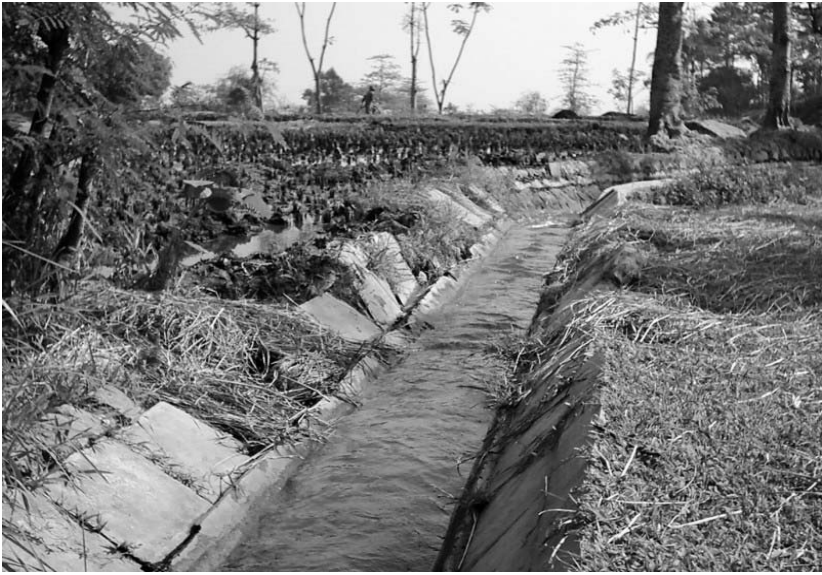
Scheme	D.I Gung	District	Tegal & Kodia Tegal		
Technical Level	Technical	Registered Area	12,999 ha	Year of Construction	1991/1998
 		<u>Category</u> Irrigation (Main Canal)			
		<u>Structure</u> Main Canal			
		<u>Condition</u> <input type="checkbox"/> A <input type="checkbox"/> B <input checked="" type="checkbox"/> C <input type="checkbox"/> D			
		<u>Problems</u> Require removal of sediments at inside of canal

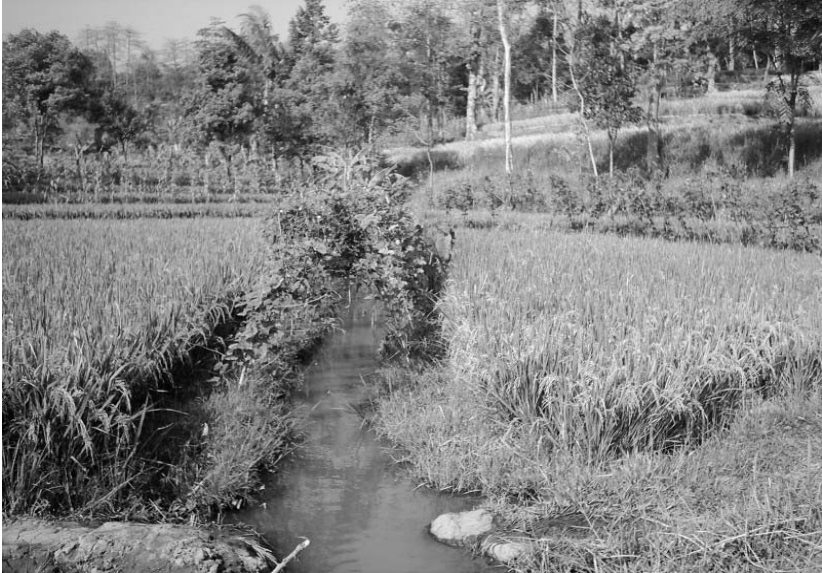
<u>Category</u> Irrigation (Secondary Canal)			
		<u>Structure</u> Concrete Lined Canal			
		<u>Condition</u> <input type="checkbox"/> A <input type="checkbox"/> B <input checked="" type="checkbox"/> C <input type="checkbox"/> D			
		<u>Problems</u> Require repair of lining

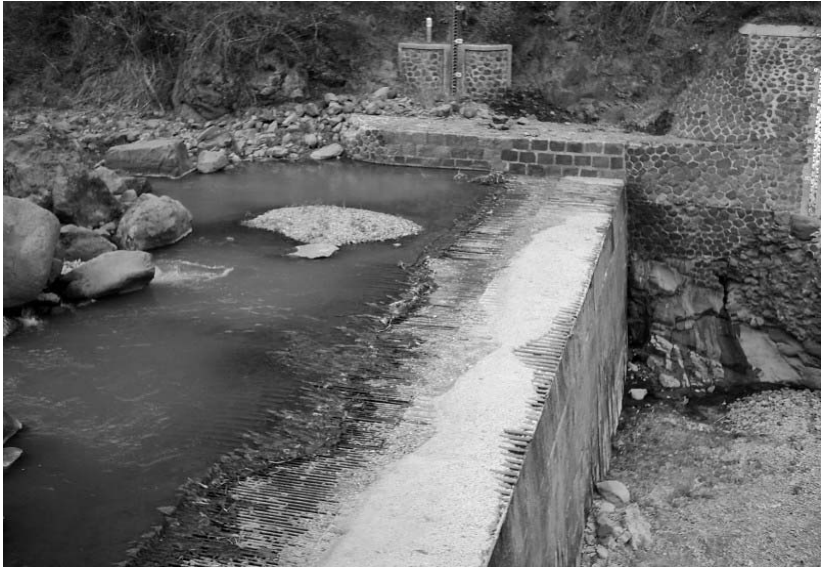
<u>Category</u> Irrigation (Headworks)			
		<u>Structure</u> Fixed Weir, Bar-screen Type			
		<u>Condition</u> <input type="checkbox"/> A <input type="checkbox"/> B <input type="checkbox"/> C <input checked="" type="checkbox"/> D			
		<u>Problems</u> Require total repair or replacement

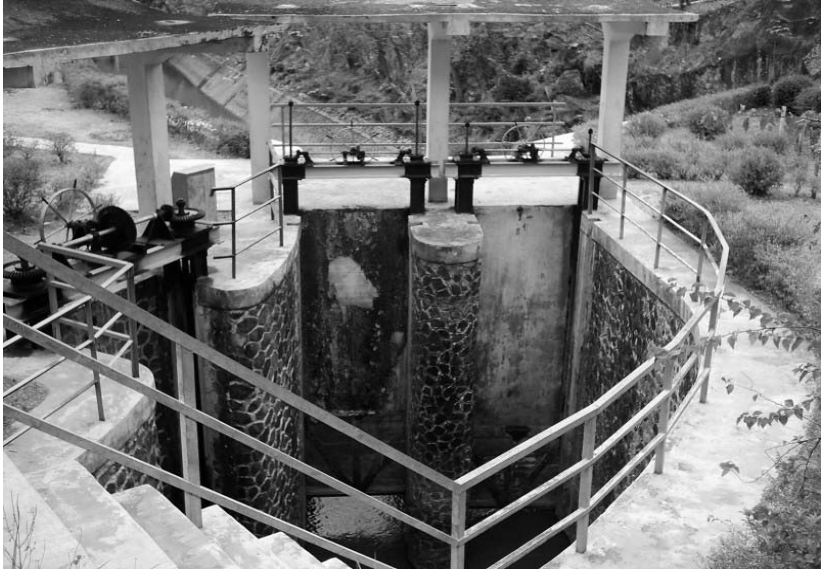
<u>Category</u> Irrigation (Headworks)			
		<u>Structure</u> Intake Gate, Rear View			
		<u>Condition</u> <input type="checkbox"/> A <input type="checkbox"/> B <input checked="" type="checkbox"/> C <input type="checkbox"/> D			
		<u>Problems</u> Require major repair of civil and gate works

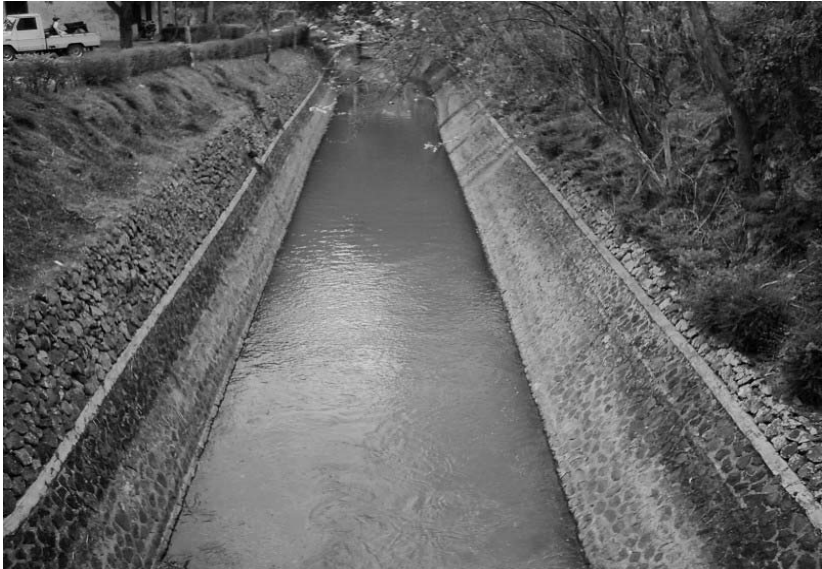
<u>Category</u> Irrigation (Headworks)			
		<u>Structure</u> Masonry Lined Canal and Settling Basin			
		<u>Condition</u> <input type="checkbox"/> A <input type="checkbox"/> B <input checked="" type="checkbox"/> C <input type="checkbox"/> D

<u>Problems</u> Require provision of inspection road
