The Study on Comprehensive Recovery Program of Irrigation Agriculture
Japan International Cooperation Agency

Location Map of Irrigation Schemes in Pekalongan District

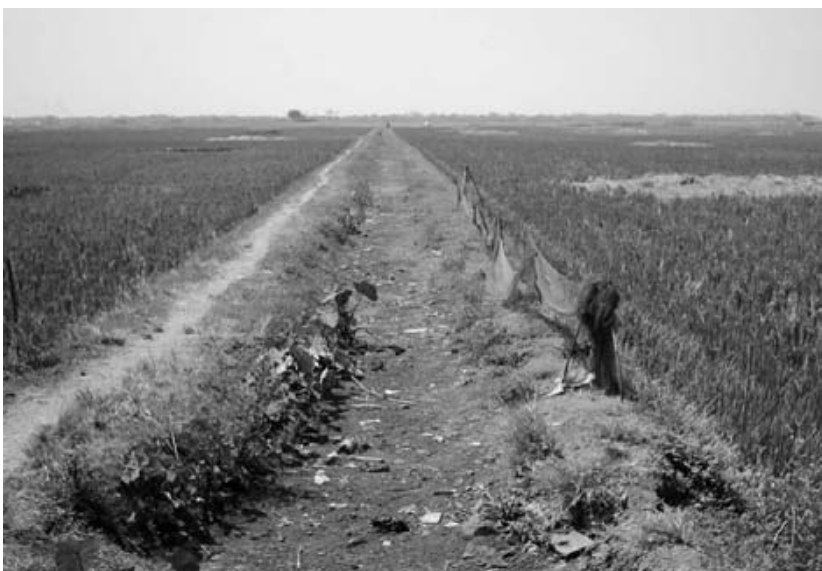
<p><u>Category</u> Irrigation (Tertiary System)</p>			
		<p><u>Structure</u> Tertiary System</p>

<p><u>Condition</u> <input type="checkbox"/> A <input type="checkbox"/> B <input checked="" type="checkbox"/> C <input type="checkbox"/> D</p>			
		<p><u>Problems</u> Require provision of farm road and canal with related structures</p>

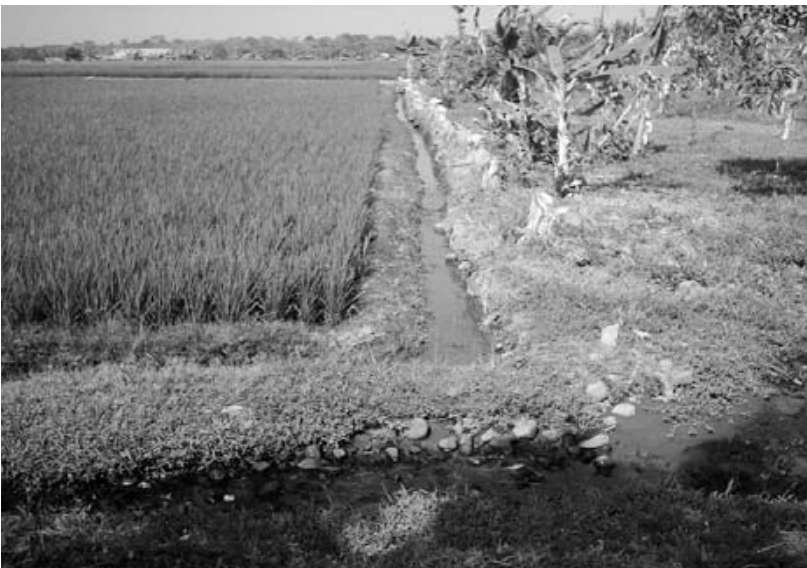
<p><u>Category</u> Irrigation (Tertiary Canal)</p>			
		<p><u>Structure</u> Farm Ditch</p>

<p><u>Condition</u> <input type="checkbox"/> A <input type="checkbox"/> B <input type="checkbox"/> C <input checked="" type="checkbox"/> D</p>			
		<p><u>Problems</u> Require division box and farm road</p>

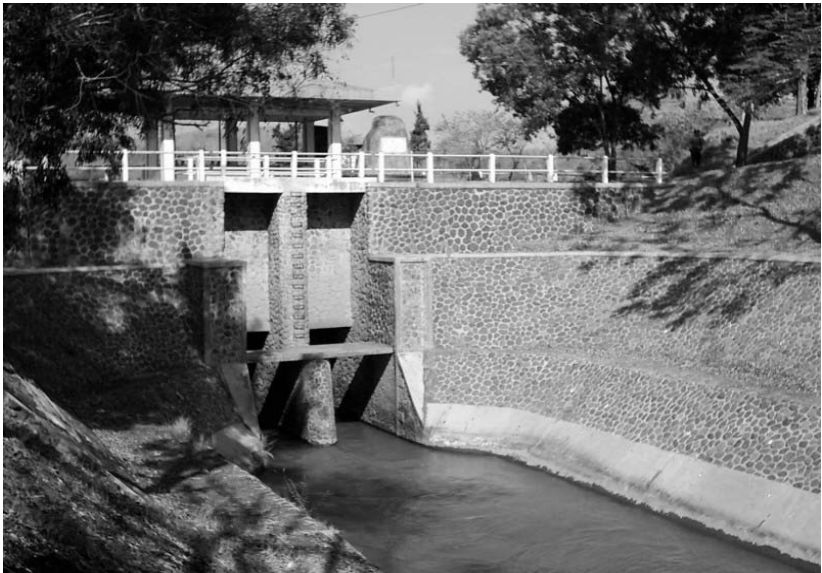
<p><u>Category</u> Irrigation (Headworks)</p>		
		<p><u>Structure</u> Intake, Rear View</p>

<p><u>Condition</u> <input type="checkbox"/> A <input type="checkbox"/> B <input checked="" type="checkbox"/> C <input type="checkbox"/> D</p>		
		<p><u>Problems</u> Require provision of settling basin</p>

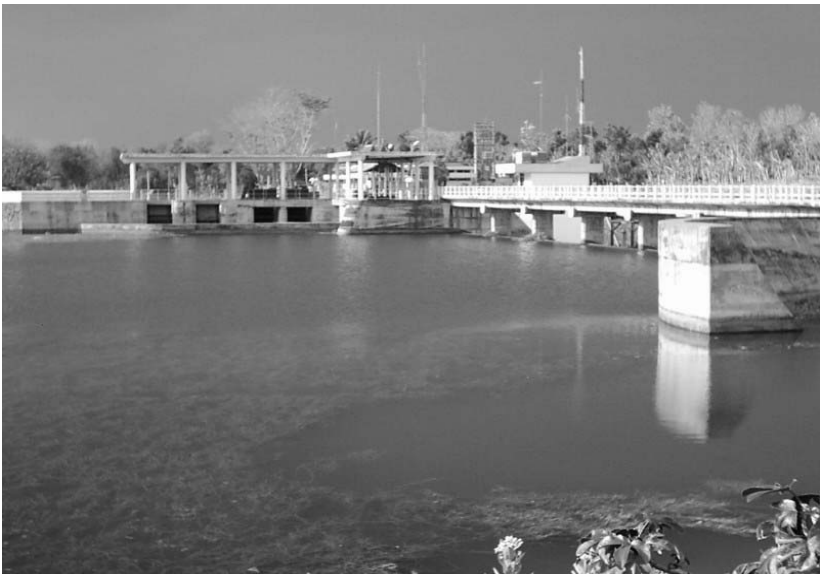
<i>Category</i> Irrigation (Headworks)			
		<i>Structure</i> Fixed Weir, Upstream View (operated by PLN)			
		<i>Condition</i> <input checked="" type="checkbox"/> A <input type="checkbox"/> B <input type="checkbox"/> C <input type="checkbox"/> D			
		<i>Problems</i> Irrigation and mini-hydro power purpose

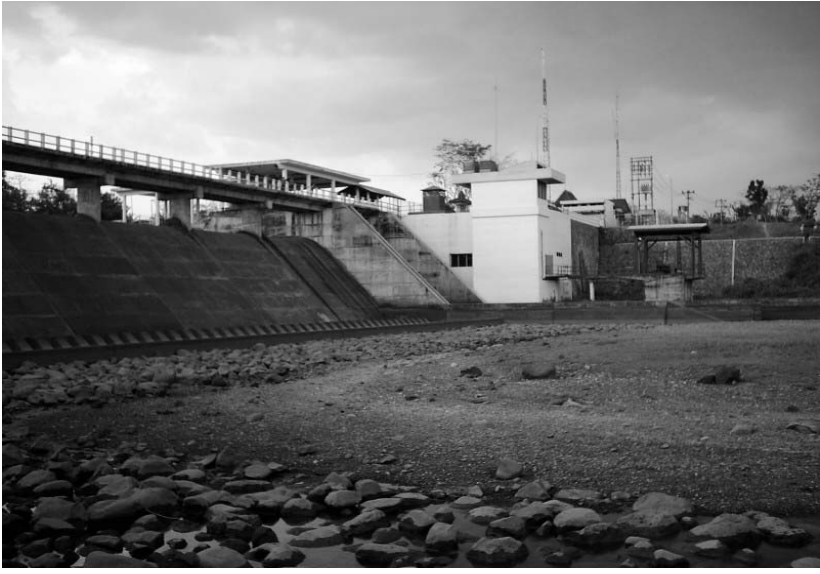
<i>Category</i> Irrigation (Headworks)			
		<i>Structure</i> Fixed Weir, Downstream View			
		<i>Condition</i> <input checked="" type="checkbox"/> A <input type="checkbox"/> B <input type="checkbox"/> C <input type="checkbox"/> D			
		<i>Problems</i> Irrigation and mini-hydro power purpose

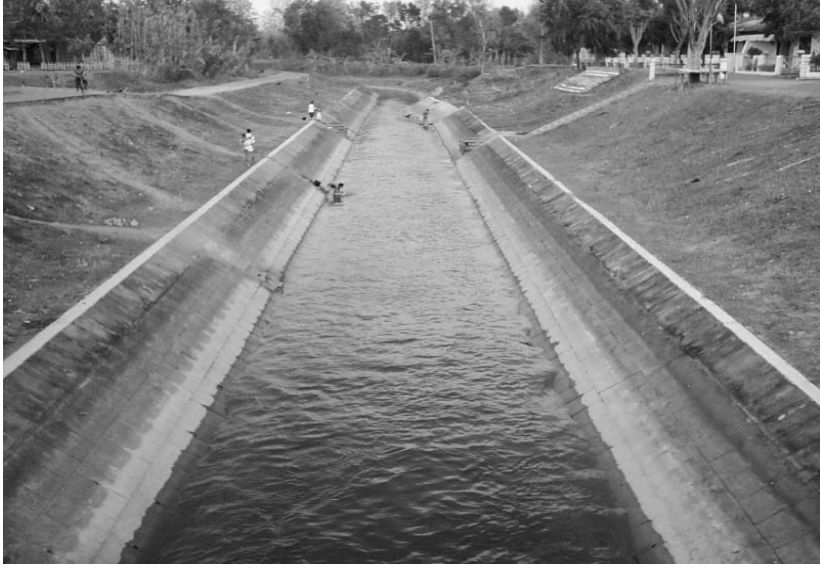
<i>Category</i> Irrigation (Main Canal)			
		<i>Structure</i> Concrete Lined Canal at Downstream of Intake			
		<i>Condition</i> <input type="checkbox"/> A <input checked="" type="checkbox"/> B <input type="checkbox"/> C <input type="checkbox"/> D

<i>Problems</i> Require repair of canal lining

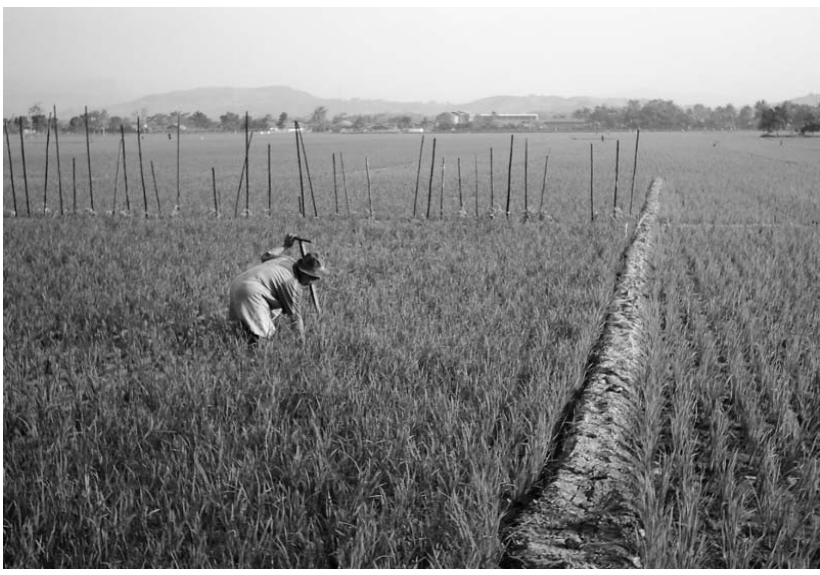
<p><u>Category</u> Irrigation (Paddy Field)</p>		
		<p><u>Structure</u> Paddy Field</p>		
		<p><u>Condition</u> <input type="checkbox"/> A <input type="checkbox"/> B <input type="checkbox"/> C <input checked="" type="checkbox"/> D</p>

<p><u>Problems</u> Require tertiary development</p>
