The Study on Comprehensive Recovery Program  
of Irrigation Agriculture

Japan International Cooperation Agency

**Location Map of Irrigation Schemes  
in Luwu Utara District**

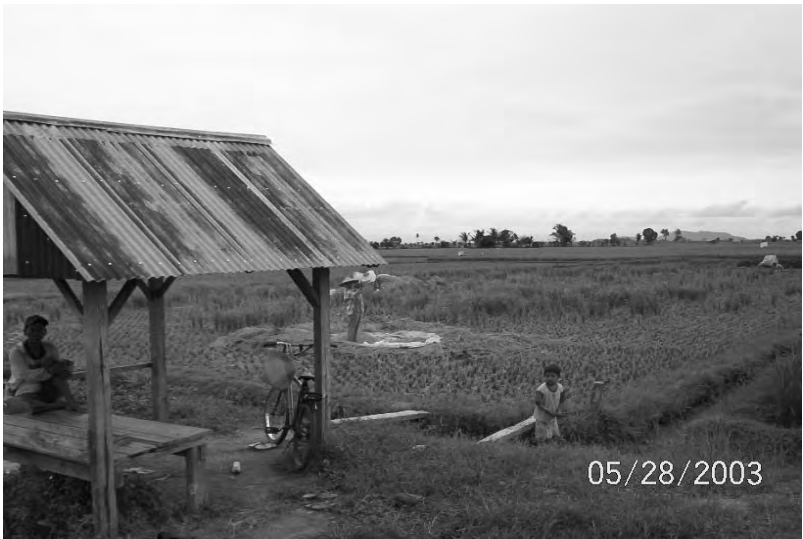
<p><u>Category</u> Irrigation (Main Canal)</p> <hr/> <p><u>Structure</u> Earth Canal</p> <hr/> <p><u>Condition</u>  <input type="checkbox"/> A    <input type="checkbox"/> B    <input type="checkbox"/> C    <input checked="" type="checkbox"/> D</p> <hr/> <p><u>Problems</u> Sedimentation; collapse of canal; leakage from canal; difficulty on maintenance of earth canal; no inspection road.</p>

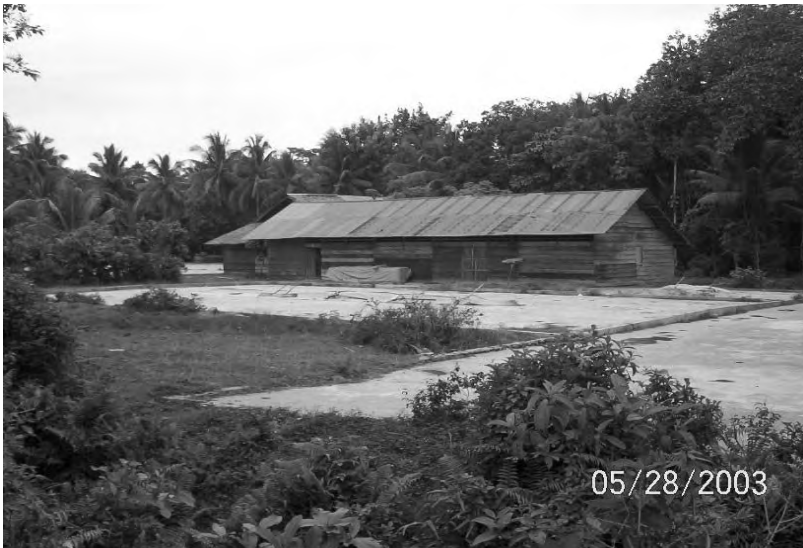
<p><u>Category</u> Ariculture, On-farm</p> <hr/> <p><u>Structure</u> On-Farm Canal</p> <hr/> <p><u>Condition</u>  <input type="checkbox"/> A    <input type="checkbox"/> B    <input checked="" type="checkbox"/> C    <input type="checkbox"/> D</p> <hr/> <p><u>Problems</u></p>
