APPENDIX C

DOCUMENTATION
OF
PUMP & GATE SURVEY

List of Pump and Gate Survey Location 2003

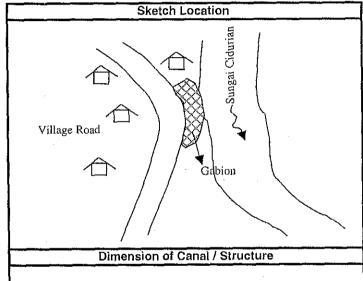
-Land slide occurred in river bend area, but some area was protected by gabion.

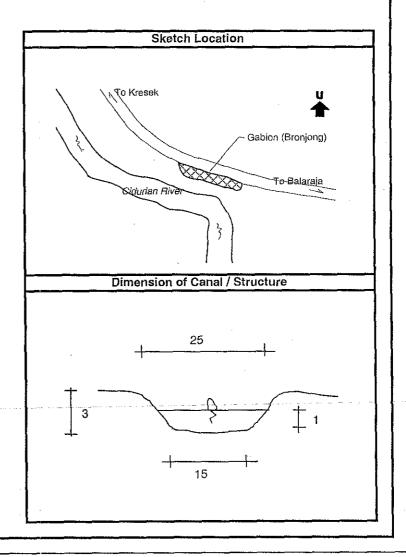
Gabion as slope protection of Cidurian riverbank which is vulnerable for land slide and erosion.

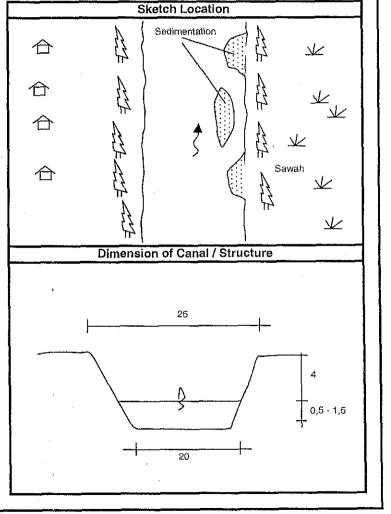
- Sand extraction and collection from the river sediment.

The water level and flow are change from sand extraction.

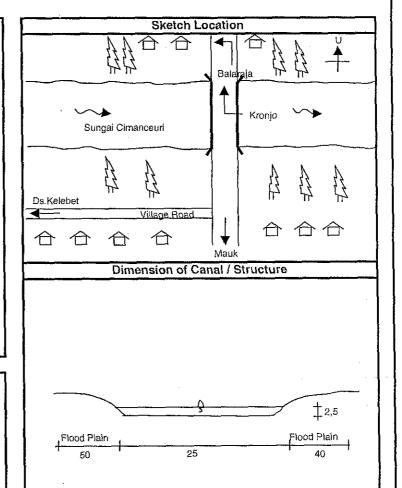
-Water level increase and inundated the settlement area during flood 2003 to a depth of 50 - 100 cm for 5-15 days.

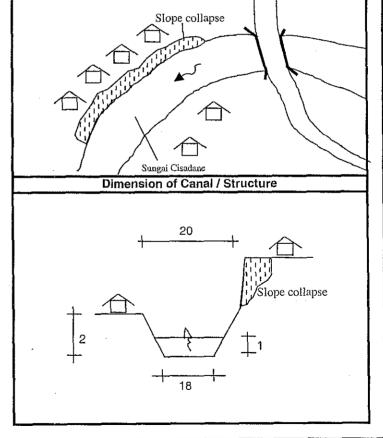
- Housing is restricted zone of river, cause erosion and sedimentation.

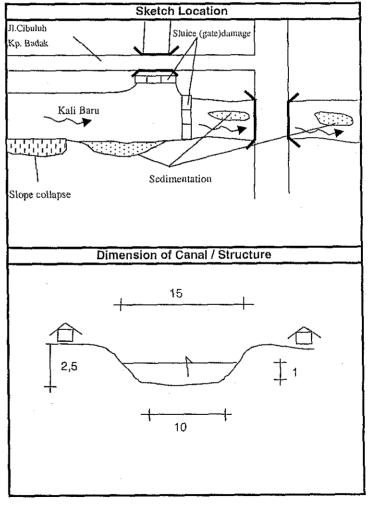
- Housing along river, and use the river as disposal area, no solid waste facilities in the housing area.
- Sediments and garbages appear in the river, decrease flow capacity of the river to increase flood area.

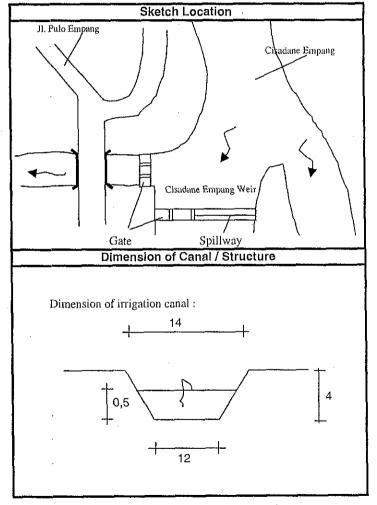
- Gate already rehabilitation, improve the pump height and dikes.
- Garbage accumulated at upstream gate.
- Large reduction of irrigation area, become 1250 ha from 4500 ha.

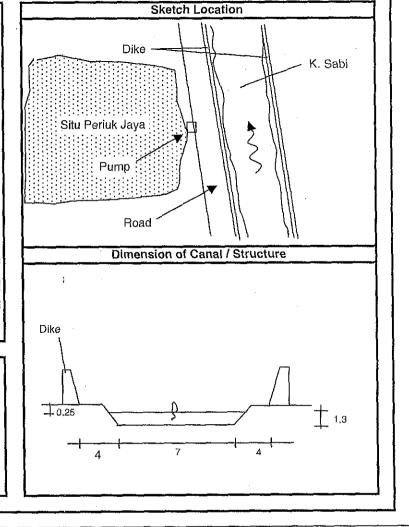
Density housing around the situ (lake). Pump operates to control flood in the reservoir to Kali Sabi. The housing suffers of annual flooding as it low lying area

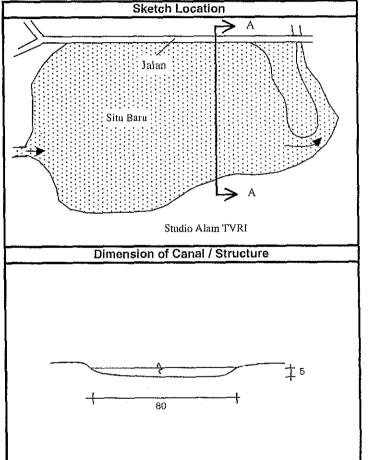
Flooding condition in 2002 gate facilities not function

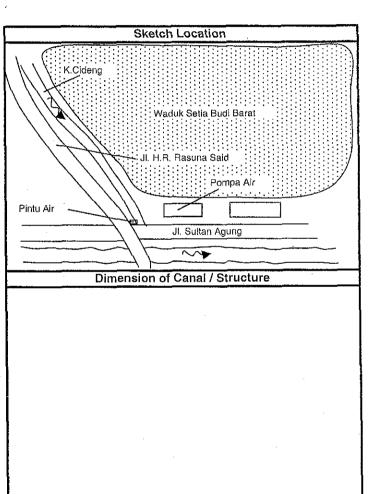
- There is five old pumps and add two news pump

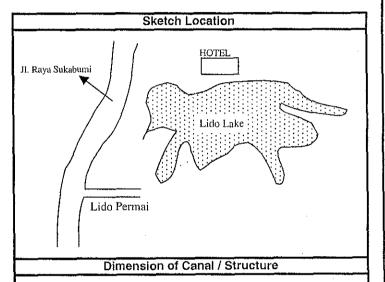
- Lake is used by local people to change into rice field; will reduce also retension capacity of the lake

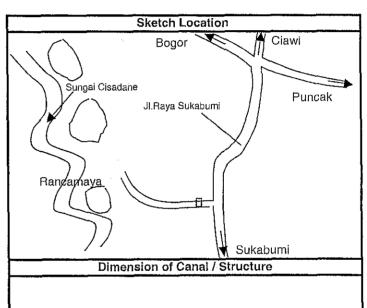
Rancamaya golf property, lakes are provided as retension basin to keep runoff before flows to Cisadane

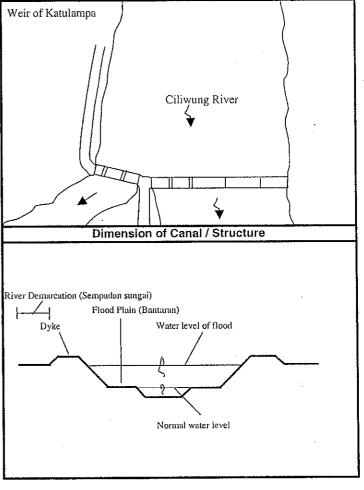
- Height water level during survey 0.30 m

- Katulampa aquipped with AWLR and communication facilities, as it use for important reference control of flooding to the downstream.

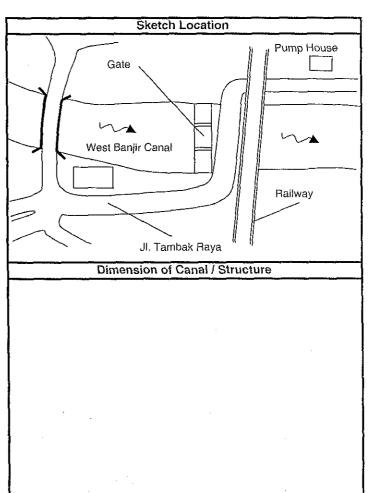
Gate works property width 5.20 m (2 Unit) attached with trash rack, electrically operated equipped with radio communication and warning system operated by PIPWSCC.

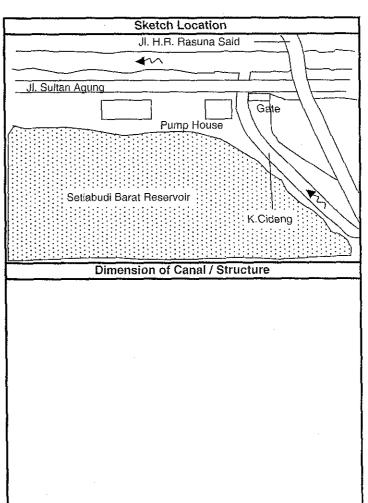
- Condition of pump is good with capacity 1.1 m3/sec (5 Series) in West Setiabudi and 3 series pump (1.1 m3/sec) in East Setiabudi.
- Gate operated manually to control Setiabudi reservoir and flow to Cideng river.

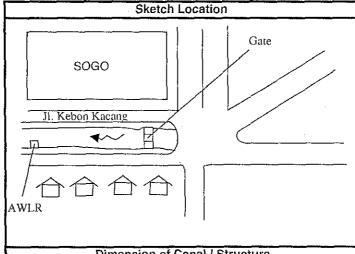
Sluice gate in function (2 gate at width of 2 m) ,electrical operated, AWLR and warning system through radio telecomunitation are provided, under PU-DKI JKT.

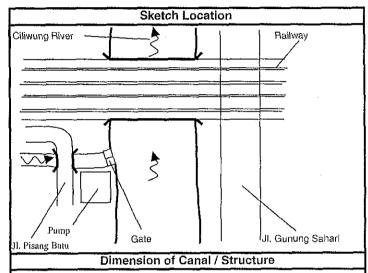
Sluice gate (2 gate in 2m width) not stright but in function.

Pump capacity 1.8 m 3/sec x 2, good condition operated when area around pump location flooded, under PU - DKI JAKARTA.

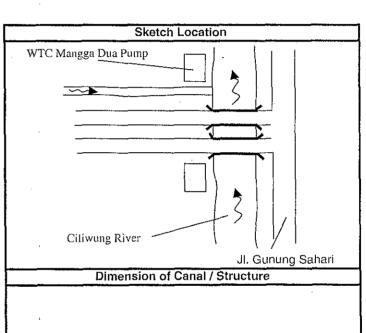
Pump capacity is 159m3/sec each, from total 2 unit at working condition in the south, operate by Mangga Dua Square in the north, operate by WTC Mangga Dua

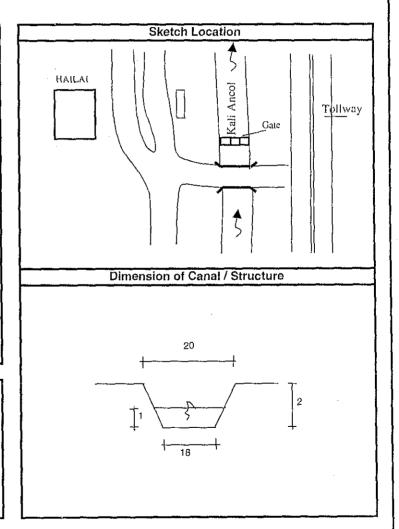
- Shice gate (2 gate of 2.5 m width) and scholl balk are in good operation, in flushing Ancol river from Ciliwung operated by PU - DKI JAKARTA.

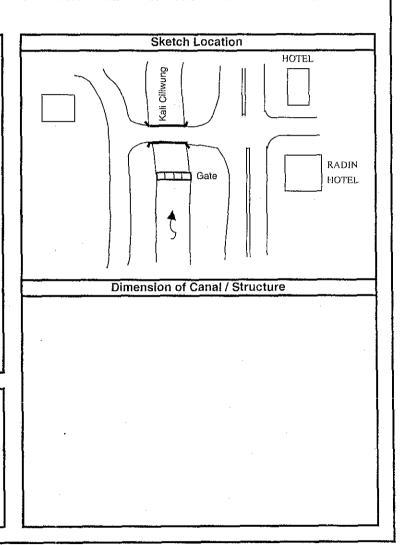
- Gate in good operation but measuring level scale was damaged. The function is to regulate the tidal influence to Ciliwung river. Operated by PU- DKI JAKARTA.

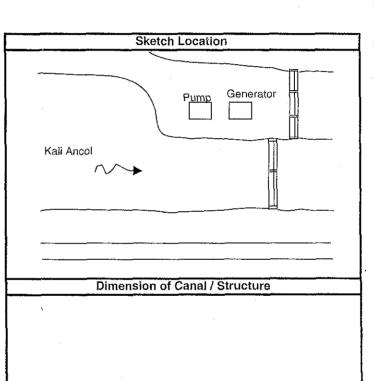
The gate working well. (2 gate each 3 m width). 3 Unit pumps are provided with each capacity 5 m3/sec. Equipped with radio communication operate under PU - DKI JAKARTA.

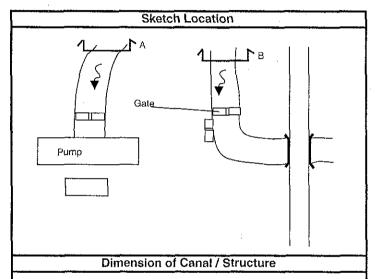
- 3 unit station pump with capacity 3,3 m3/sec. New pump with 4 m3/sec will add in year 2004.
- 2 unit moveable pump, with capacity each 250 l/sec. Propided for emergency
- The pump conserve for 2000 Ha catchment of North Jakarta and will be in operation when water level above + 70 cm.
- -Pump cannot control waterlevel for longperiod of rain (more than 4 hours).
- Operated under PU DKI JAKARTA.

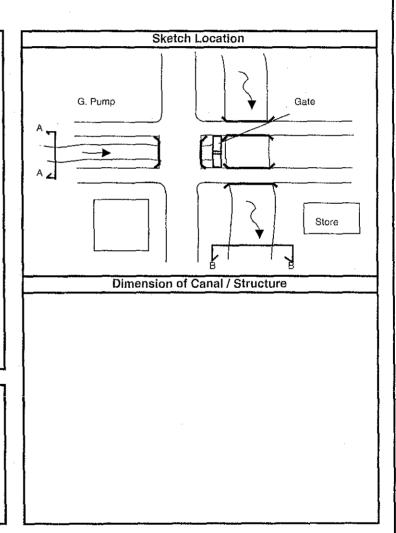
- Sluice gate good condition
- The width of gate is 2 x 3 m
- Gate not completed with house gate

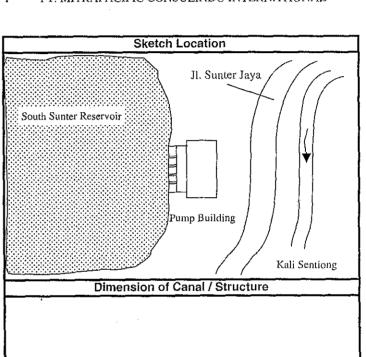
- Pump capacityu is 6 x 2.5 m3/sec (6 series) in good operation, use to control water level on the south Sunter reservior, cleaning gambage with manual. Equipped with radio communication and operated by PU - DKI JAKARTA.
