**BARRAGE LEDGER NOTE**

**CONCRETE DIAGNOSIS**

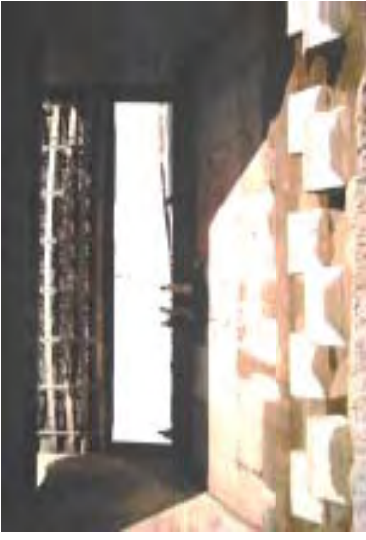
DESIGN CONDITION		Gate No. 60
Barrage Width	4,343 ft (1,324.66 m)

Abrasion	C	Flooring	C	
Exfoliation	A	B	A	
Corrosion	B	Flooring	B	
Cracking	B	C	C	
(B) Displacement				
Cracking	C	C	C	
Exfoliation	C	C	C	
(C) Sedimentation	A	A	A	
(D) Neutralization		15 mm		
(E) Concrete Strength (N/mm2)	30.3	30.9	32.8	
Schmidt hammer	Ave. 31.32 N/mm2			
<u>Diagnosis</u>	Edge Corrosion	Crest Abrasion	Edge Corrosion	Sedimentation before Gate is more than 2 m and Friction Block is silted. Exfoliation at the gate edge on the both pier was repaired by concrete.
<u>Evaluation</u>	Partially Repair			Category /A: need to repair /B: monitoring /C: not need to repair

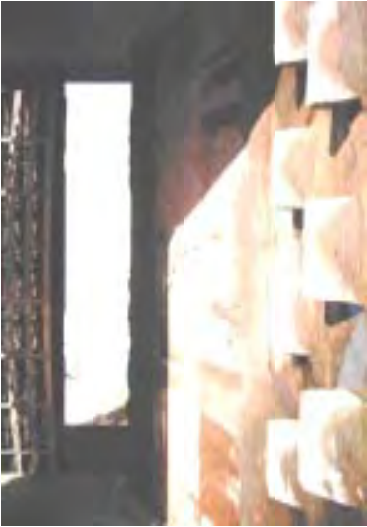
DESIGN CONDITION		Gate No. 61
Barrage Width	4,343 ft (1,324.66 m)

Check Item	CONCRETE DIAGNOSIS		Location
	Right Pier	Centre Creast	
(A) Deterioration			
Abrasion	B	Flooring	B
Exfoliation	C	B	C
Corrosion	B	A	B
Cracking	C	C	C
(B) Displacement			
Cracking	C	C	C
Exfoliation	C	C	C
(C) Sedimentation	A	A	A
(D) Neutralization		8 mm	
(E) Concrete Strength (N/mm2)	32.8	30.3	33.4
Schmidt hammer	Ave. 32.17 N/mm2		
<u>Diagnosis</u>	Edge Corrosion	Crest Abrasion	Edge Corrosion
<u>Evaluation</u>	Partially Repair

Comments  
Sedimentation before Gate is more than 2 m and Friction Block is silted. Exfoliation at the gate edge on the both pier was repaired by concrete.

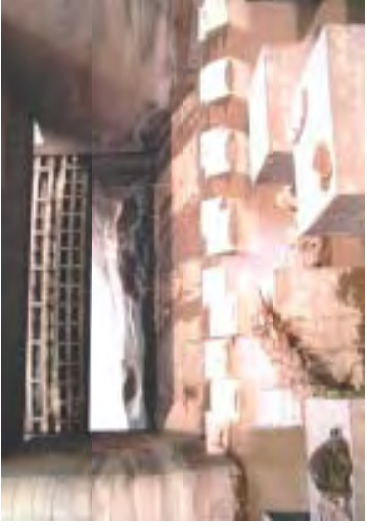
DESIGN CONDITION		Gate No. 62
Barrage Width	4,343 ft (1,324.66 m)

Check Item	Right Pier	Centre Crest	Left Pier	Location
(A) Deterioration				
Abrasion	B	A	B	
Exfoliation	C	A	C	
Corrosion	C	A	C	
Cracking	C	C	C	
(B) Displacement				
Cracking	C	C	C	
Exfoliation	C	C	C	
(C) Sedimentation	A	A	A	
(D) Neutralization		5 mm		
(E) Concrete Strength (N/mm2)	31.5	30.3	30.9	
Schmidt hammer	Ave. 30.90 N/mm2			Partially exfoliation on the Crest
<u>Diagnosis</u>	Edge Corrosion	Crest Abrasion	Edge Corrosion	Comments
<u>Evaluation</u>	Crest Repair			Sedimentation before Gate is more than 2 m and Friction Block is silted. Exfoliation is at the gate edge on the both pier.

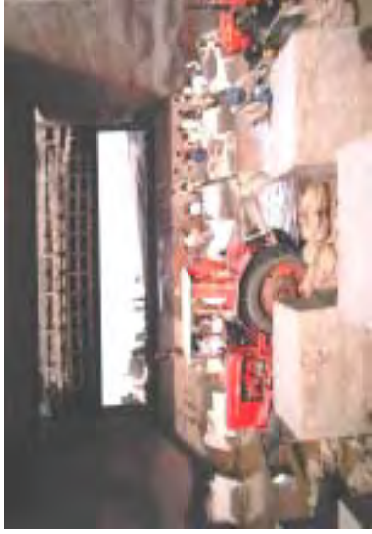
DESIGN CONDITION		Gate No. 63
Barrage Width	4,343 ft (1,324.66 m)

Check Item	Right Pier	Centre Crest	Left Pier	Location
(A) Deterioration				
Abrasion	B	A	B	
Exfoliation	C	A	C	
Corrosion	C	A	C	
Cracking	C	C	C	
(B) Displacement				
Cracking	C	C	C	
Exfoliation	C	C	C	
(C) Sedimentation	A	A	A	
(D) Neutralization		6 mm		
(E) Concrete Strength (N/mm <sup>2</sup> )	30.3	33.4	32.8	
Schmidt hammer	Ave. 32.17 N/mm <sup>2</sup>			Partially exfoliation on the Crest
<u>Diagnosis</u>	Edge Corrosion	Crest Abrasion	Edge Corrosion	Comments
<u>Evaluation</u>	Crest Repair			Sedimentation before Gate is more than 2 m and Friction Block is silted. Exfoliation is at the gate edge on the both pier.

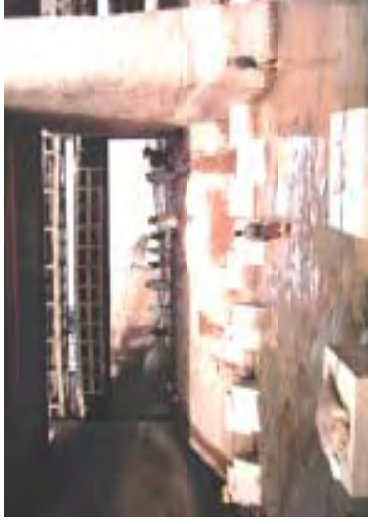
Gate No. 65

Check Item	Concrete Diagnosis		Location
	Right Pier	Centre Crest	
(A) Deterioration			
Abrasion	B	Flooring	B
Exfoliation	C	A	C
Corrosion	C	A	C
Cracking	C	Flooring	C
(B) Displacement			
Cracking	C	C	C
Exfoliation	C	C	C
(C) Sedimentation	A	A	A
(D) Neutralization		10 mm	
(E) Concrete Strength (N/mm <sup>2</sup> )	31.5	30.9	33.4
Schmidt hammer	Ave. 31.95 N/mm <sup>2</sup>		
<u>Diagnosis</u>	Edge Corrosion	Crest Abrasion	Edge Corrosion
<u>Evaluation</u>	Crest Repair
