ANNEX. II

FORMATS OF DAMAGE CONDITIONS

BAY NO. 65

FORMATS OF DAMAGE CONDITIONS-BAY NO. - 65

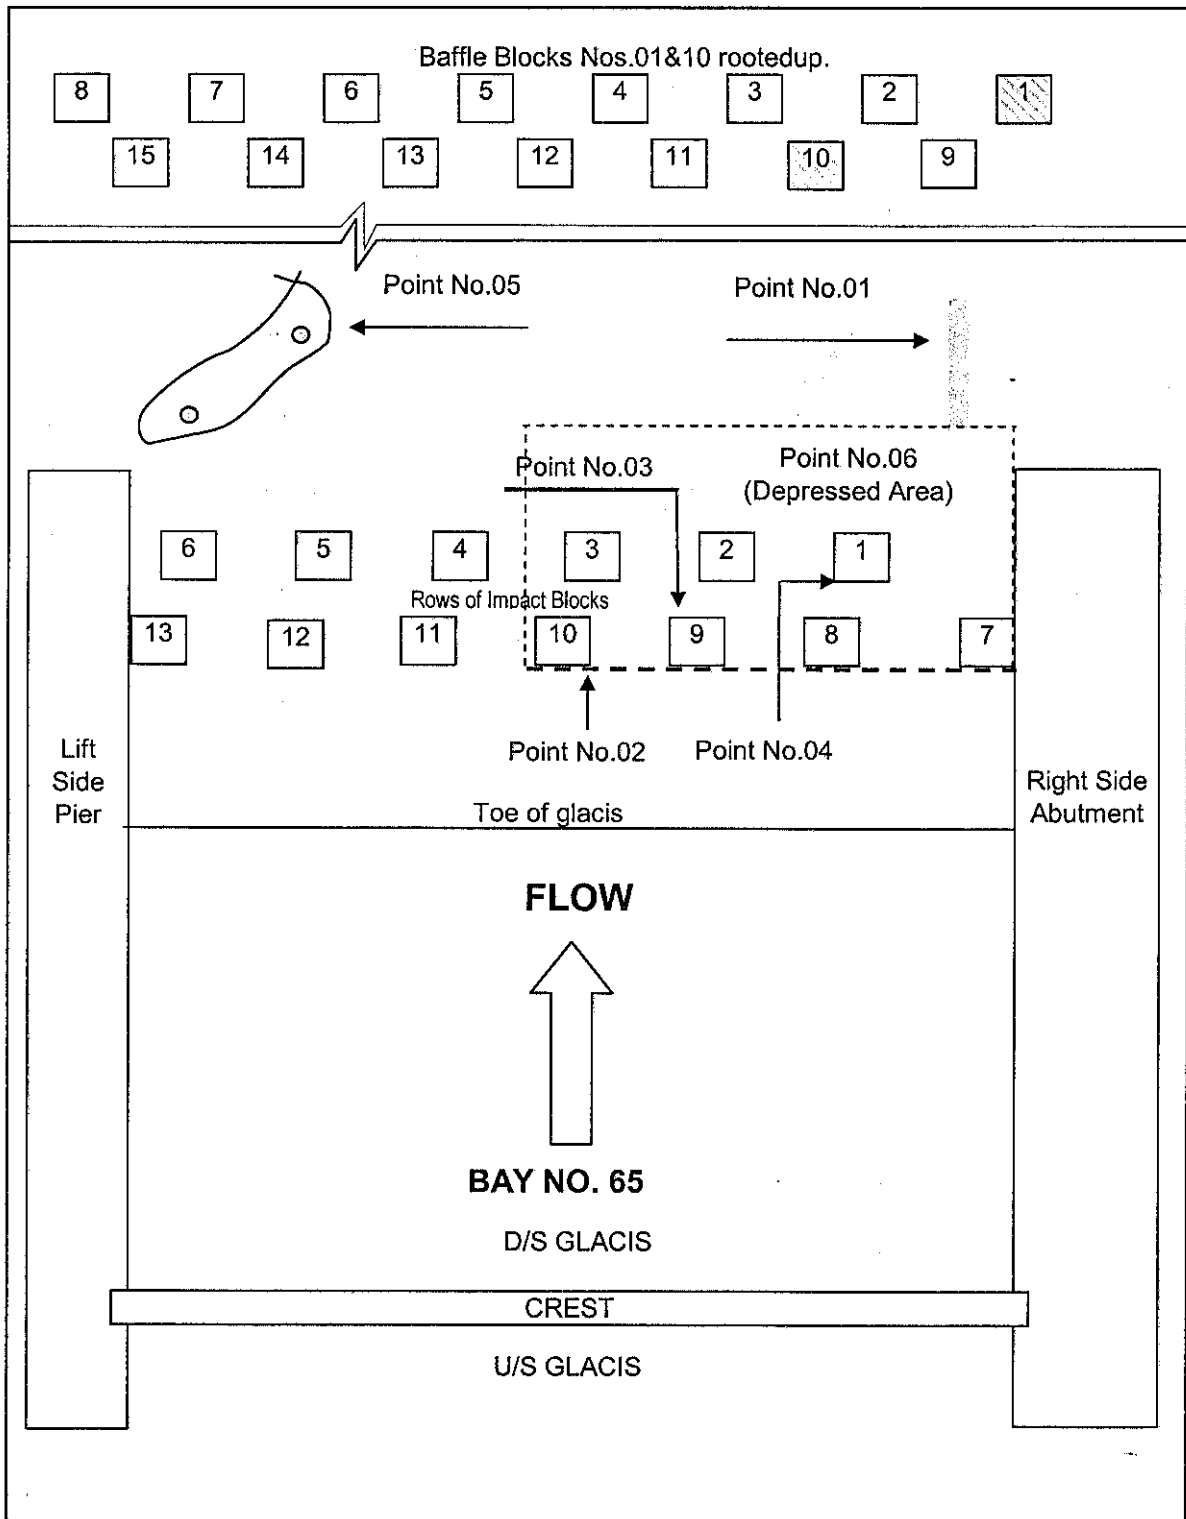
Bay No. 65 From Left
(Sketch)

Ref No: Point No. 01	Survey date: 14-01-2004
<p>Location.</p> <p>D/S of 65th Gate/Bay from left side. (Position diagram).</p> <p>Given below.</p>	<p>Outline of damage.</p> <p>Boiling of water taking place from underneath the floor at the location shown below.</p>

Ref No: Point No.02	Survey date: 14-01-2004
Location. D/S of 65th Gate/Bay from left side. (Position diagram). Given below.	Outline of damage. Ripping up/erosion of skin concrete (which is not monolithic with the underlying mass concrete) adjacent to the impact block- at the location shown below.

Ref No; Point No.03	Survey date: 14-01-2004
Location. D/S of 65th Gate/Bay from left side. (Position diagram). Given below.	Outline of damage. Ripping up/erosion of skin concrete (which is not monolithic with the underlying mass concrete) adjacent to the impact block- at the location shown below.

Ref No; Point No.04	Survey date: 14-01-2004
<p>Location.</p> <p>D/S of 65th Gate/Bay from left side. (Position diagram).</p> <p>Given below.</p>	<p>Outline of damage.</p> <p>Ripping up/erosion of skin concrete (which is not monolithic with the underlying mass concrete) adjacent to the impact block- at the location shown below.</p>

Ref No; Point No.05	Survey date: 14-01-2004
Location. D/S of 65th Gate/Bay from left side. (Position diagram). Given below.	Outline of damage. Boiling points at D/S of Bay No.65 from Left Side.

Ref No; Point No. 06	Survey date: 14-01-2004
Location. D/S of 65th Gate/Bay from left side. (Position diagram). Given below.	Outline of damage. Depressed Area below the existing D/S Floor Level.

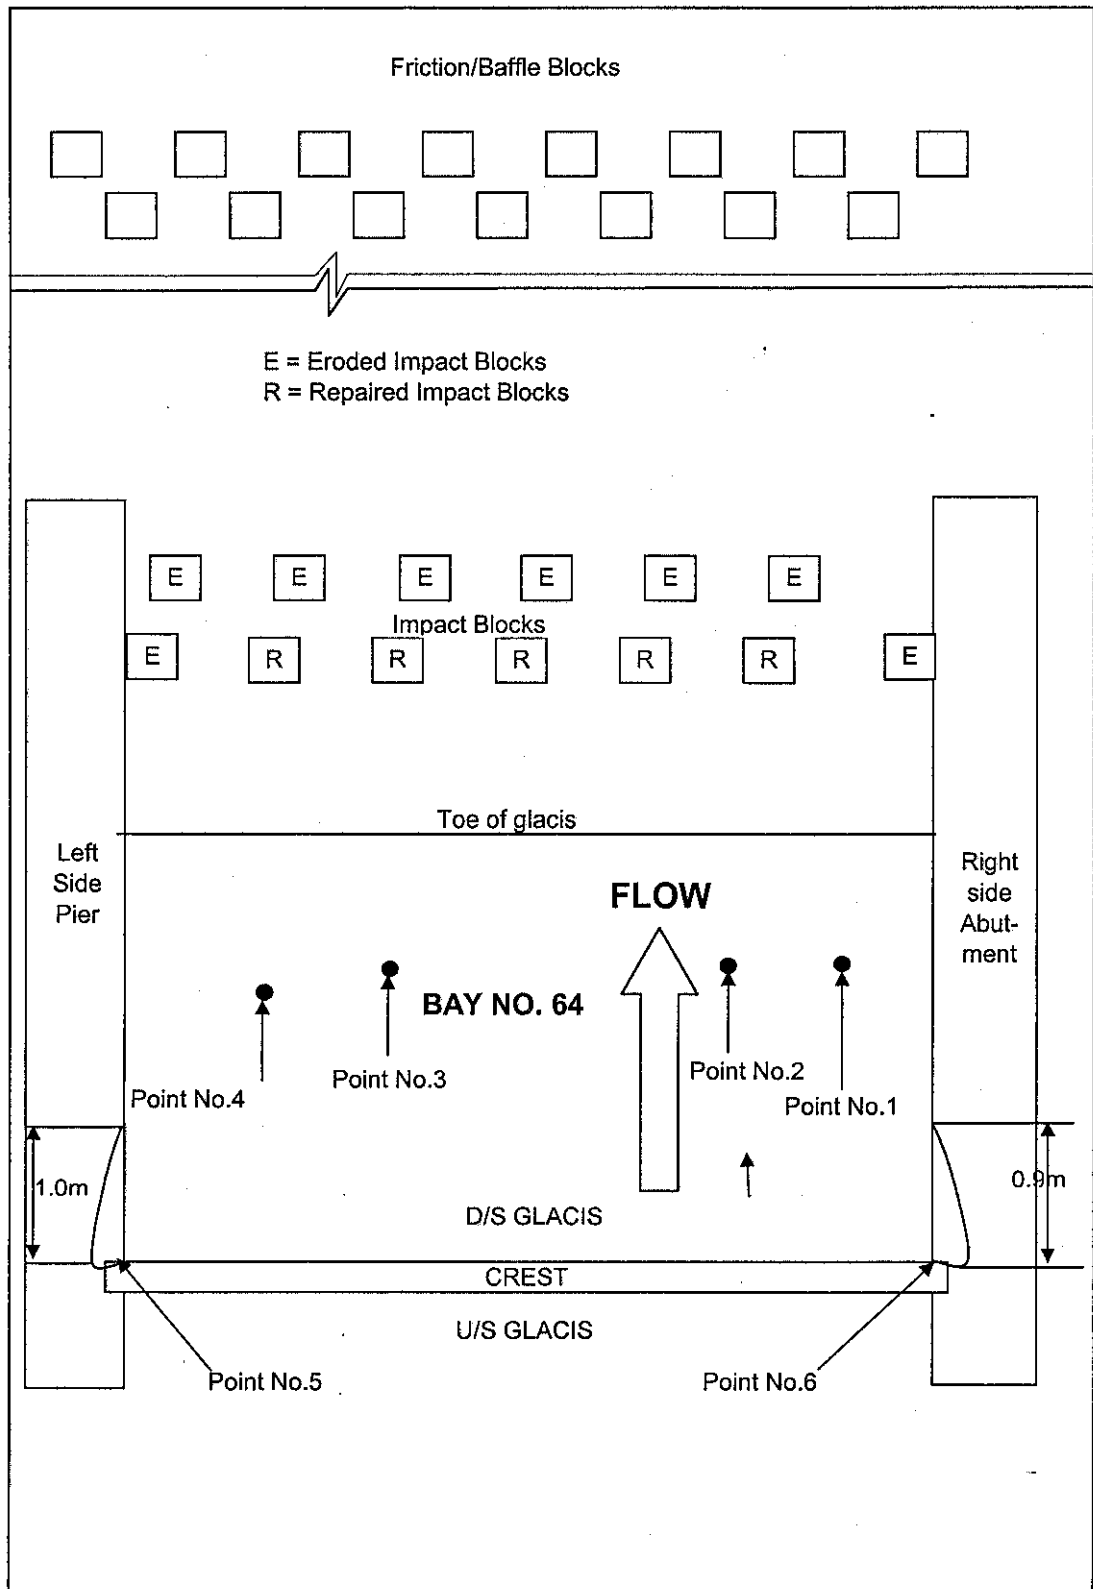
Bay No. 64 From Left

Ref No; Point No.01	Survey date: 14-01-2004
Location. D/S of 64th Gate/Bay from left side. (Position diagram). Given below.	Outline of damage. Water leakage from repaired glacis

Ref No; Point No.02	Survey date: 14-01-2004
Location. D/S of 64th Gate/Bay from left side. (Position diagram). Given below.	Outline of damage. Water Leakage from the surface of repaired downstream glacis

Ref No; Point No.03	Survey date: 14-01-2004
<p>Location.</p> <p>D/S of 64th Gate/Bay from left side. (Position diagram).</p> <p>Given below.</p>	<p>Outline of damage.</p> <p>Water Leakage from the surface of D/S repaired glacis.</p>

Ref No; Point No.04	Survey date: 14-01-2004
Location. D/S of 64th Gate/Bay from left side. (Position diagram). Given below.	Outline of damage. Water Leakage from the surface of repaired downstream glacis

Ref No; Point No.05	Survey date: 14-01-2004
<p>Location.</p> <p>D/S of 64th Gate/Bay from left side. (Position diagram).</p> <p>Given below.</p>	<p>Outline of damage.</p> <p>Erosion of Pier due to high velocity flow passing down below the gates.</p>

Ref No; Point No.06	Survey date: 14-01-2004
<p>Location.</p> <p>D/S of 64th Gate/Bay from left side. (Position diagram).</p> <p>Given below.</p>	<p>Outline of damage.</p> <p>Erosion of Pier due to high velocity flow passing down below the gates.</p>

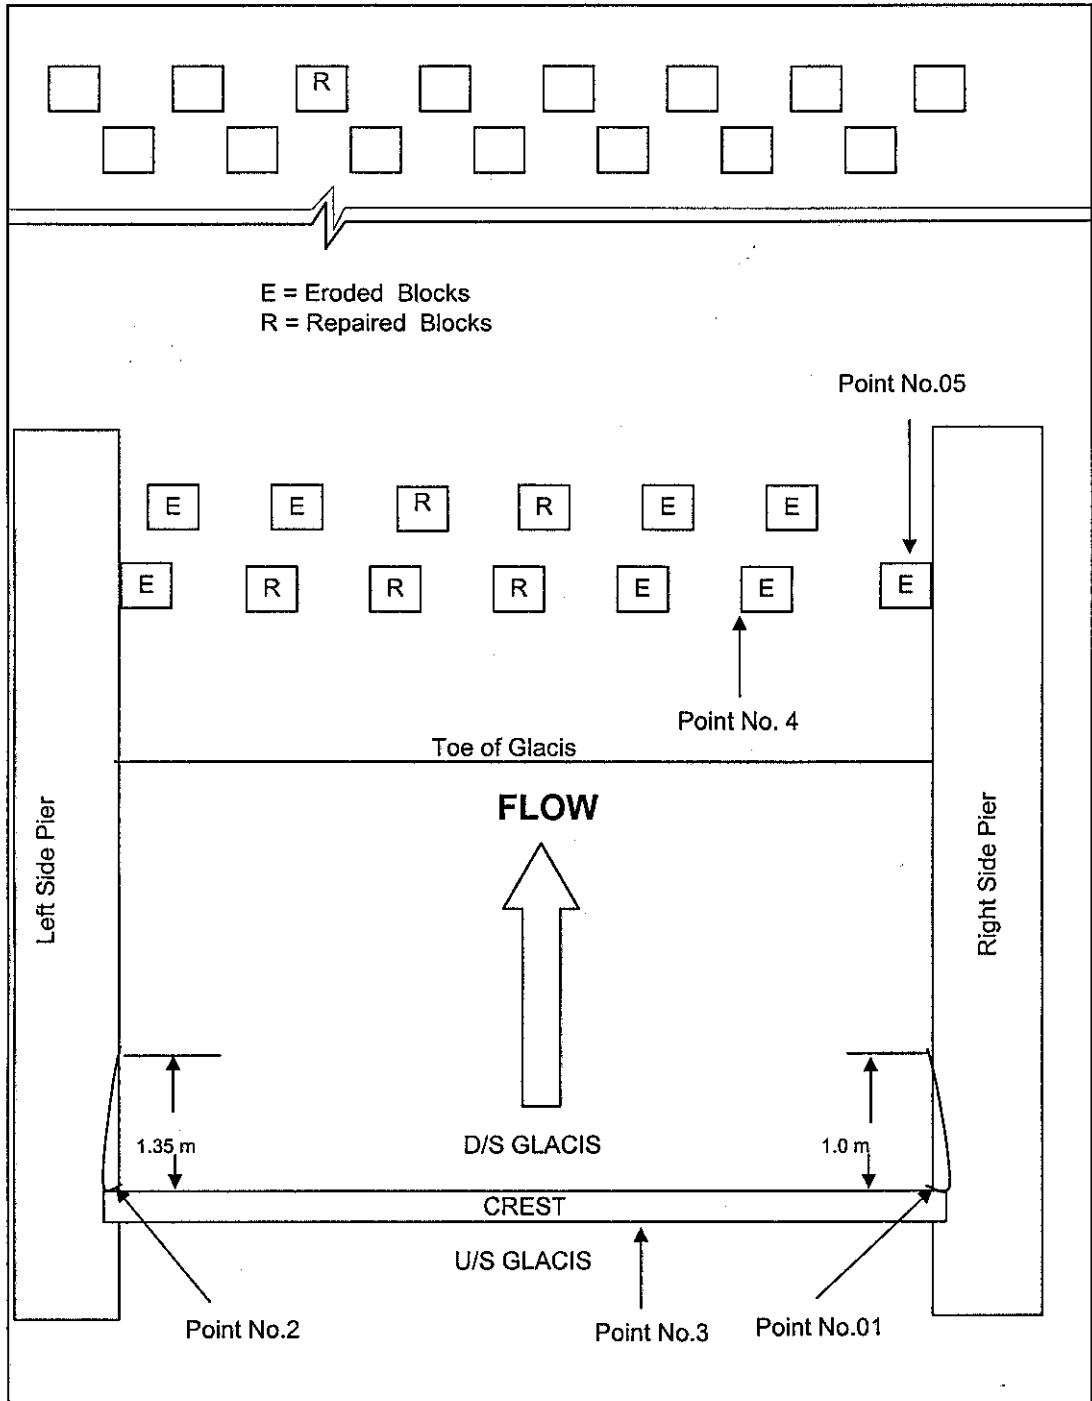
Bay No. 62 From Left (Sketch)

Ref No. Point No.01	Survey date: 14-01-2004
Location. D/S of 62nd Gate/Bay from left side. (Position diagram). Given below.	Outline of damage. Erosion of Piers due to high velocity flow near its bottom.
