P5; Results of the site survey

P5 Geological Section

P5—Geological issues (Outlet & Lower reservoir)

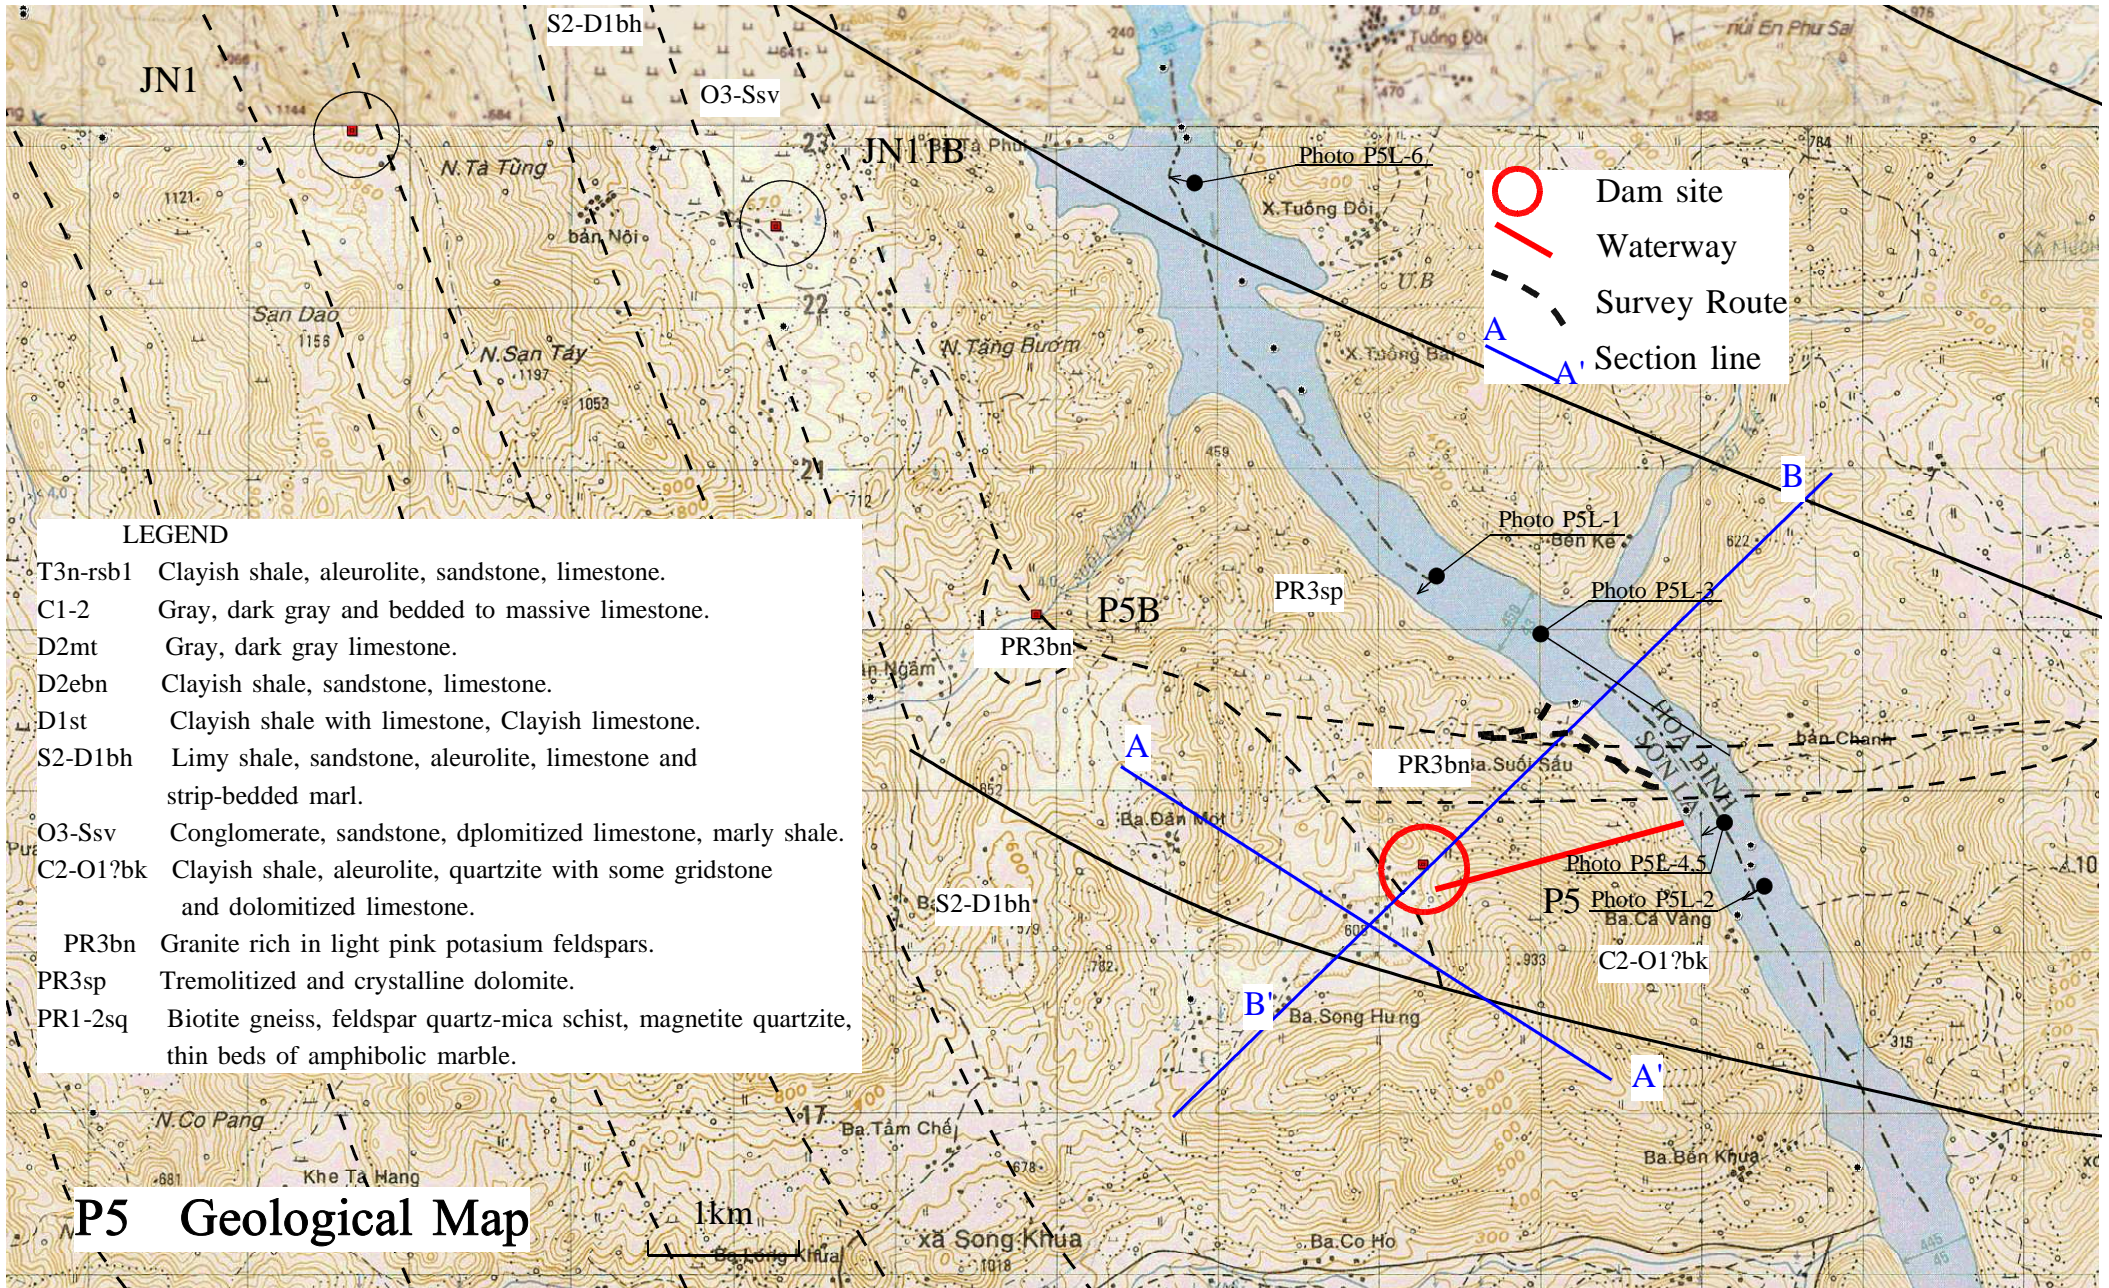
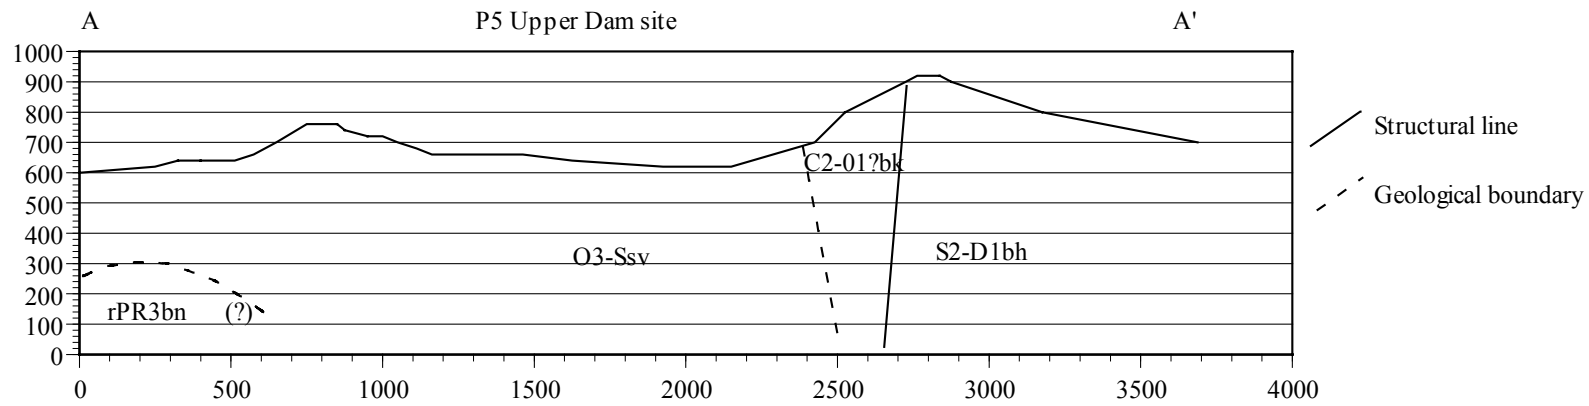
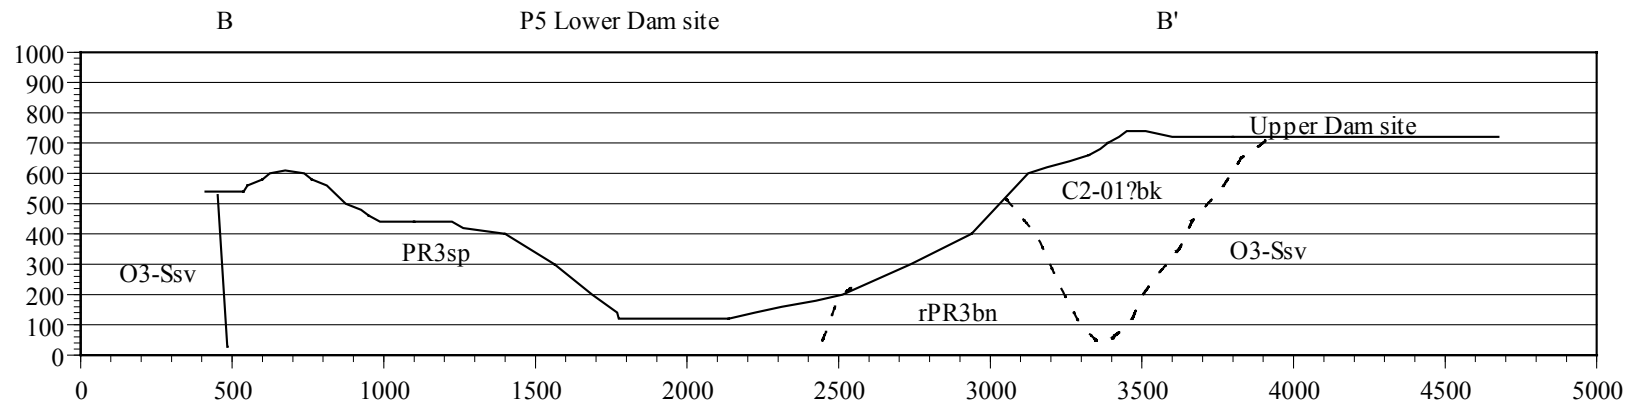
20-30degrees of limestone as C2-O1?bk, granite vein as γ PR3bn outcrops with 100-200m width near the waterway line. The condition of limestone is hard and massive with many open holes. The granite outcrops in the left side of the river looks rather granodiorite from the mineral composition. The condition of this granite in the right side of the river was not found clearly due to strong weathering. As for gently sloped limestone, many of small caves and eroded open holes along the Hoa Binh Lake are found.

The conditions and the rock mass permeability around the Underground Power Station are gently inclined bedding as 20-30degrees of limestone with many eroded holes as relatively high permeability. The condition around the boundary of granite and limestone is not clear by the strongly weathered surface and secondary sediments. There were no fresh outcrops of granite in right side of the river. There are some red colored soil originated by the weathered granite in the slope, the other small intrusion of granite probably exists under the ground potentially. This red colored soil is quite easy to be eroded.
