## PART III FEASIBILITY STUDY OF THE AYALA BRIDGE

### 13. BRIDGE CONDITION SURVEY AND TESTS

## 14. ASSESSMENT OF EXISTING CONDITION

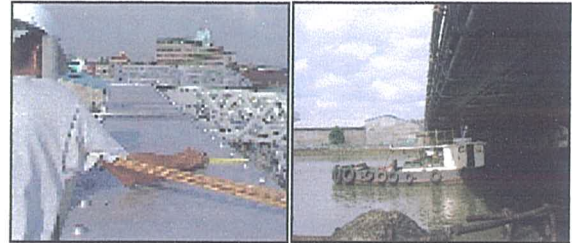
Measurement of Members at Truss Top Chord and with Tugboat

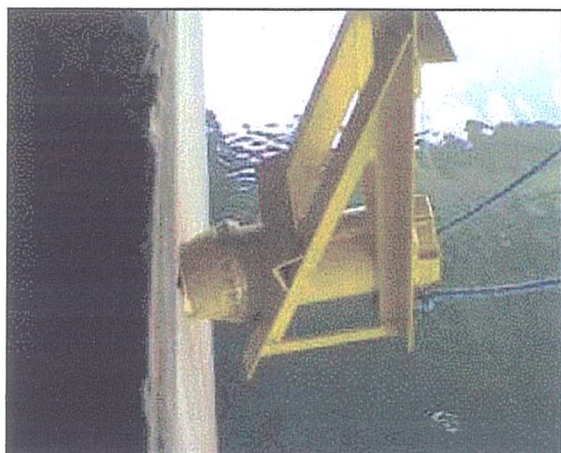
The pendulum was positioned to impact the centerline of the middle truss of the bridge. The impacting head used had a mass of about 100 kg. The tip of the head was covered with rubber.

Impact Head of Yellow-Painted Pendulum
