PART IV FEASIBILITY STUDY OF SELECTED BRIDGES

19. SECOND AYALA BRIDGE

20. JONES BRIDGE

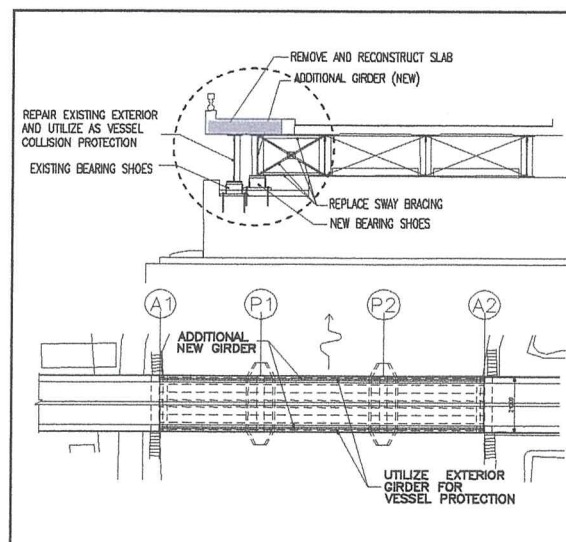
Scheme 3 : Large Scale Rehabilitation

The large-scale rehabilitation measure was recommended as the best scheme in terms of engineering and economic aspects. Structural capacity and durability is improved. Installation of additional girder augments the capacity and stability of the superstructure and eliminates out-of-plane girder deformation. Existing exterior girder can be utilized as vessel collision protection without transmitting impact forces to the superstructure.

- Cleaning and Painting the steel structures for the whole bridge.
- Replacement of ruptured sway bracing
- Provide additional girder with new bearing shoes next to existing exterior girder
- Repair and retain existing exterior girder to functions as vessel collision protection
- Remove and reconstruct existing related portion at deck slab, sidewalk, railing and expansion joint.

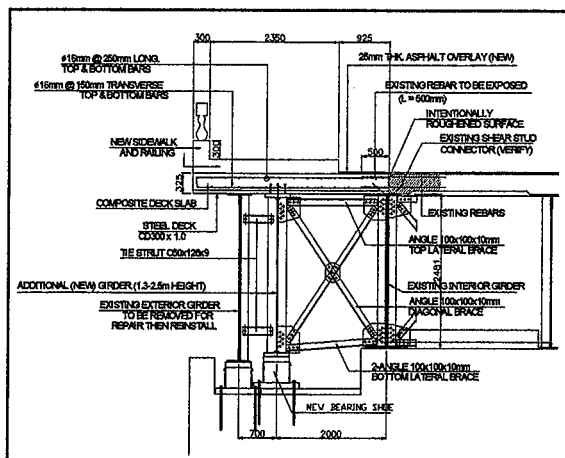
Additional Girder and new sidewalk detail

This scheme is to retain existing exterior girder to function as vessel collision protection, installing new exterior girders adjacent to the existing exterior girder. Therefore the total width and alignment of the bridge are kept the same as the existing one.

- Additional (new) steel girders are installed next to the existing exterior girders keeping space to install new bearing shoes. The height of the new girder is shallower than the existing exterior girders.
- All sway bracings between new and existing girders are removed and replaced with new ones.
- The new deck slab is composite type with steel deck to shorten construction period. The railing shall be preserved.

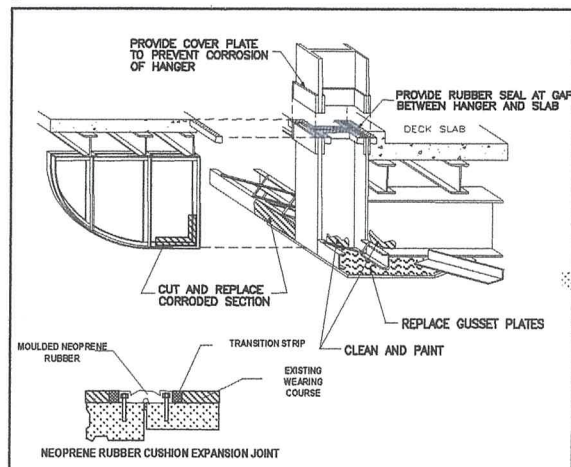
Scheme 2 : Medium-Scale Rehabilitation

The recommended alternative as best scheme in terms of engineering aspects is Scheme 2, Medium-Scale Rehabilitation. Structural capacity and durability of the bridge is improved considerably by replacing heavily corroded members and providing corrosion protection.

- Cleaning and painting floor system including corroded vertical hanger and truss.
- Replace expansion joint to seal water leakage.
- Replacement of Gusset Plates.
- Replacement of corroded section of floor beam, longitudinal tie beam and vertical members by cutting affected areas and placing new sections.
- Sealing gap between vertical hanger and sidewalk concrete and provide plates to prevent further corrosion of vertical hanger.
- Removal and reconstruction of deck slab near abutment.
- Replacement of corroded stringers near abutment.

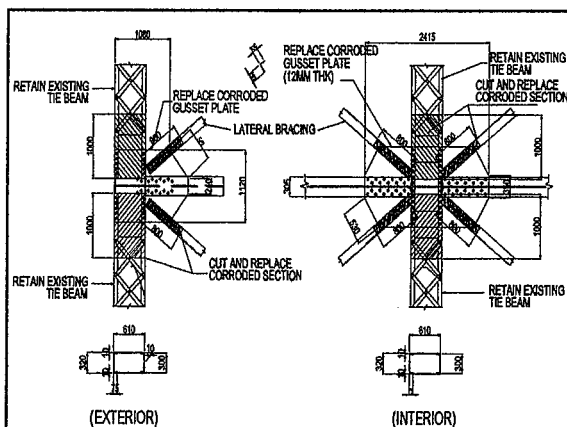
Replacement of Corroded Section

The design is to replace the sections of corroded members and seal water to prevent further corrosion of the members in accordance with the inspections carried out.

- The corroded sections of floor beams, longitudinal tie beams, and vertical hangers are replaced with the new members by cutting.
- Waterproof plates are welded around the vertical hanger and the gap between the plate and deck slab sealed by elastomeric rubber.
- Prevent corrosion of bearing support, by connecting new drain pipe at the existing drain pipe of deck slab.
- Expansion joint are replaced with watertight joint to prevent corrosion of floor stringer.

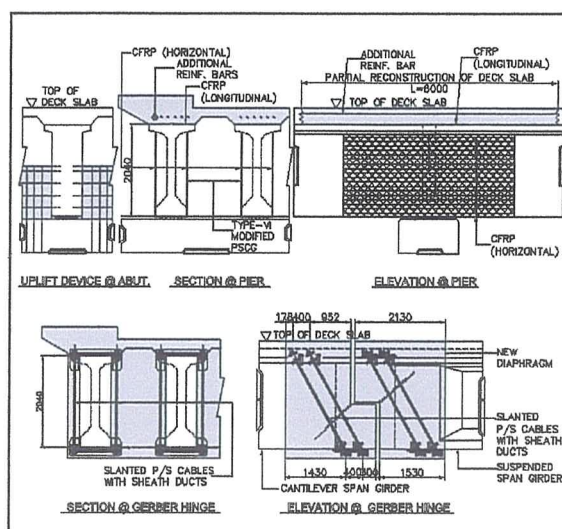
Scheme 2 : Medium-Scale Rehabilitation

The recommended scheme among the three schemes is the medium-scale rehabilitation scheme. Using this scheme, it will remedy the problem of uplift at abutments. It will also improve condition of gerber by increasing the shear capacity. Flexure above pier supports will also be improved using CFRP (Carbon Fiber Reinforced Polymer)

- Additional concrete block doweled to abutment and girder as uplift countermeasure.
- Installation of CFRP vertically at web near hinge and longitudinally at top of girder over pier support.
- Repair/Sealing of concrete cracks, honeycomb and spalling.
- Stressing of slanted prestress cables at gerber hinges.
- Reconstruction of diaphragm at gerber hinge.

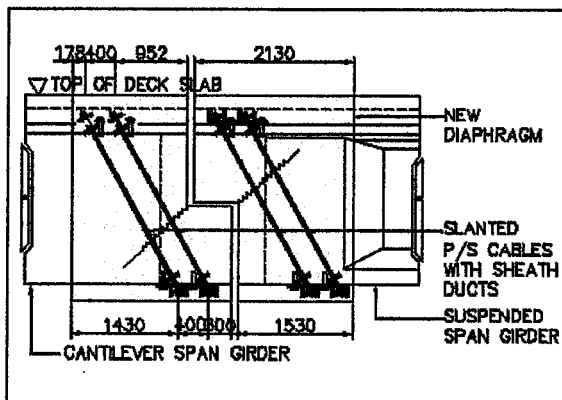
Slanted Prestress Cables Layout

The design is to rehabilitate the damaged sections of gerber hinges, top of girder at piers, and uplift anchors at abutments in accordance with the inspections carried out.

- The slanted prestressing cables are installed outside of girders. The diaphragms at gerber hinge are reconstructed with wider ones in order to distribute reactions from deck slab.
- The CFRP and additional reinforcing bars are installed outside of girder at piers to increase capacity of longitudinal negative reinforcement.
- Additional reinforcing bars with additional concrete block are installed at abutment supports in order to increase uplift capacity.

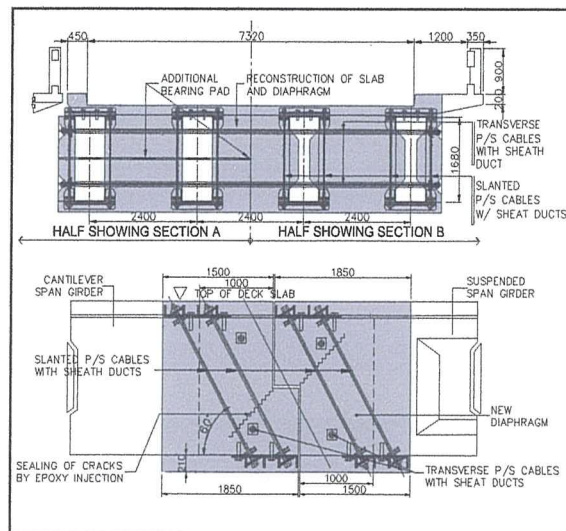
Scheme 3 : Large Scale Rehabilitation

The recommended best scheme in terms of engineering aspects is Scheme 3 Large-scale Rehabilitation. Structural capacity and durability of the bridge will be improved considerably by providing P/S cables at gerber hinge and at the diaphragm. Construction duration for this scheme is 12 months and cost is justifiable for the overall improvement of the bridge.

- Repair and sealing of concrete cracks, honeycomb and spalling.
- Rehabilitation of gerber hinge portion with slanted P/S cables.
- Reconstruction of diaphragm and partial reconstruction of deck slab at gerber hinge portion.
- Additional elastomeric bearing pads at diaphragm.
- Installation of transverse P/S cables at diaphragm of gerber hinge portion.

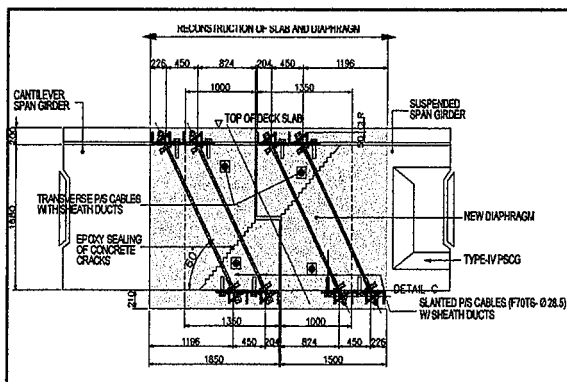
Strengthening of Gerber Hinge

Cracks at exterior gerber hinge is the major damage of this bridge. To recover this defect, the required measures are:

- For strengthening of gerber hinge, slanted prestressing cables are installed outside of the girder around the cracks at the hinge.
- For equal distribution of loads, the diaphragm at the hinge is widened and transversal prestressing cables are installed.
- For safety to failure of existing bearings, additional elastomeric bearing pads at diaphragm are installed.

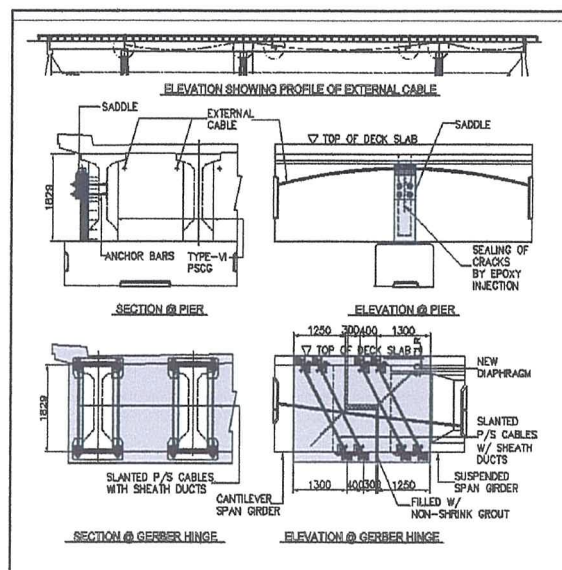
Scheme 3 : Large Scale Rehabilitation

The large-scale rehabilitation was recommended as the best scheme which propose to remedy cracks at gerber hinge with P/S cable and large deflection at the cantilever portion with external cables.

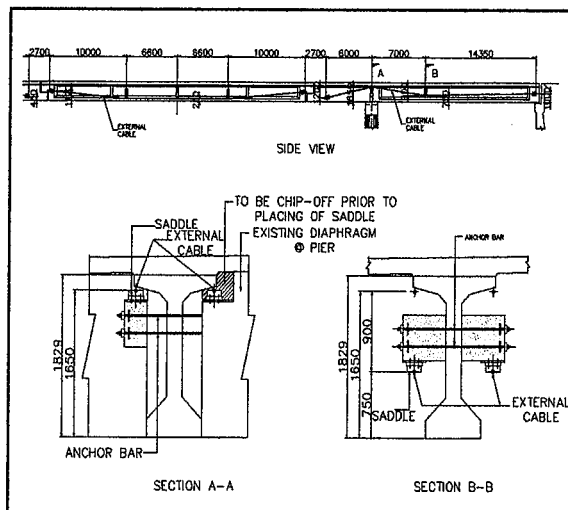
External cable for Girder Deformation

The major damages are sagging deformation of girder and cracks at gerber hinge. To recover these defects, the required measures are:

- For strengthening of gerber hinge, slanted prestressing cables are installed outside the girder around the cracks at the hinge.
- For preventing further girder deformation, external longitudinal prestressing cables are installed.
