THE STUDY  
ON  
THE IMPROVEMENT OF EXISTING BRIDGES  
ALONG PASIG RIVER AND MARIKINA RIVER  
IN  
THE REPUBLIC OF THE PHILIPPINES

FINAL REPORT  
MAIN TEXT (2/3)

JULY 2004

<b>Chapter 13</b>	<b>DETAILED BRIDGE SURVEY AND ASSESSMENT</b>	
13.1	Review of Design and Repair Works .....	13-1
13.1.1	Review of Design.....	13-1
13.1.2	Review of Rehabilitation Works.....	13-3
13.1.3	Historical Background .....	13-5
13.2	Natural Condition Survey .....	13-8
13.2.1	Topographic Survey.....	13-8
13.2.2	Geotechnical Survey.....	13-9
13.2.3	Scour Survey.....	13-10
13.3	Bridge Condition Survey and Identification of Damages.....	13-11
13.3.1	Measurement of Shapes and Dimensions .....	13-11
13.3.2	Close-Up Visual Inspection.....	13-15
13.3.3	Non-Destructive Test of Material .....	13-17
13.3.4	Static Load Test of Superstructure.....	13-19
13.3.5	Microtremor Measurement Survey.....	13-22

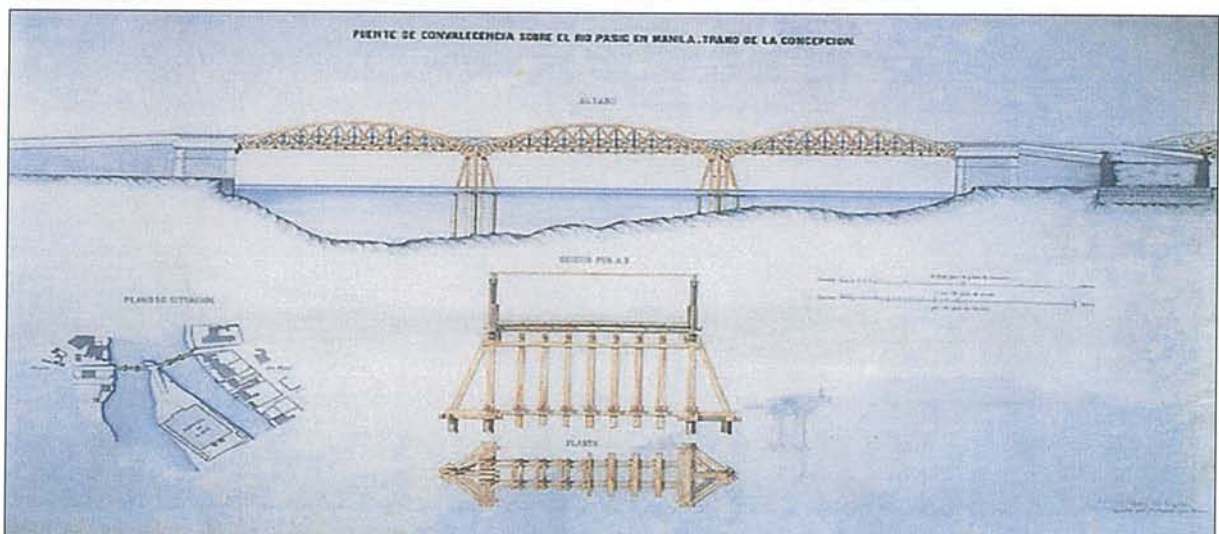
Figure 13.1.3-1 Ayala Bridge (South Span Side)

**Figure 13.1.3-1** shows the Ayala Bridge constructed in 1876, which crossed the river in two independent sections that converged on Convalecencia Island. Three low arches and a lower platform, all of which were timber-built, formed each of these sections.

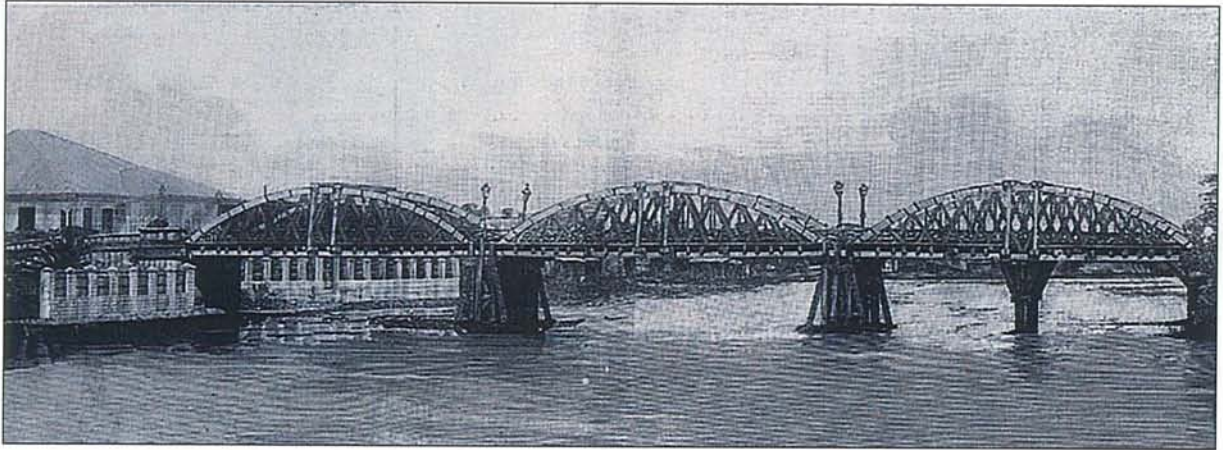
Figure 13.1.3-2 Ayala Bridge After Repair Works (Added Pier at the Center of Right Span) in 1890 (South Span Side)

In 1882, repair works were made in the bridge, following which another re-assessment of the bridge was conducted for possible repairs to be executed as shown in **Figure 13.1.3-2**. Although scarcely ten years had passed since it was opened, by 1889 the Ayala Bridge was in a dangerous condition. The section between the island and the San Miguel district collapsed, and only a few months later the conception section followed suit.
