FEASIBILITY STUDY OF JONES BRIDGE REHABILITATION PLAN

20.1 DETAILED BRIDGE SURVEY AND ASSESSMENT

20.1.3 Bridge Condition Survey and Identification of Damages

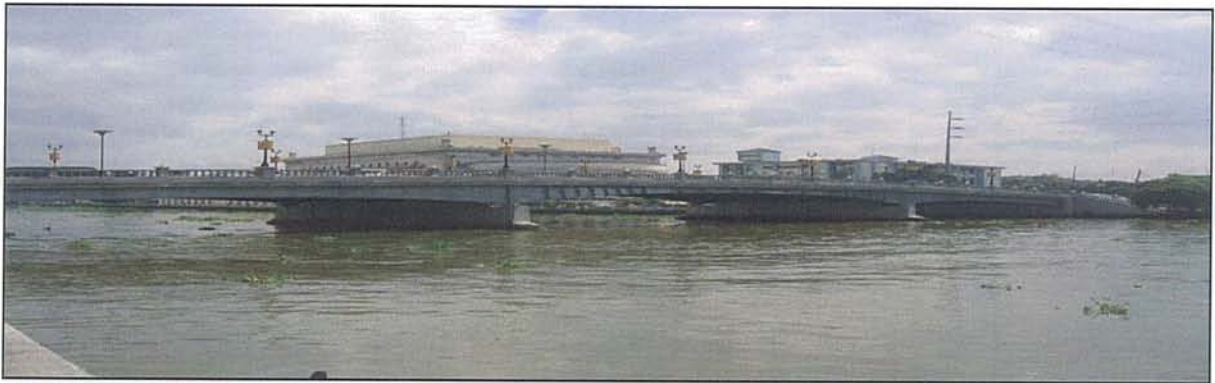
Photo 20.1.1-1 Panoramic View of Jones Bridge

- Structure Type : Three-Span Continuous Steel Girder Bridge
Eight (8) steel girders support the four-lane separated concrete deck. The girders rest on a 22m wall type piers.
- Bridge Length : 114.43m (35.46m + 43.31m + 35.46m)
- Date of Construction : 1948

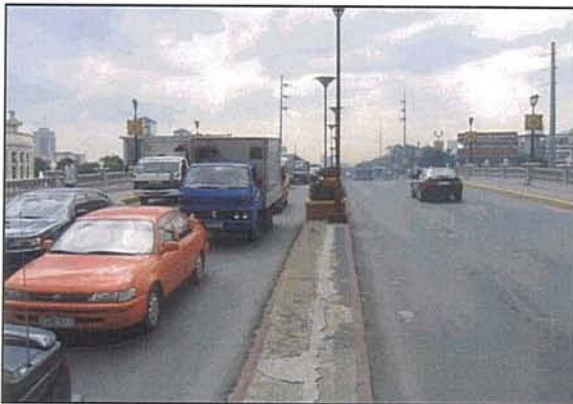
Verification of Road Deck Level includes road deck width, length of bridge, dimensions of post, railing, sidewalks and expansion of joint gap (see to Photo 20.1.3-1).

Photo 20.1.3-1 Road / Deck Level Inspection

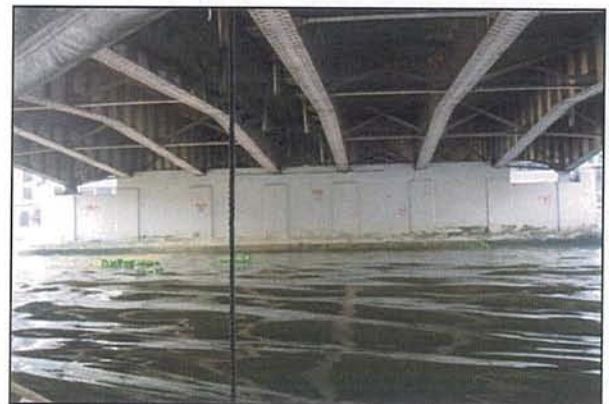
Photo 20.1.3-2 Below Deck Level – Bottom Soffit of Steel Girders and Sway Bracings

Verification below deck level was taken at various locations of girders (see **Photo 20.1.3-2**). Since the section varies at different locations, several sections were measured, taking into considerations that the dimensions of external girders are different from internal girders. All girders were verified.

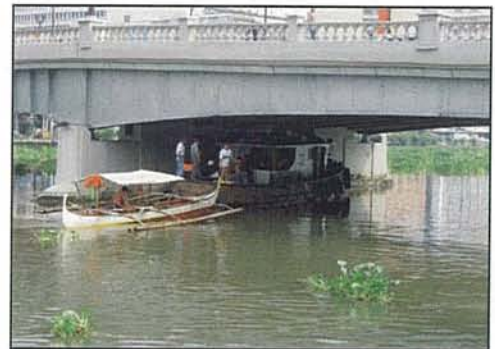
Verification of measurements below deck level required the use of tugboat with mounted scaffold (see **Photo 20.1.3-3**). Transferring of scaffolding was faster using this system. Each activity and inspected damages were supported with still photos and each dimension was recorded. Results of special test were also supplemented with photos. The bearings of piers and abutments were inspected with the aid of telescopic ladders and were measured using a caliper.

Photo 20.1.3-3 Tugboat with Scaffoldings, and Canoe - Equipment used in Below Deck Inspection

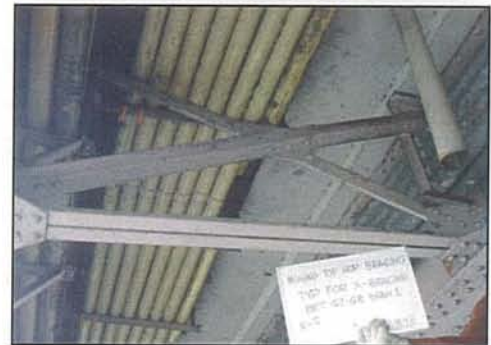
Non-structural elements such as pipes, lighting and other architectural accessories were noted and photographs were taken (see **Photo 20.1.3-4**).

Photo 20.1.3-4 Miscellaneous Utilities in Jones Bridge

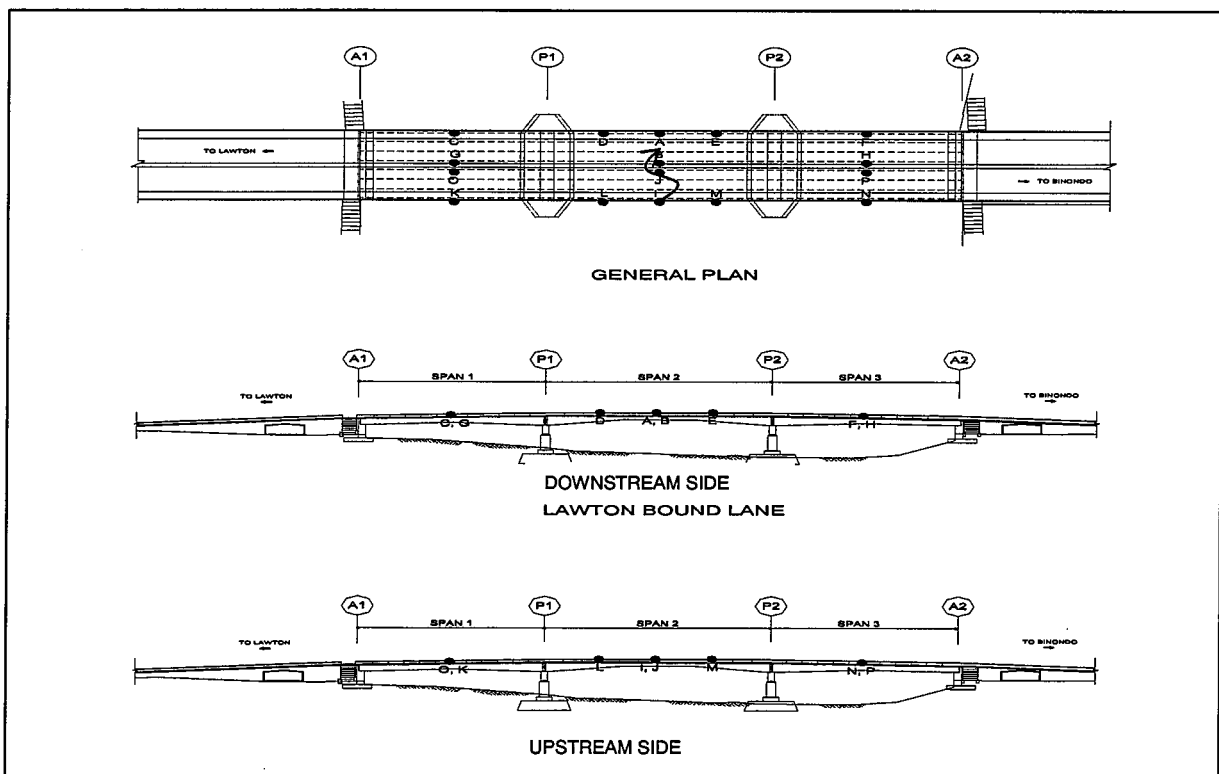
Microtremor surveys on the two (2) superstructures of Jones Bridge – the Lawton Bound lane and the Binondo Bound Lane – were conducted at sixteen (16) pre-selected locations on the bridge. The time histories and frequency spectra of the recorded events were analyzed to identify natural frequencies of each three (3) span superstructure and the corresponding mode shapes.

Figure 20.1.3-3 Location of Sensors on the Bridge during Conduction of Micro-tremor Survey

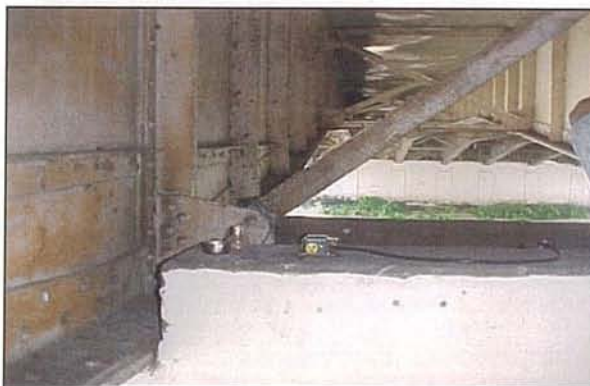
Vibration response of the pier due to each impact was recorded at two (2) pre-selected locations on top of the pier: one at the off center of the pier (see **Photo 20.1.3-4**), directly in front of the impact point, and the other, near one end of the pier. The primary mode of vibration of the pier in the longitudinal direction of the bridge was determined using the acceleration records at the center of the pier. Data from the sensors were acquired using sophisticated computer system as shown in **Photo 20.1.3-5**.

Photo 20.1.3-4 Sensor Location B, off center on top of Pier P2

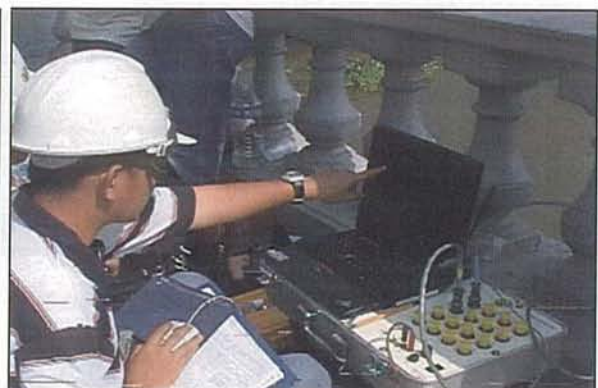
Photo 20.1.3-5 Data acquisition system

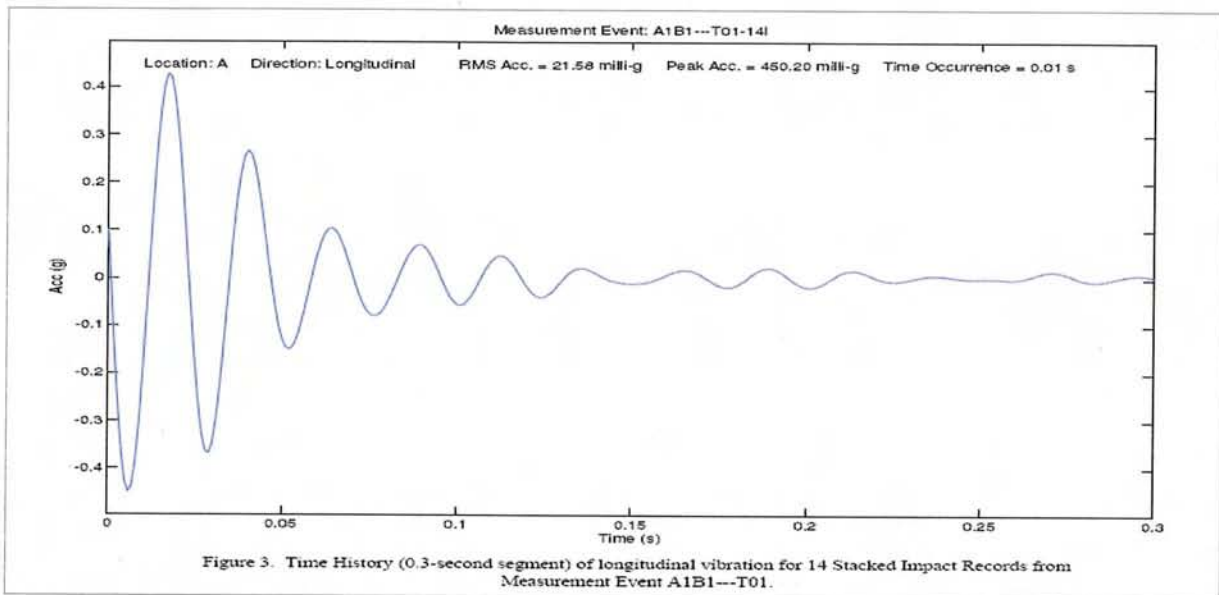
Fourteen (14) individual data impact records were superimposed to form a stacked data for Pier P2. (See Figure 20.1.3-4). The natural frequency of the pier corresponds to the location of the spectral peak in the Amplitude Spectrum. From the amplitude spectrum and phase spectrum of the stacked data, the fundamental natural frequency of Pier P2 in the longitudinal direction is about **42 Hz**.

Figure 20.1.3-4 Time History of Longitudinal Vibration from Stacked Impact Records of Pier P2

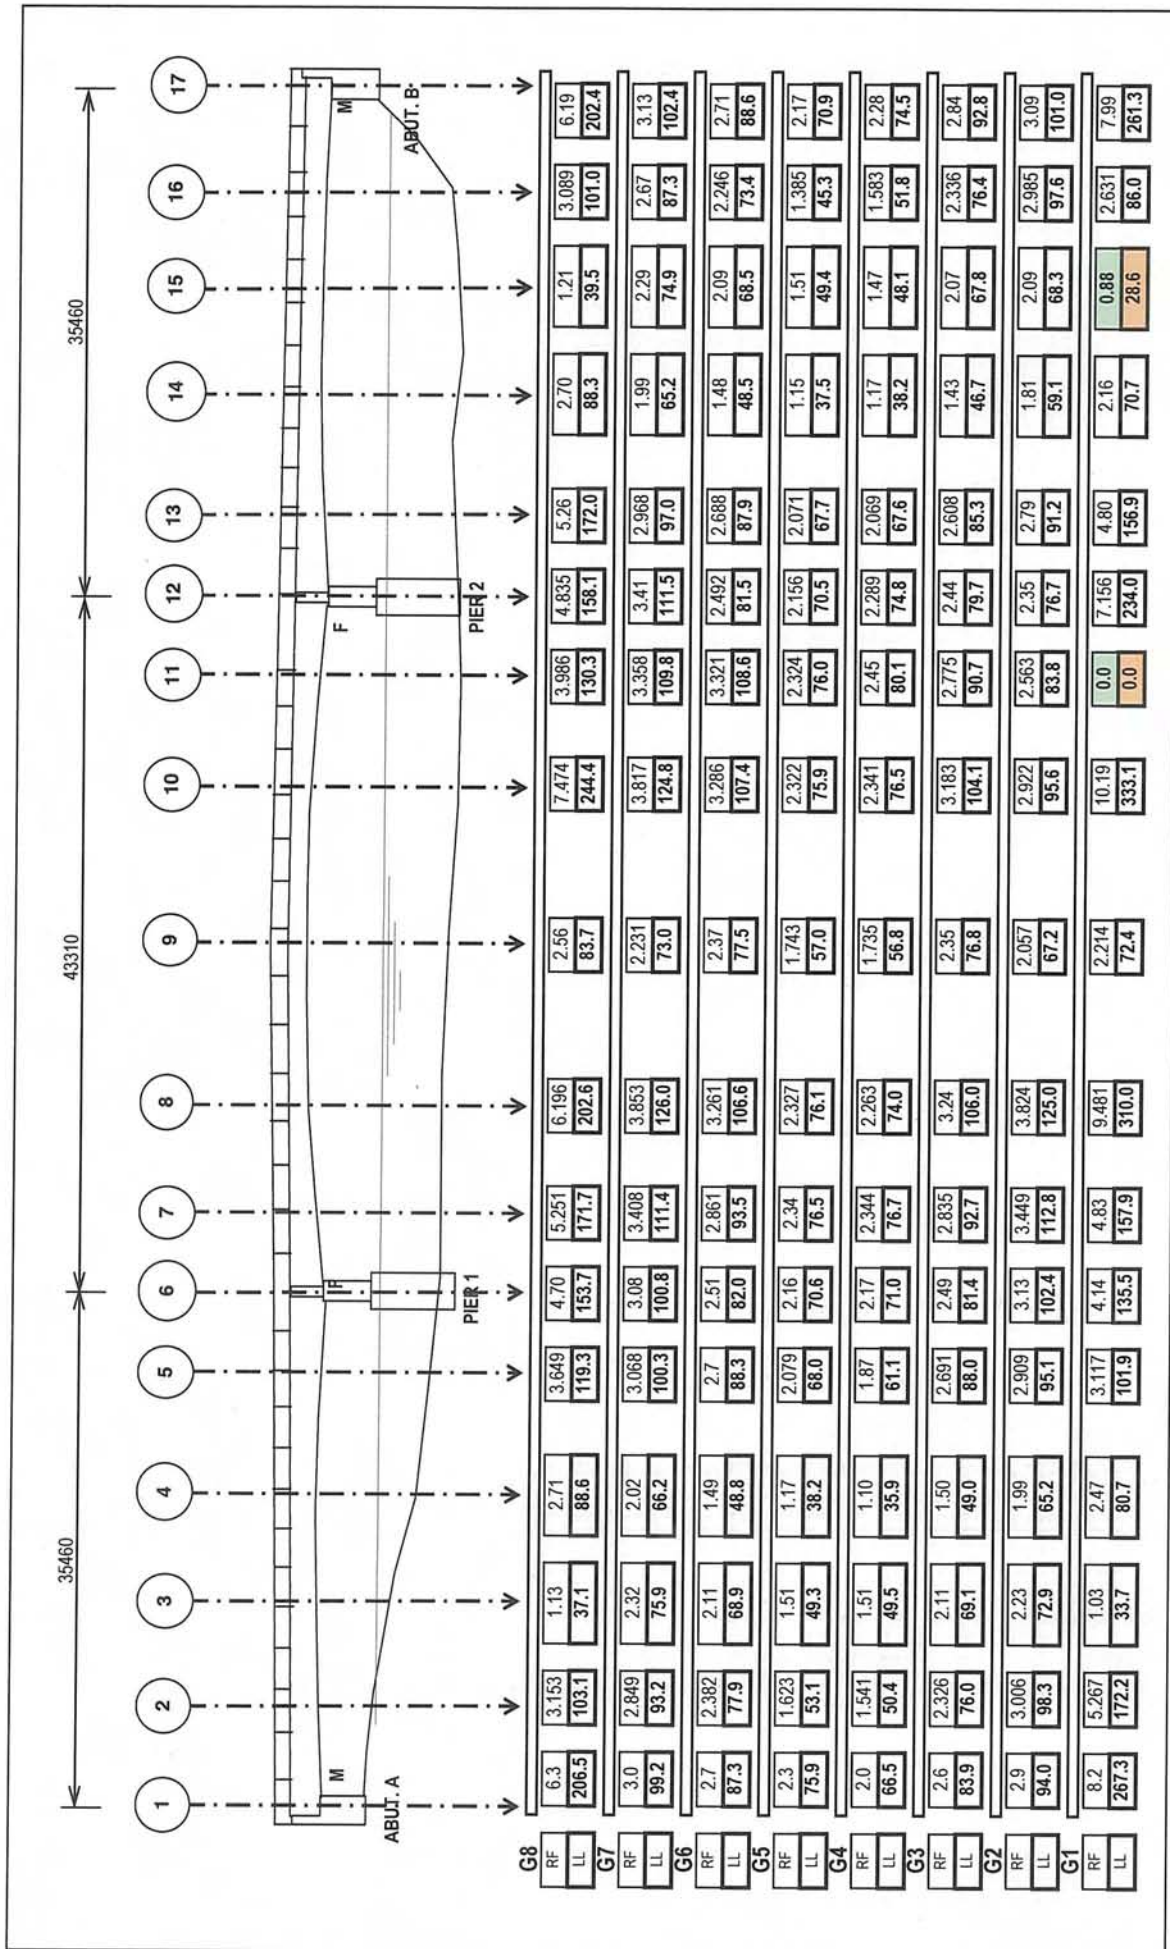
Table 20.1.4-1 Load Rating of Superstructure – Inventory Level (Allowable Stress Rating)

Note: RF – Rating Factor
 LL – Equivalent Truck Loading in tons

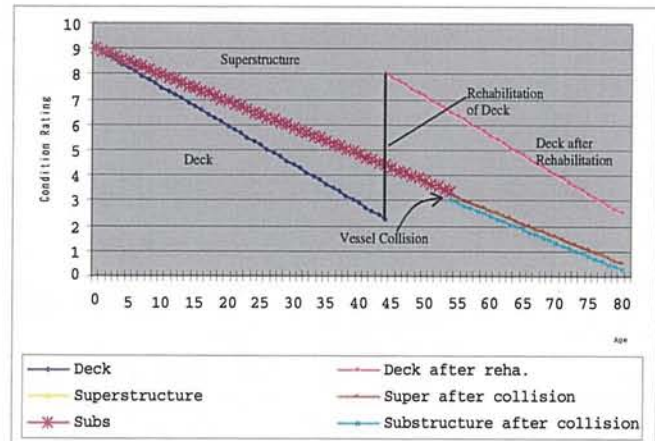
The deterioration curve of the Jones Bridge is estimated and shown in **Figure 20.2.3-1**.

Figure 20.2.3-1 Deterioration Curve of Jones Bridge

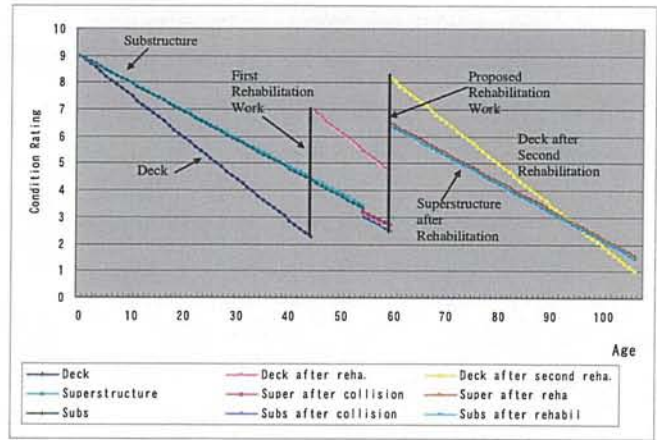
If large scale rehabilitation is implemented, the service life of the bridge is expected to extend 31 years so total service life will be 36 years from 2007.

Figure 20.2.3-2 Deterioration Curve of Jones Bridge after Rehabilitation
