FEASIBILITY STUDY OF QUEZON BRIDGE REHABILITATION PLAN

21.1 DETAILED BRIDGE SURVEY AND ASSESSMENT

21.1.1 Review of Design and Repair Works

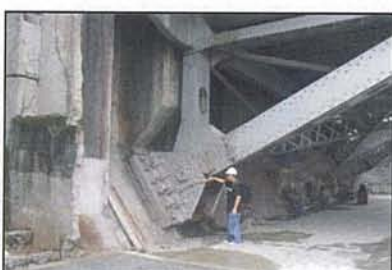
Photo 21.1.3-2 Abutment

- Concrete cracks on abutments are sealed and repaired.
- Cracks on the South side abutment extend to almost the entire width while cracks on the North side abutment are observed to be minimal.

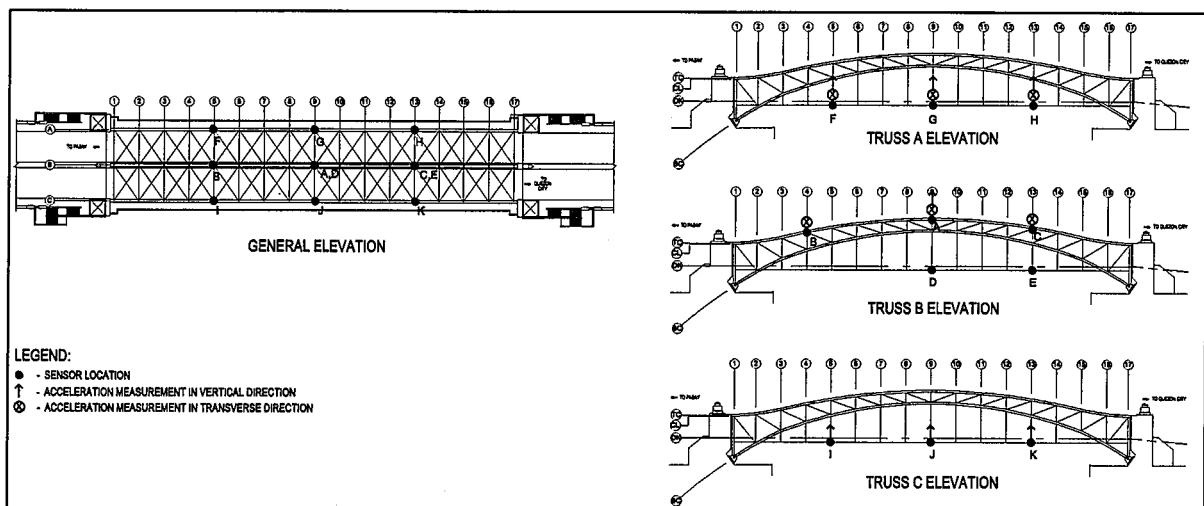
Figure 21.1.3-1 Location of Acceleration Sensors

Figure 21.1.3-1 shows the locations and orientations of the reference and roving sensors for each set up.

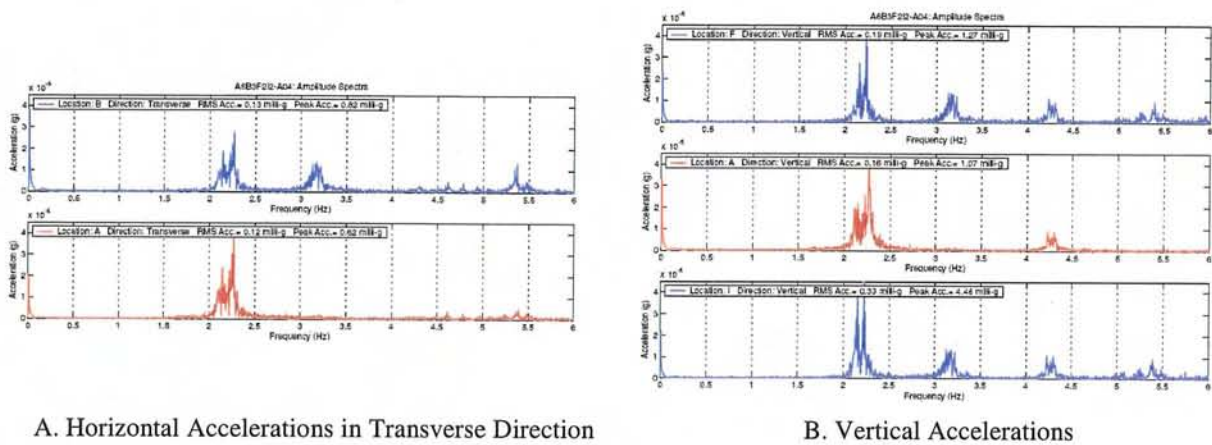
From the spectra of each measurement event, the resonant peaks (at least 5 micro-g of the spectral amplitude) were identified and their associated frequencies were noted. Where such peaks occurred clearly and consistently from one set-up, which consists of two measurement events, to the other set-up, a natural frequency was deemed indicated. Following this procedure, it was inferred that among the most probable natural frequencies of the bridge were 2.2 Hz, 2.3 Hz, 3.1 Hz, 4.3 Hz, and 5.4 Hz.

From the plots of amplitude spectra, natural frequencies around 2.2 Hz and 2.3 Hz can be associated with vertical modes (see **Figure 12.1.3-4**) with side sway of the trusses. The amplitudes of vertical vibration around these frequencies were slightly different in the three (3) trusses. Correspondingly, the transverse acceleration records on locations A, B, and C on top chord of Truss B at these frequencies have significant spectral amplitudes.

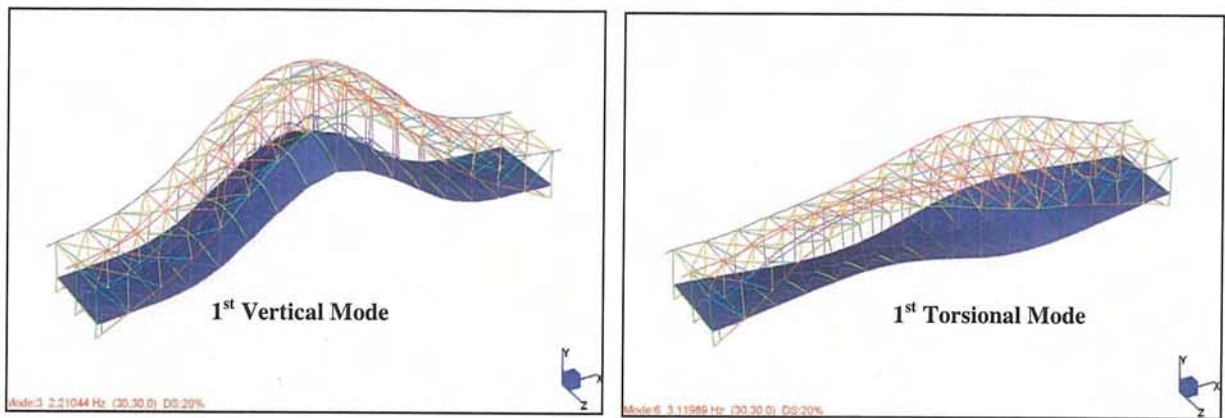
Figure 21.1.3-4 First Vertical and Torsional Modes

The peaks at around 3.1 Hz and 5.4 Hz, on the other hand, can be associated with torsional modes (see **Figure 12.1.3-4**), taking into account that the amplitudes of vertical vibration are significant and almost the same at quarter-span locations on the outer trusses (F and H on Truss A, and I on Truss C), while the amplitude at locations in Truss B (D and E) is considerably less. At midspan locations on the outer trusses (G and J), spectral amplitudes were considerably less.

The transverse acceleration records on locations B and C (quarter-span locations on top chord of Truss B), which give significant spectral amplitudes as compared to location A (midspan), confirm that the modes associated around 3.1 Hz and 5.4 Hz are torsional.

Transverse acceleration records at road deck level (locations F and H), which gave considerably less spectral amplitudes, provided adequate confirmation that the estimated mode shapes for these frequencies were torsional and not to be associated with lateral mode of the bridge.

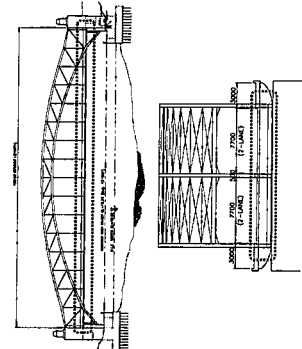
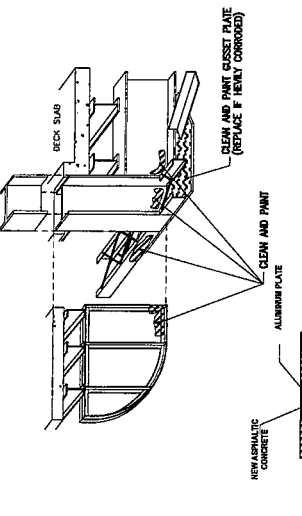
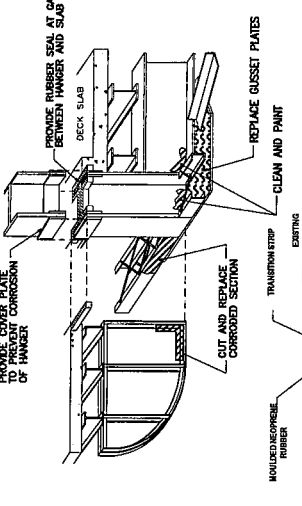
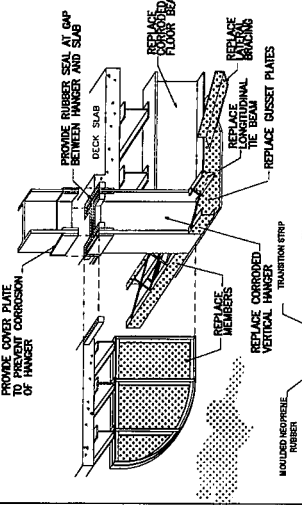
Table 21.2.2-1 Comparative Study of Possible Scheme for Quezon Bridge

(1) STRUCTURAL ASPECT (30%)	CAPACITY / STABILITY	<ul style="list-style-type: none"> Basic structural repair and maintenance to restore intended function No capacity strengthening of reduced sections due to corrosion 	<ul style="list-style-type: none"> Present capacity condition is improved considerably by replacing gusset plates and corroded sections New sections will have more capacity than corroded sections 	<ul style="list-style-type: none"> Present capacity is increased to a greater degree by replacement of gusset plates, bracing, tie beams and other corroded sections Capacity higher than Schemes 1 & 2 	A

<ul style="list-style-type: none"> Cleaning and Painting Corroded Sections of Floor System Only Repair of Expansion Joint to Seal Water Leakage Cleaning and Painting of Corroded Gusset Plates and Replacement of Heavily Corroded Gusset Plates 	<ul style="list-style-type: none"> Cleaning and Painting Floor System for the Whole Bridge Replacement of Expansion Joint to Seal Water Leakage Replacement of Gusset Plates, Lateral Bracing and Longitudinal Tie Beam Replacement of Corroded Section of Floor Beam and Vertical Member by Cutting Affected Areas and Placing New Sections Sealing Gap Between Vertical Hanger and Sidewalk Concrete and Provide Plates to Prevent Further Corrosion of Vertical Hanger Removal and reconstruction of deck slab near abutment Replacement of corroded stringers

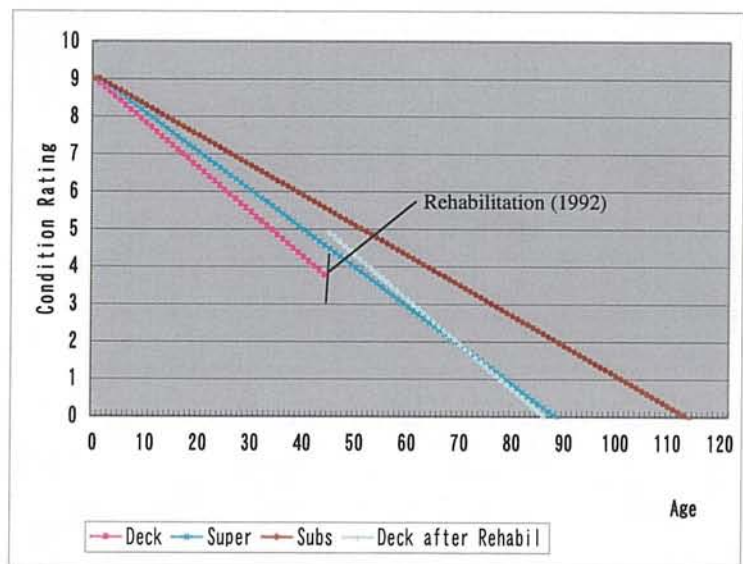
Figure 21.2.3-1 Deterioration Curve of Quezon Bridge

In 1992, rehabilitation of deck was made

The deterioration curve of the Quezon Bridge is estimated and shown in **Figure 21.2.3-1**.

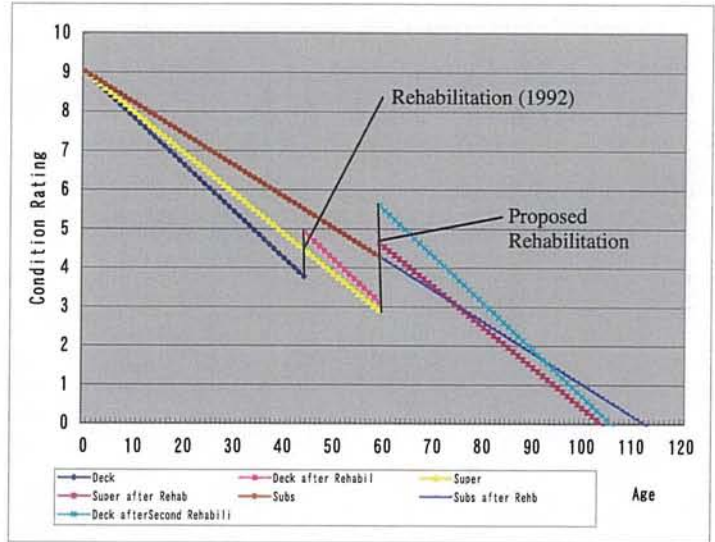
Figure 21.2.3-2 Estimated Deterioration Curve of Quezon Bridge in Case of Medium-Scale Rehabilitation Case

Using the deterioration curve in Figure 21.2.3-2, the relationship between investment cost and improvement condition rating shown in Figure 14.3.5-1 of Section 14.3.5, the expected extended service life of Quezon Bridge is calculated and shown in Figure 21.2.3-3. The service life of the Bridge is varied to extend by type of rehabilitation. If medium scale rehabilitation is implemented, the service life of the bridge is expected to extend 22 years so total service life will be 27 years from 2007.

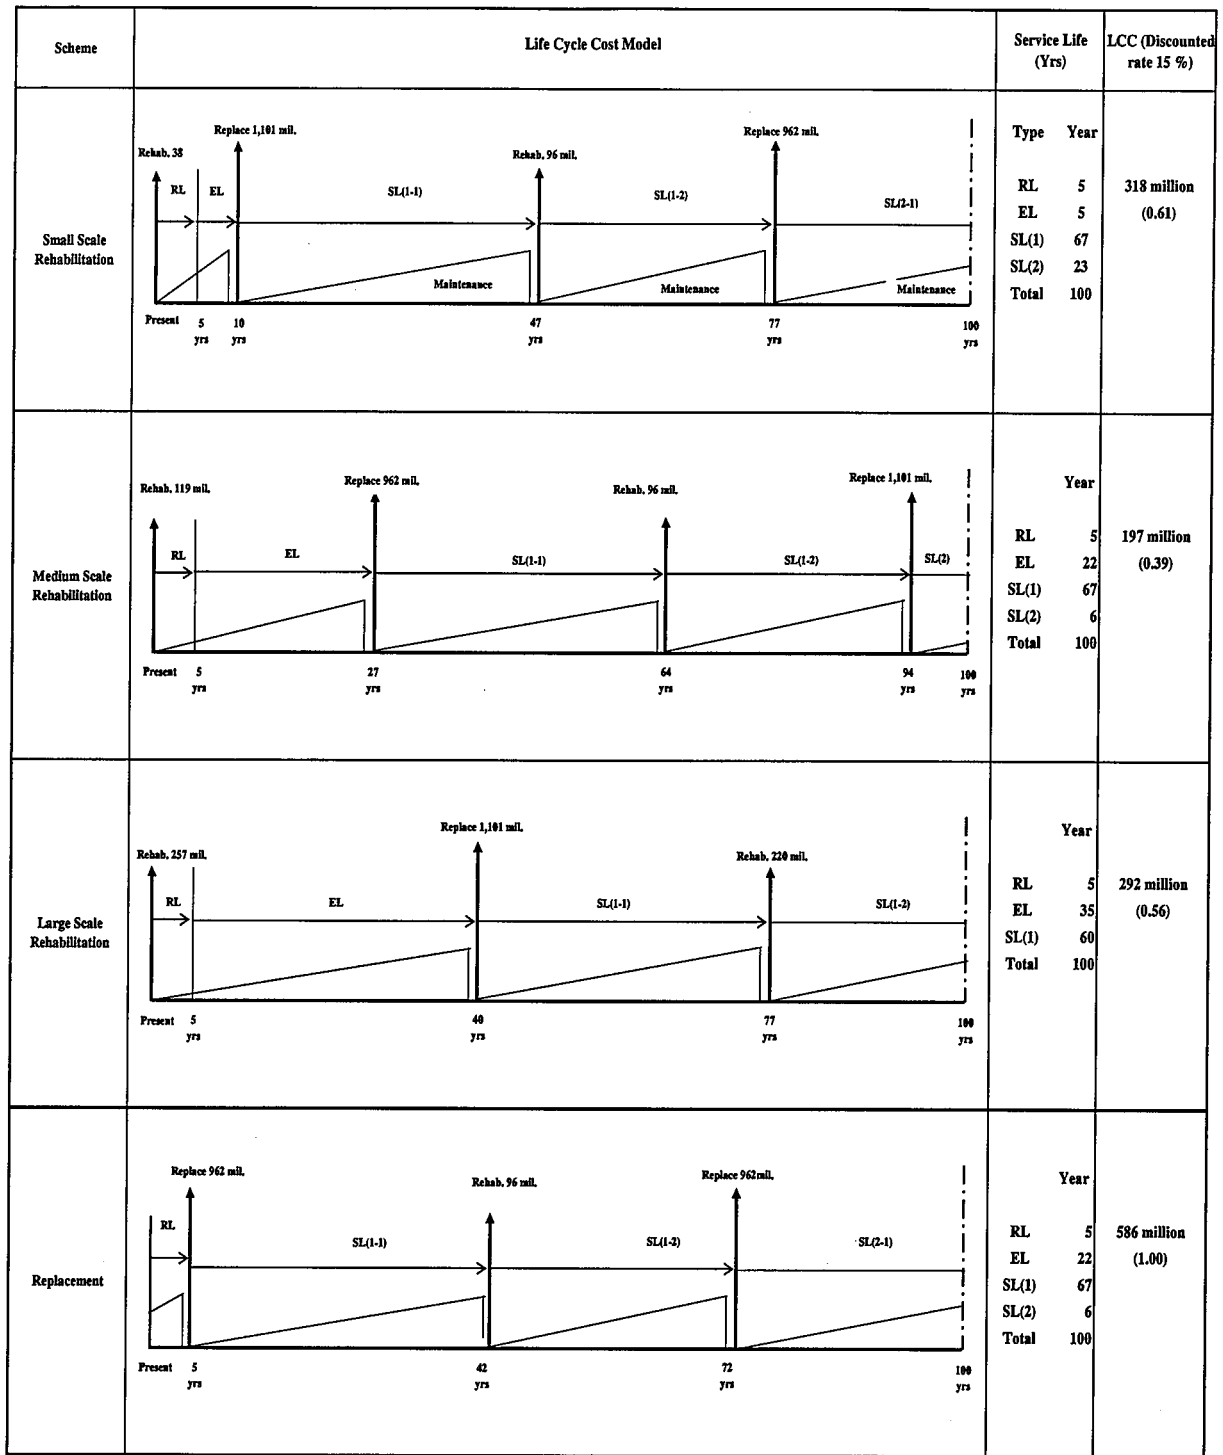
Figure 21.2.3-3 Life Cycle Analysis of Quezon Bridge

The result of the life cycle cost (LCC) analysis shows that the medium scale rehabilitation scheme has the least cost among the alternatives.

Judging from LCC view point of Quezon Bridge, the medium scale rehabilitation scheme is recommended.

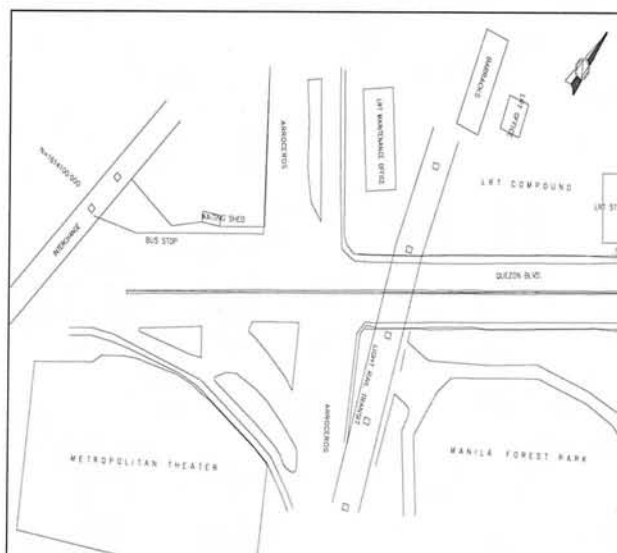
Figure 21.3.1-6 Existing Approach 1 Intersection before Improvement

The existing intersection is permanently provided with raised median barrier. Bus stop is also provided at one side of the road coming from the Quiapo area. Traffic congestion is observed during peak periods approaching the bridge towards Quiapo area. Uncontrolled loading and unloading is observed near the bridge approaches.
