FEASIBILITY STUDY OF GUADALUPE BRIDGE REHABILITATION PLAN

FEASIBILITY STUDY OF GUADALUPE BRIDGE (BOTH SIDES) REHABILITATION PLAN

23.1 DETAILED BRIDGE SURVEY AND ASSESSMENT

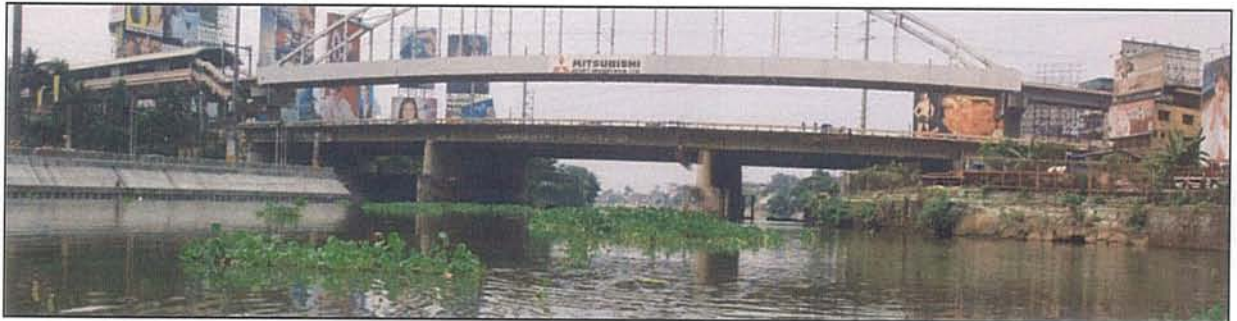
Photo 23.1.3-1 Panoramic View of Guadalupe Bridge

- Structural Type : Three (3) Span PC Gerber Bridge
Foundation Type for Pier and Abutment are PSC Piles.
- Bridge Length : 114.44m (abutment to abutment)
- Date of Construction : 1979

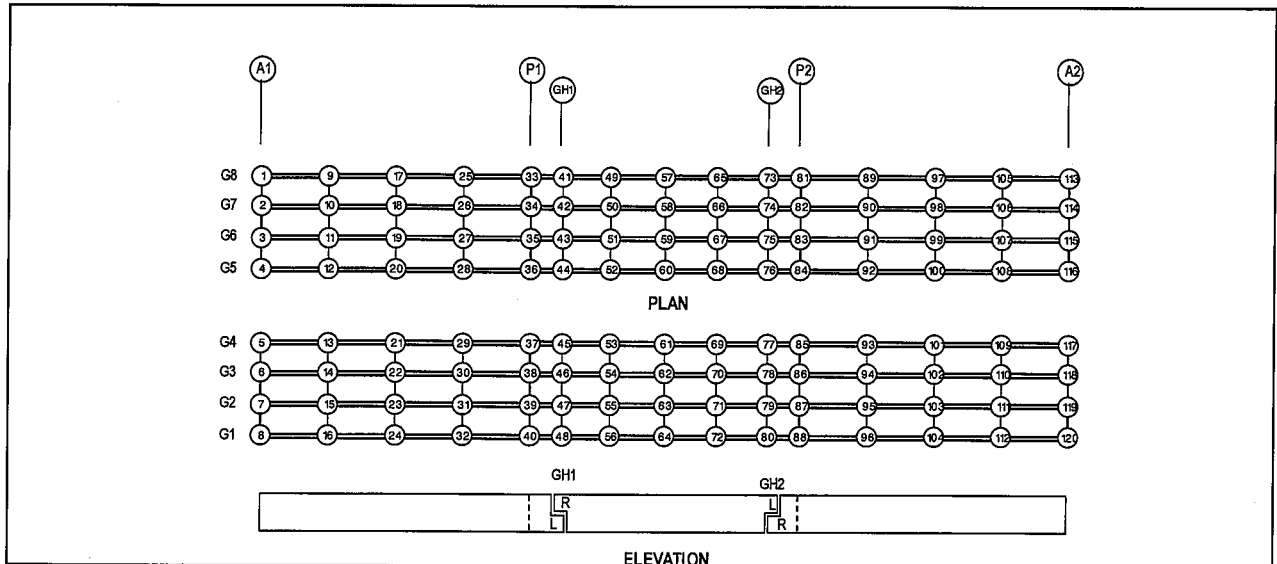
Table 23.1.3-4 Evaluation of Major Damages on Guadalupe Bridge

Location		Evaluation Based on Field Survey				Evaluation Based on Non-Destructive Test	Evaluation based on Special Test
	Member	Node	Damage Type	Damage Rating	Diagnostic	Estimated Section Loss		
SUPERSTRUCTURE	Sidewalk Slab	33	SER	II	B	5%	• Ultrasonic Pulse Velocity Test – Varies from no evidence to full depth cracks OK	
	Gerber GH1, L	44	SER	II	B	3%		
	Gerber GH1, L-R	43	SER	II	B	3%		
	Gerber GH 1, L-R	42	SER	II	B	3%		
	Gerber GH 1, R	41	SER	II	B	3%		
	Girder	60	SER	II	B	3%		
	Gerber GH2, L	80	SER	II	B	3%		
	Girder	17-21, 23, 24	CR	III	B	-		
	Gerber GH1, L	48	CR	I	A	10%		
	Gerber GH1, R	48	CR	I	A	10%		
	Gerber GH1, L	44	CR	I	A	10%		
	Gerber GH1, R	44	CR	I	A	10%		
	Gerber GH1, R	43	CR	I	A	10%		
	Gerber GH1, L	42	CR	I	A	10%		
	Gerber GH1, R	41	CR	I	A	10%		
	Girder	57	CR	III	B	-		
	Gerber GH2, R	80	CR	I	A	10%		
	Gerber GH2, L	76	CR	I	A	10%		
	Gerber GH2, R	76	CR	I	A	10%		
	Gerber GH2, L	75	CR	I	A	10%		
Gerber GH2, L	73	CR	I	A	10%

Gerber GH2, R	73	CR	I	A	10%			
SUB-STRUCTURE	Bearing	33	CO	III	B	4%	• Schmidt Rebound Hammer Test – OK • Compression Test – OK, fc' Range 21.1 – 30.7 MPa	
	Bearing	84	CO	III	B	4%		
	Pier 2 Wall, D/S	81-84	SER	III	B	3%		
	Pier 2 Wall, U/S	81-84	SER	III	B	3%		
	Abutment A2	113-116	CR	II	B	3%

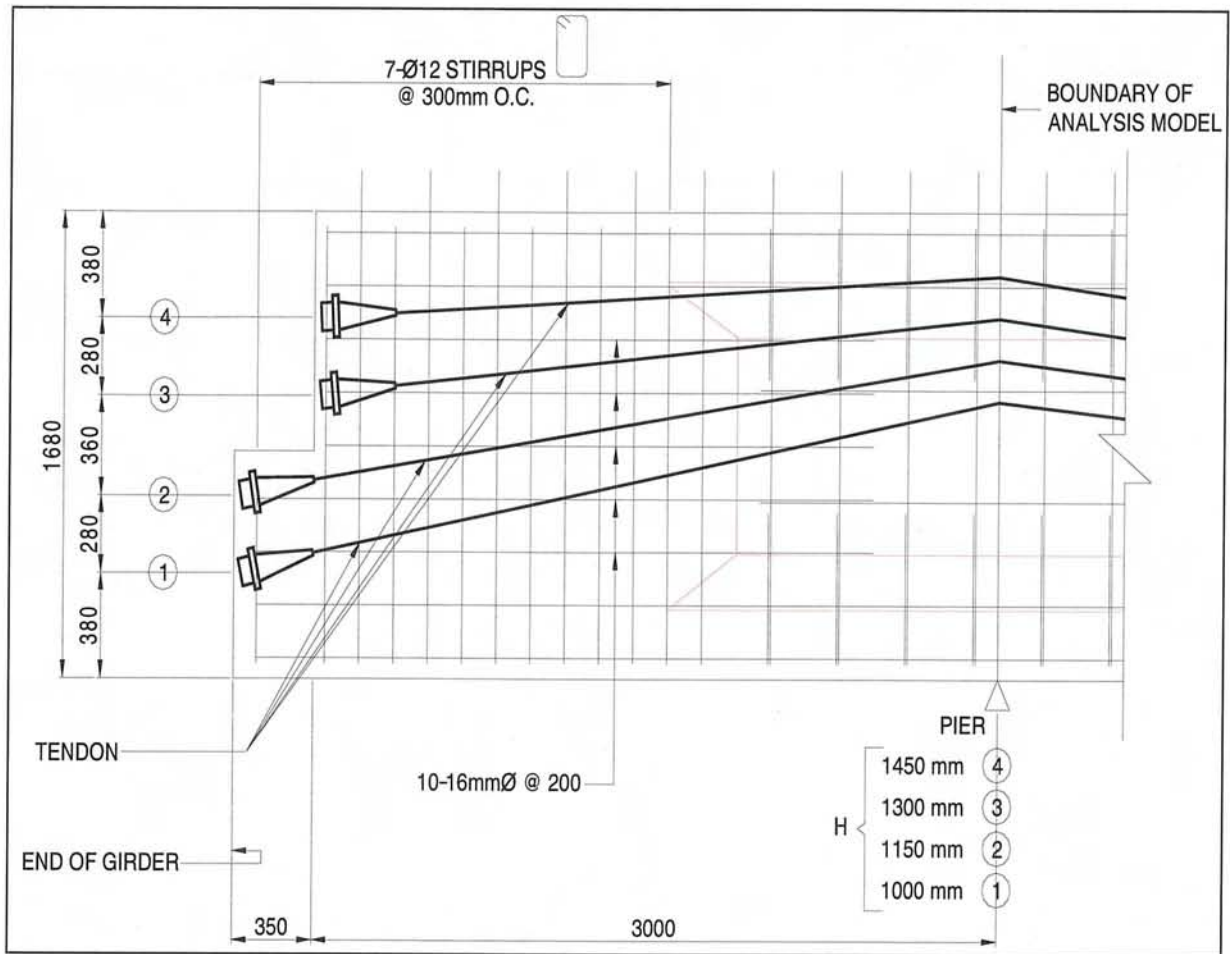
Figure 23.1.5-1 FEM Model and Construction Drawing of Gerber Hinge Part

Model	Description	Remarks	
1	E	<ul style="list-style-type: none"> • To simulate existing condition <ul style="list-style-type: none"> : Effective post-tensioning forces are 0.50fsu for all tendons specified in the design code. : The amount of reinforcements shown in the construction drawings is used (See Figure 23.1.5-1). 	<ul style="list-style-type: none"> • For checking the design, $f_{pu} = 1860$ Mpa
2	E_t	<ul style="list-style-type: none"> • To simulate existing condition <ul style="list-style-type: none"> : Effective post-tensioning forces are 0.35fsu for Tendon 3, 0.20fsu for Tendon 2 and 0.50fsu for Tendons 1 and 4. : The amount of reinforcements shown in the construction drawings is used (See Figure 23.1.5-1). 	<ul style="list-style-type: none"> • For checking the construction quality • Reduced values of effective post-tensioning forces are the results which would explain the occurrence of cracks observed.

3	E_s	<ul style="list-style-type: none"> • To simulate existing condition <ul style="list-style-type: none"> : Effective post-tensioning forces are the same as Model E : The amount of vertical reinforcements is reduced from 75mm spacing to 150mm. 	<ul style="list-style-type: none"> • For checking the difference in the scale of influence on the crack occurrence between Models E_t and E_s
4	R_t	<ul style="list-style-type: none"> • To simulate rehabilitated condition <ul style="list-style-type: none"> : Assumptions of existing post-tensioning forces and/or the amount of reinforcements are the same as Model E_t. 	<ul style="list-style-type: none"> • For checking the effectiveness of rehabilitation measure recommended in Section 23.2.4.

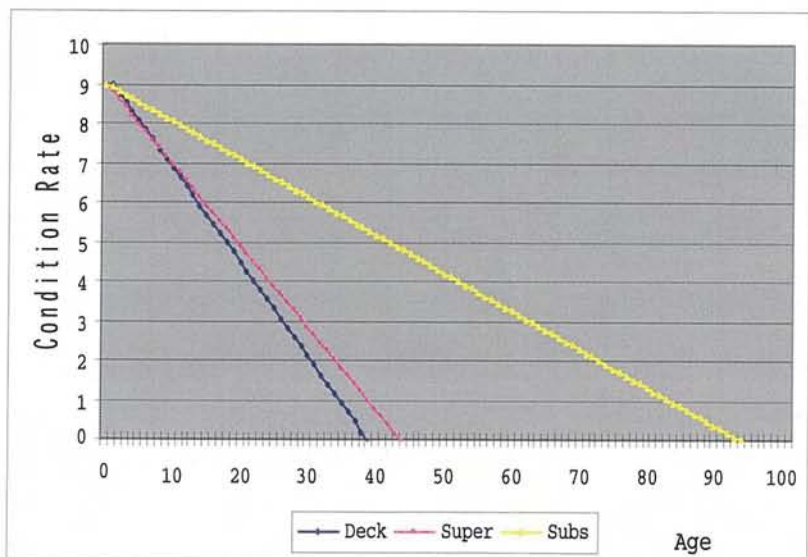
Figure 23.2.3-1 Deterioration Curve of Guadalupe Bridge

The standard deterioration curve of deck, superstructure and substructure between condition rating and age using the same equation mentioned in **Section 14.3**. According to the bridge condition survey, however, the deck and superstructure of Guadalupe Bridge have deteriorated more than two (2) times that of the standard deterioration due to the construction of superstructure being not appropriate.

The deterioration curve of the Guadalupe Bridge is estimated and shown in **Figure 23.2.3-1**.

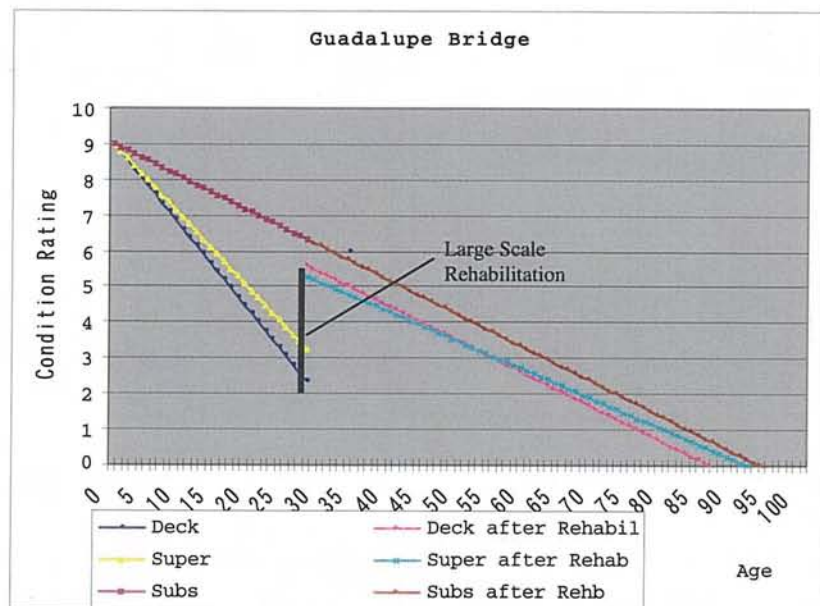
Figure 23.2.3-2 Estimated Service Life by Rehabilitation Types of Guadalupe Bridge under Large Scale Rehabilitation

From the deterioration curve in **Figure 23.2.3-2**, and using the relationship between investment cost and improvement condition rating shown in **Figure 14.3.5-1** in **Section 14.3.5**, the expected extended service life of Guadalupe Bridge is calculated and shown in **Figures 23.2.3-2**
