FEASIBILITY STUDY OF VARGAS BRIDGE REHABILITATION PLAN

24.1 DETAILED BRIDGE SURVEY AND ASSESSMENT

Photo 24.1.1-1 Panoramic View of Vargas Bridge (Upstream)

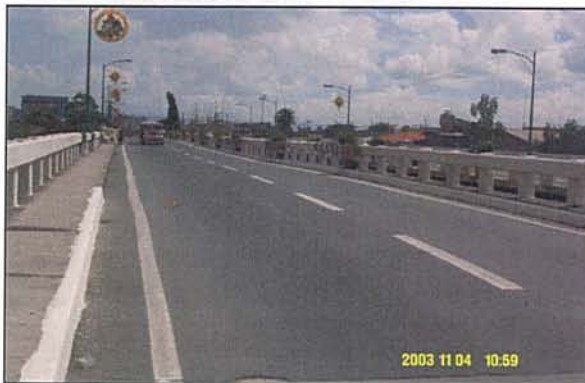
Photo 24.1.3-1 Road / Deck Level Inspection

Verification on road deck measurements includes deck slab, length of bridge, sidewalk, post, railings and expansion joint gap (see **Photo 24.1.3-1**).

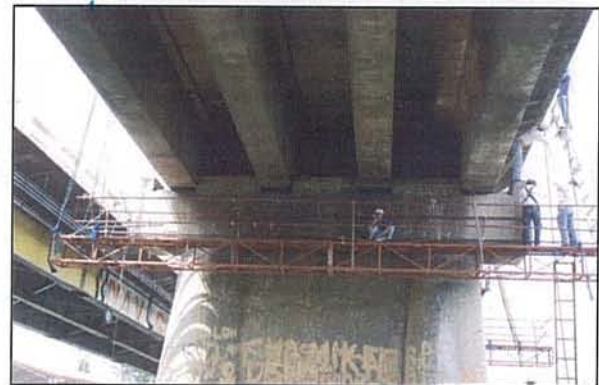
Photo 24.1.3-2 Below Deck Level Inspection

Verification of measurements below deck level were taken on all 4 girders in every span (see **Photo 24.1.3-2**). The spacing of girders was also measured as well as intermediate and end diaphragm. Gerber hinges were also measured. Substructures were also measured including the exposed areas of pile cap.

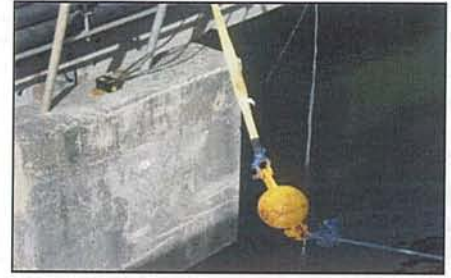
Photo 24.1.3-6 Impact Pendulum Setup

An impact pendulum was specially fabricated for this activity. The pendulum was positioned to impact the centerline of the coping beam at Pier 2 (Transverse Direction). (See **Photo 24.1.3-6**). The impacting head is 300 mm diameter steel ball with a mass of about 60 kg.

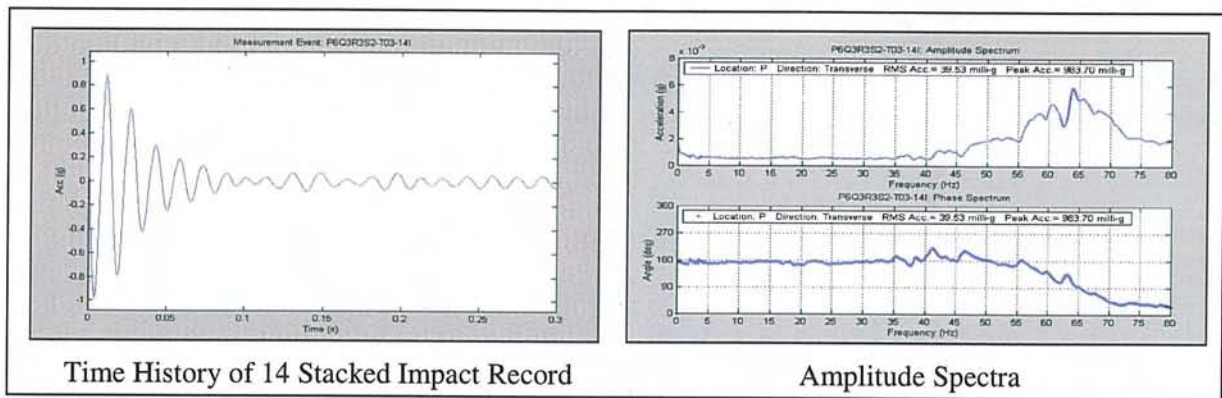
Figure 24.1.3-5 Time History and Amplitude Spectra from Impact Vibration Test Results

Mode Shape	Natural Frequency		Rating Index*	Remarks
	From Impact Test (Hz)	From STRAND7 Analysis (Hz)		
Transverse	66.00	65.70	1.005	(>0.85) ok!

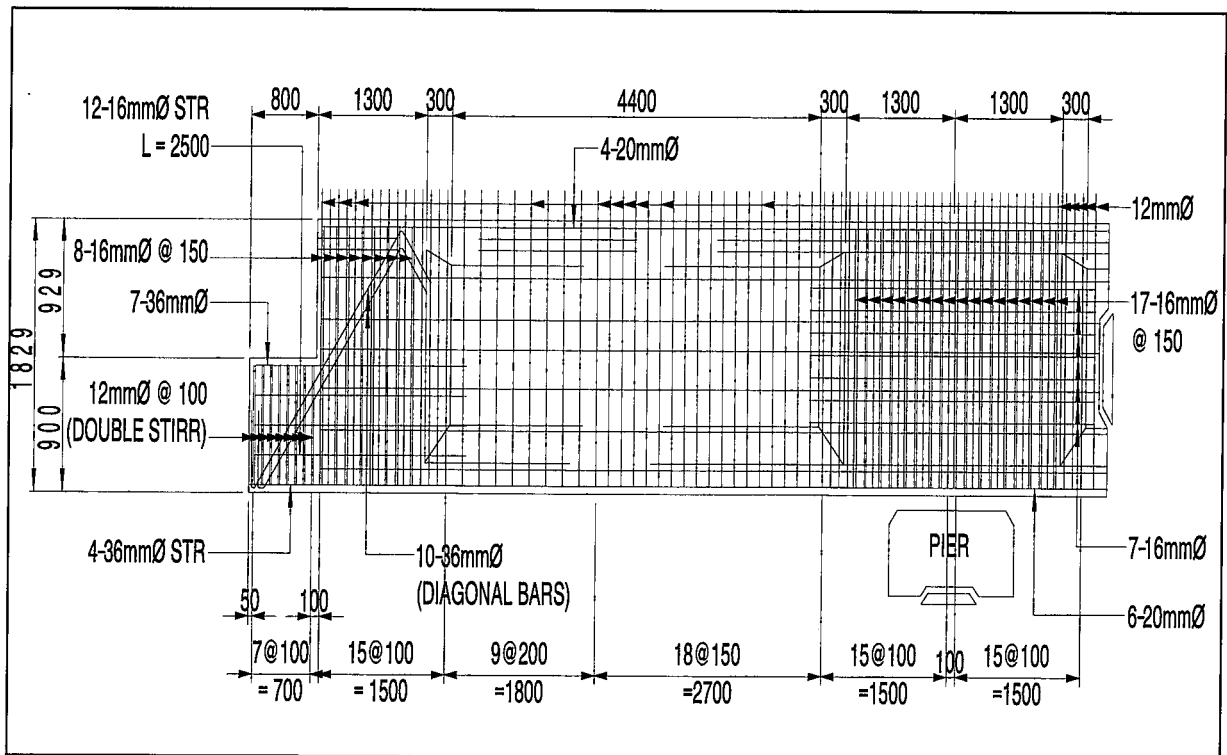
Figure 24.1.5-1 FEM Model and Construction Drawing of Gerber Hinge Part (Cantilever Portion)

The Finite Element Method (FEM) analysis was employed to estimate mathematically the causes of cracks on gerber hinge support parts and to verify the effectiveness of the rehabilitation measure which was recommended in **Section 24.2.4**.

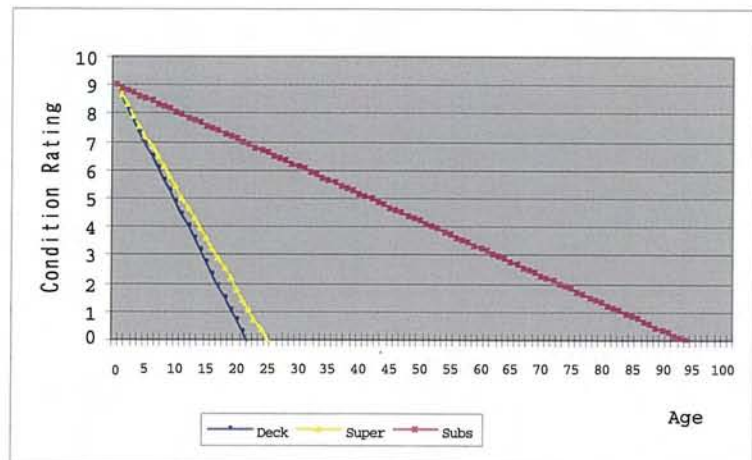
Figure 24.2.3-1 Deterioration Curve of Vargas Bridge

The standard deterioration curve of deck, superstructure and substructure between condition rating and age can be considered the same equation mentioned in **Section 14.3**. According to the bridge condition survey, however, deck and superstructure of Vargas Bridge have been deteriorated more than three (3) times than the standard deterioration due to construction of superstructure being not appropriate.

The deterioration curve of the Vargas Bridge is estimated and shown in **Figure 24.2.3-1**.

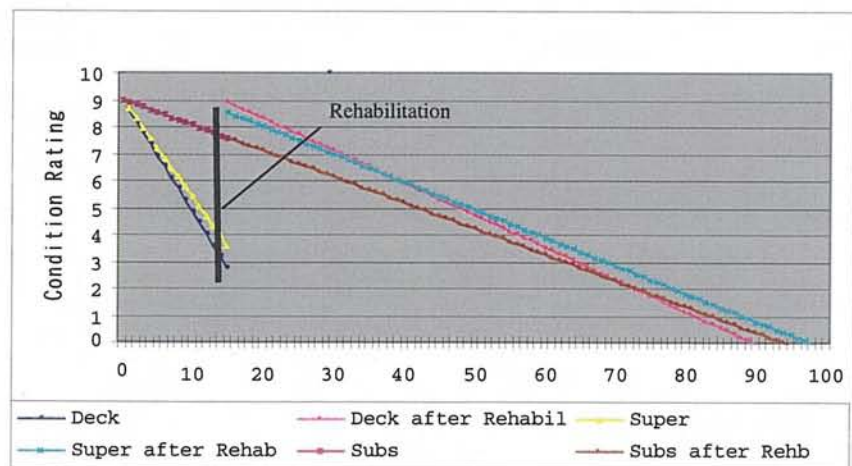
Figure 24.2.3-2 Estimated Service Life by Rehabilitation Types of Vargas Bridge under Large Scale Rehabilitation

Figure 24.2.3-2 and **Figure 24.2.3-3**. The service life of the bridge is varied to extend by type of rehabilitation. If large scale rehabilitation is implemented, the service life of the bridge is expected to extend 46 years so total service life will be 50 years from 2007.
