CHAPTER 21

FEASIBILITY STUDY OF QUEZON BRIDGE REHABILITATION PLAN

Appendix 21.1.2-1

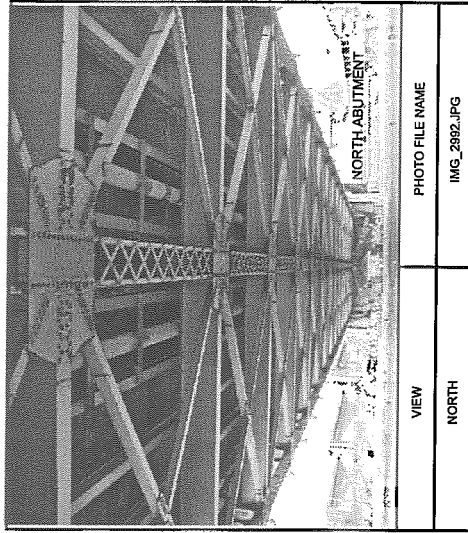
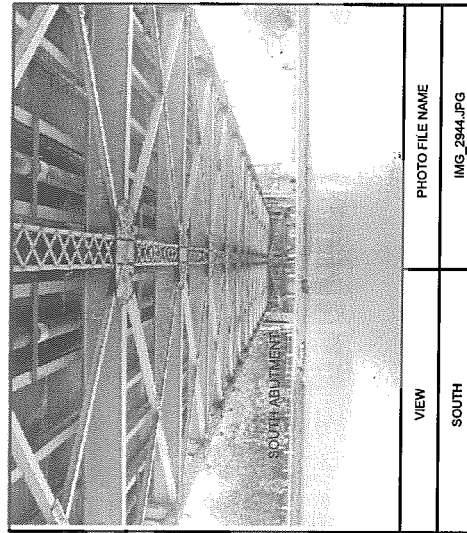
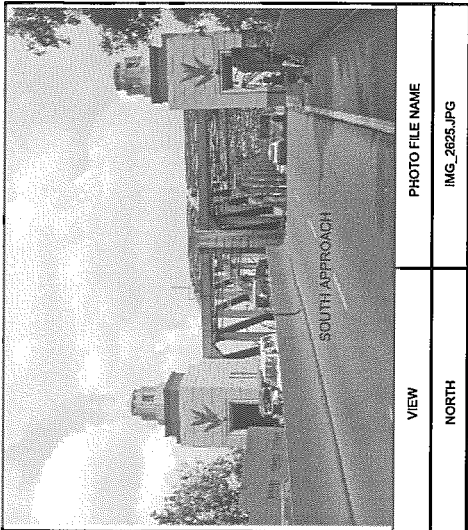
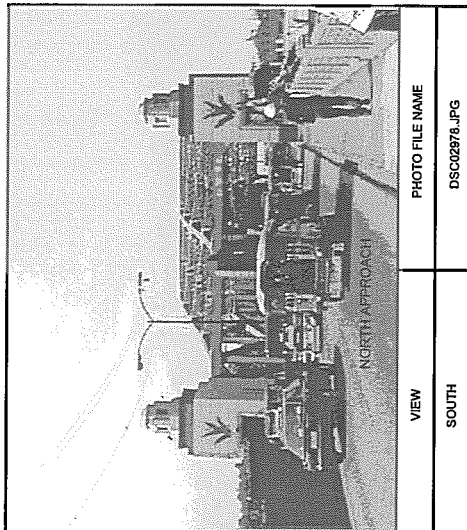
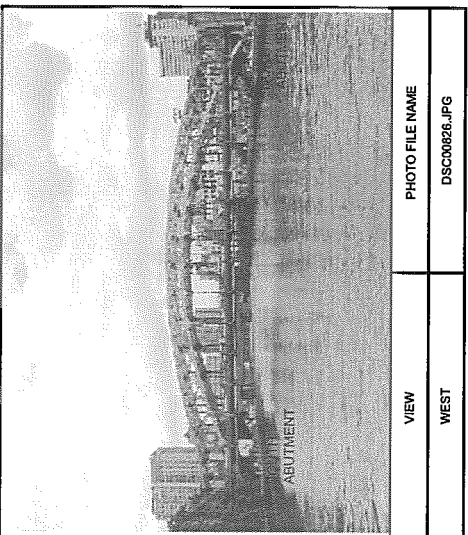
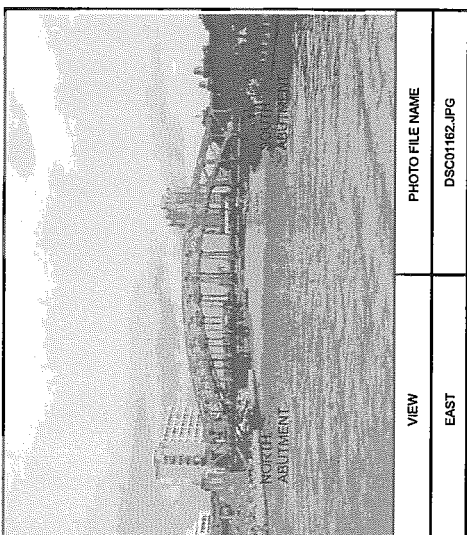
PHOTOS OF SPAN, APPROACHES AND DECK FRAME

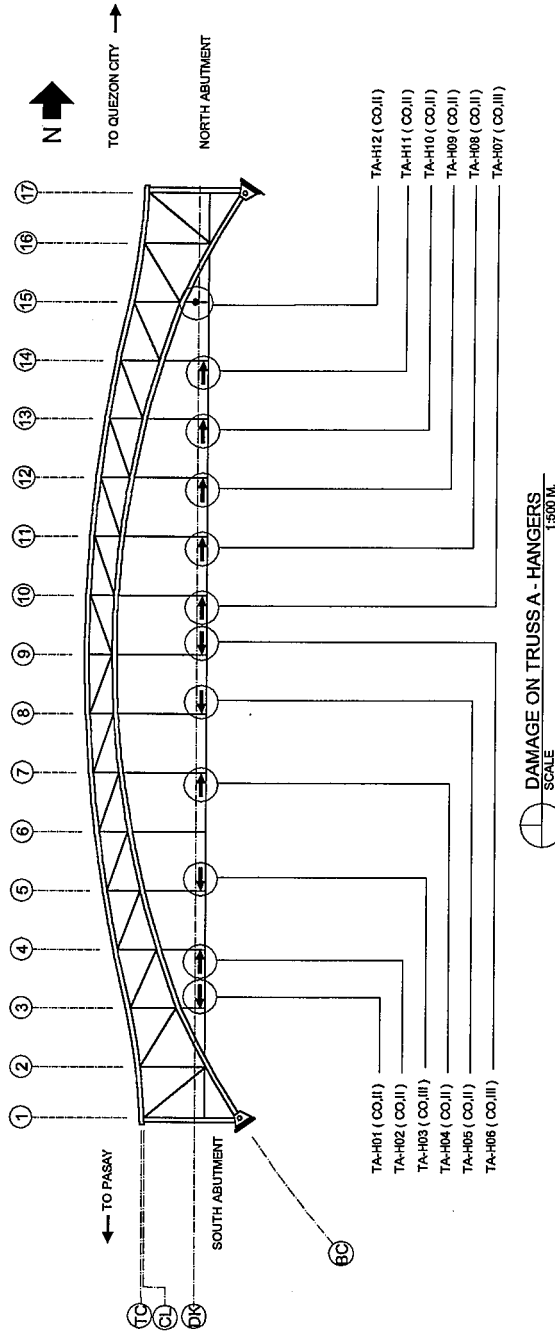
DAMAGE ON TRUSS A - HANGERS

- LEGEND:
- TA-H01 (CO.III) - DAMAGE SHEET WHERE PHOTOS OF DAMAGE CAN BE FOUND.
 - CO - CORROSION
 - III - DAMAGE RATING
 - ↑ - VIEW WHEN PHOTO WAS TAKEN.

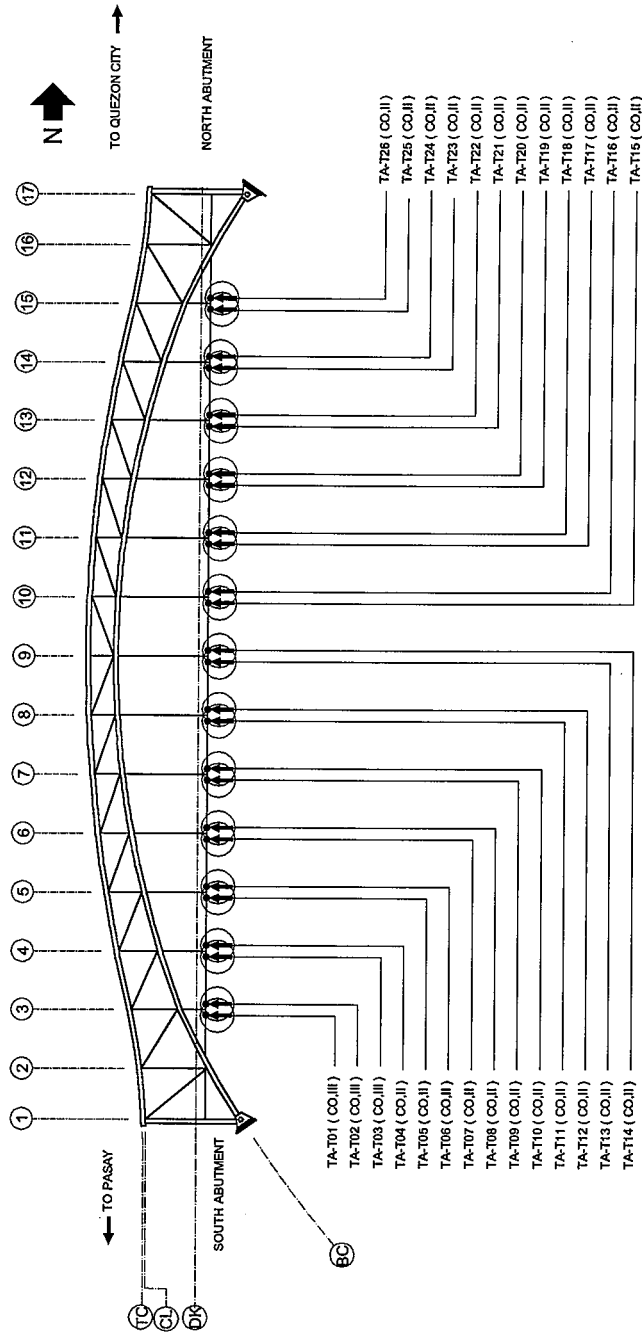
DAMAGE ON TRUSS A -TIES

LEGEND:
 TA-T01 (CO,II) - DAMAGE SHEET WHERE PHOTOS OF DAMAGE CAN BE FOUND.
 CO - CORROSION
 II - DAMAGE RATING
 ↑ - VIEW WHEN PHOTO WAS TAKEN.

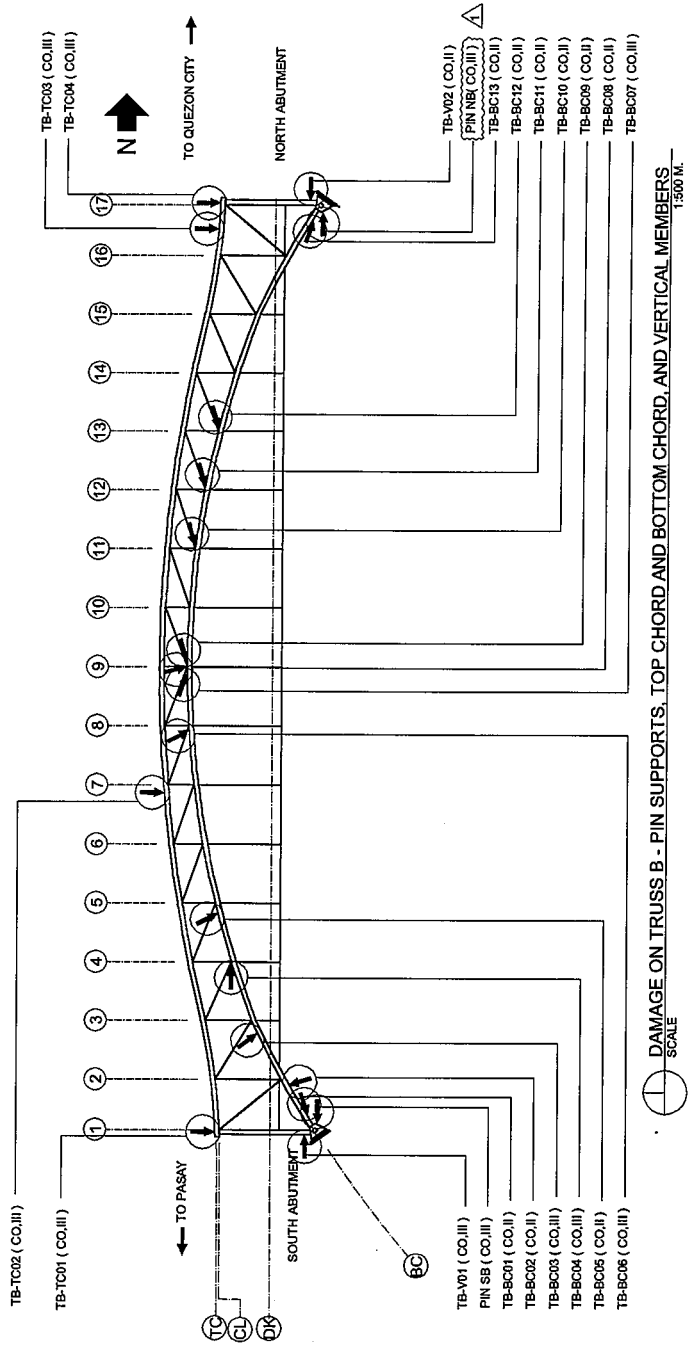
DAMAGE ON TRUSS B - PIN SUPPORTS, TOP & BOTTOM CHORDS AND VERTICAL MEMBERS

TB-BC01 (CO.II)

II - DAMAGE RATING

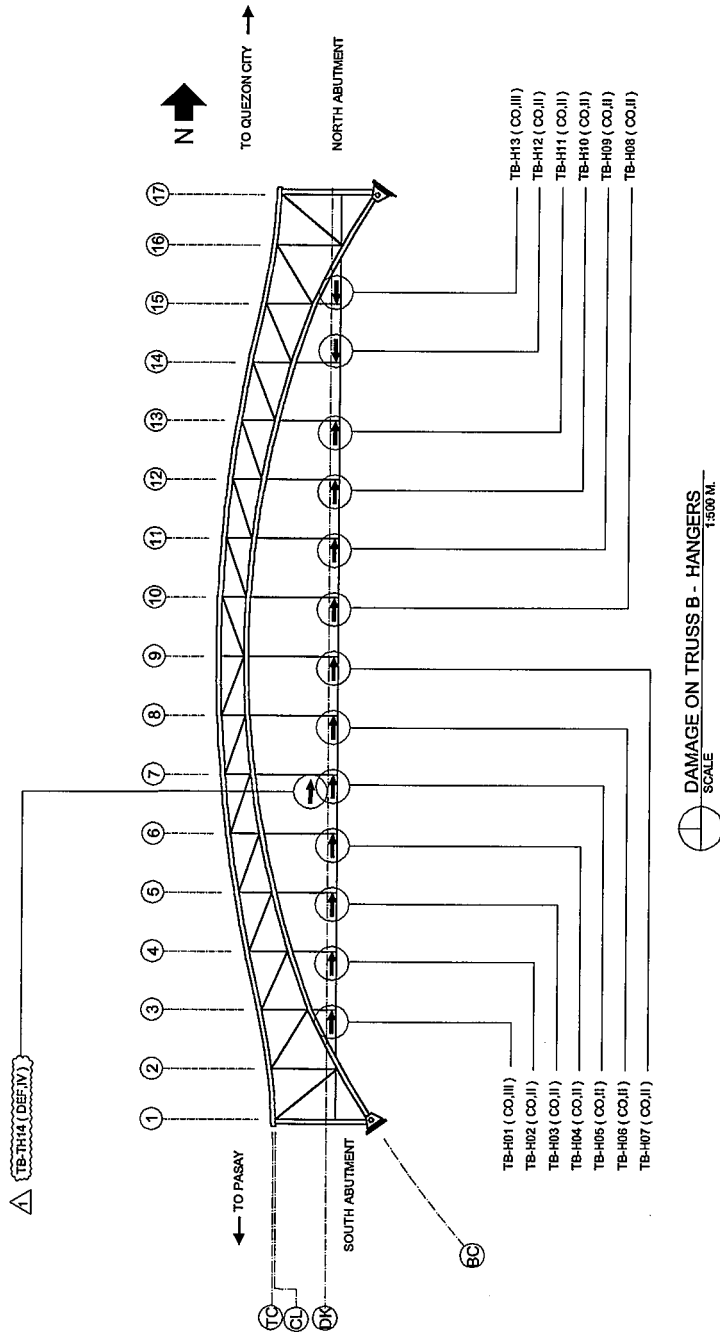
DAMAGE ON TRUSS B - HANGERS

- LEGEND:**
- TB-H01 (CO.III)
 - TB-T01 - DAMAGE SHEET WHERE PHOTOS OF DAMAGE CAN BE FOUND.
 - CO - CORROSION
 - III - DAMAGE RATING
 - ← - VIEW WHEN PHOTO WAS TAKEN.
 - △ - REVISED 12 / 1 / 03

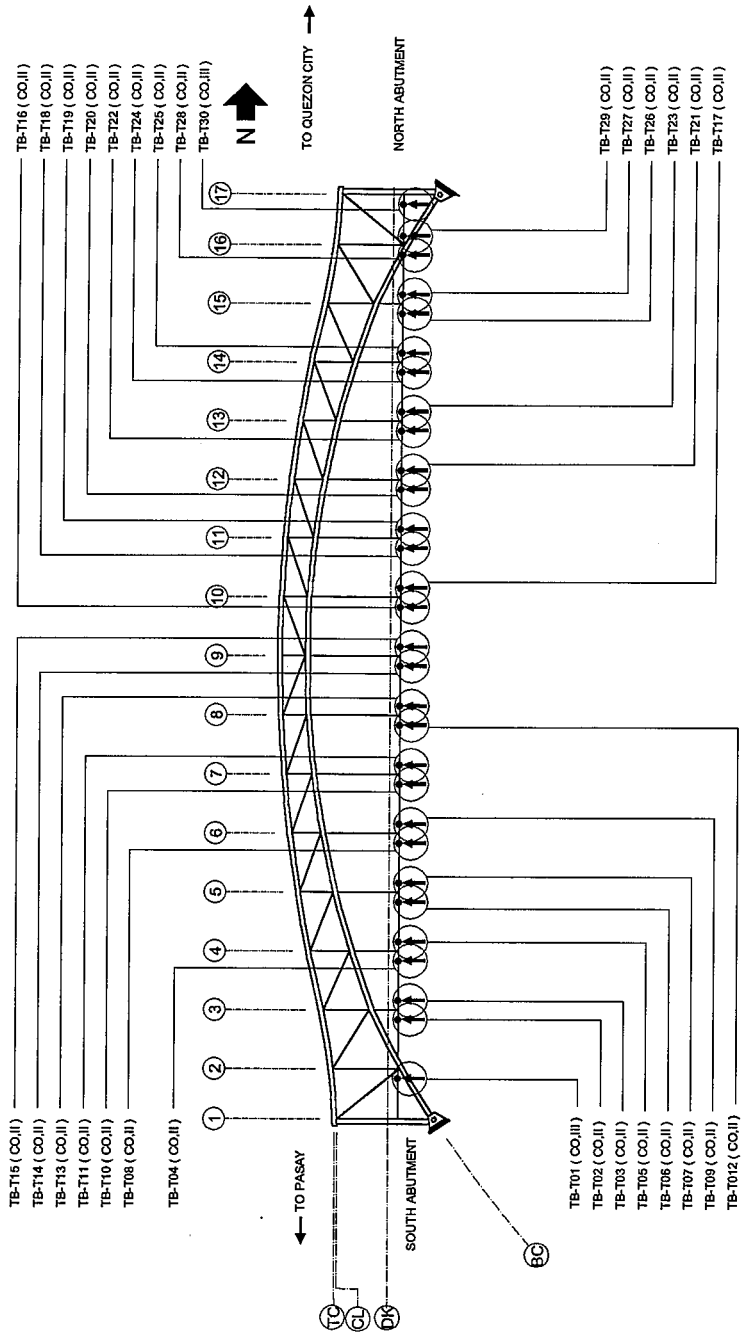
DAMAGE ON TRUSS B - TIES

- LEGEND:**
- TB-T01 (CO.III) - DAMAGE SHEET WHERE PHOTOS OF DAMAGE CAN BE FOUND.
 - CO - CORROSION
 - III - DAMAGE RATING
 - ↑ - VIEW WHEN PHOTO WAS TAKEN.

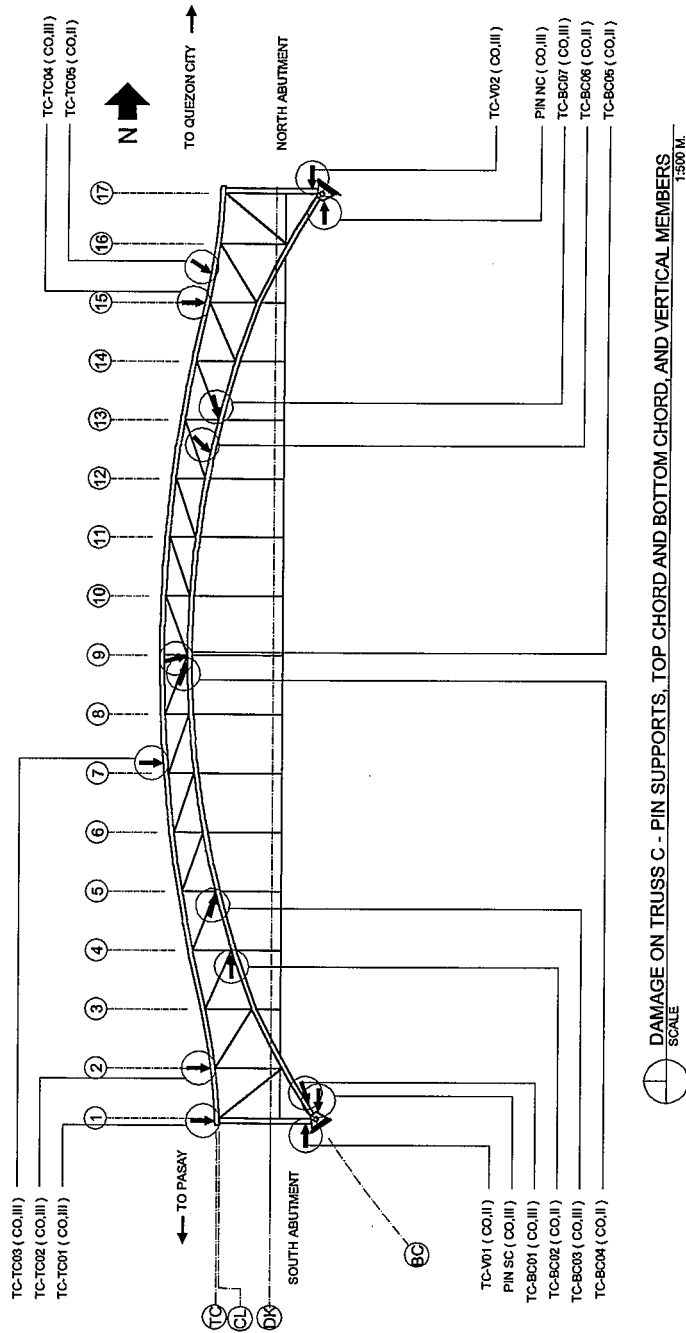
DAMAGE ON TRUSS C - PIN SUPPORTS,
TOP & BOTTOM CHORDS AND VERTICAL MEMBERS

LEGEND:
 TC-BC01 (CO.III) - DAMAGE SHEET WHERE PHOTOS
 OF DAMAGE CAN BE FOUND.
 CO - CORROSION
 III - DAMAGE RATING
 ↑ - VIEW WHEN PHOTO WAS TAKEN.

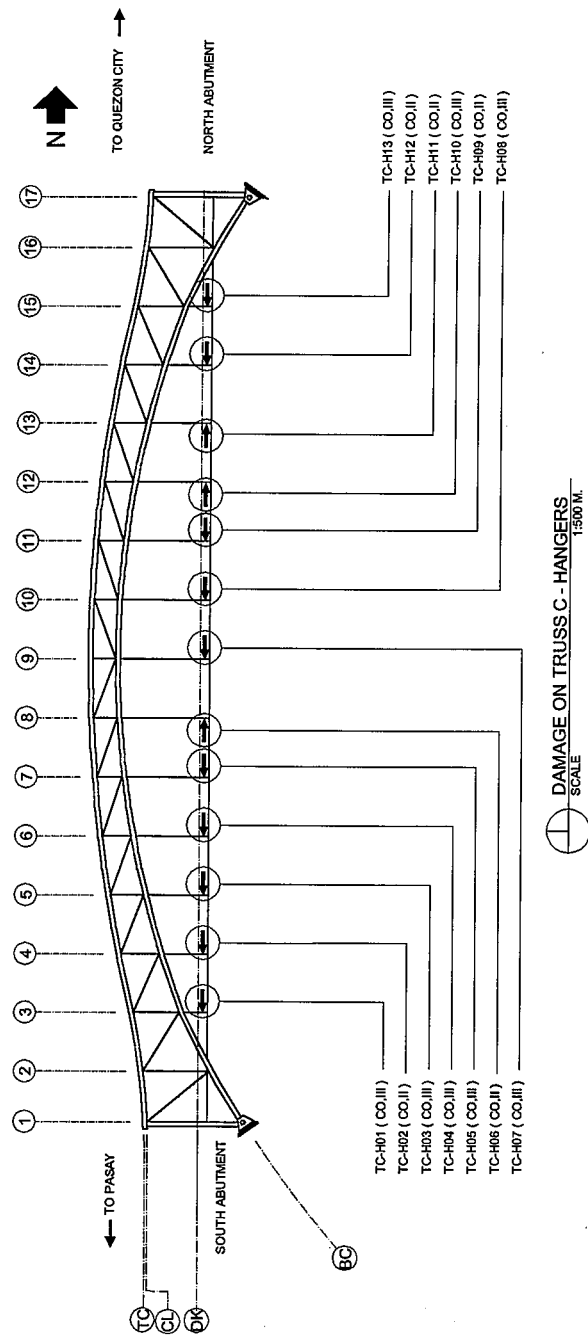
DAMAGE ON TRUSS C - HANGERS

LEGEND:
 TC-H01 (CO,III)
 TC-H01 - DAMAGE SHEET WHERE PHOTOS OF DAMAGE CAN BE FOUND.
 CO - CORROSION
 III - DAMAGE RATING
 ↑ - VIEW WHEN PHOTO WAS TAKEN.

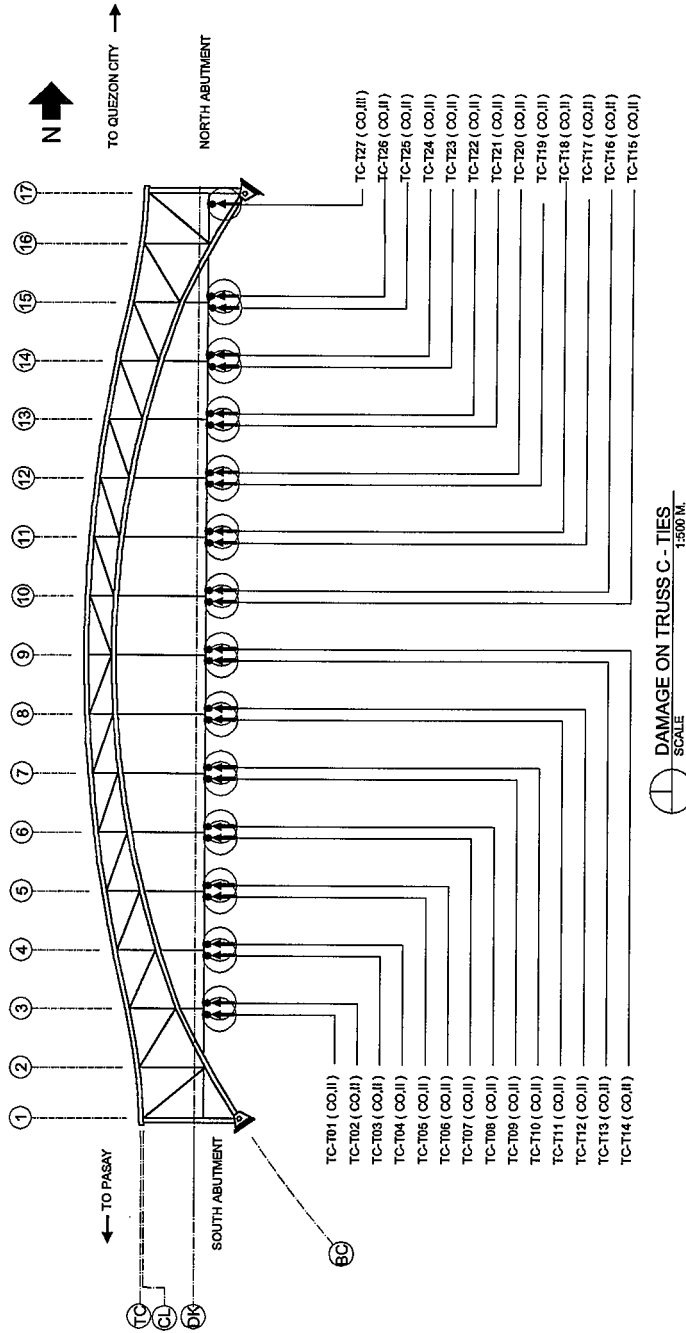
DAMAGE ON TRUSS C - TIES

LEGEND:
 TC-T01 (CO.II) - DAMAGE SHEET WHERE PHOTOS OF DAMAGE CAN BE FOUND.
 CO - CORROSION
 II - DAMAGE RATING
 ↑ - VIEW WHEN PHOTO WAS TAKEN.

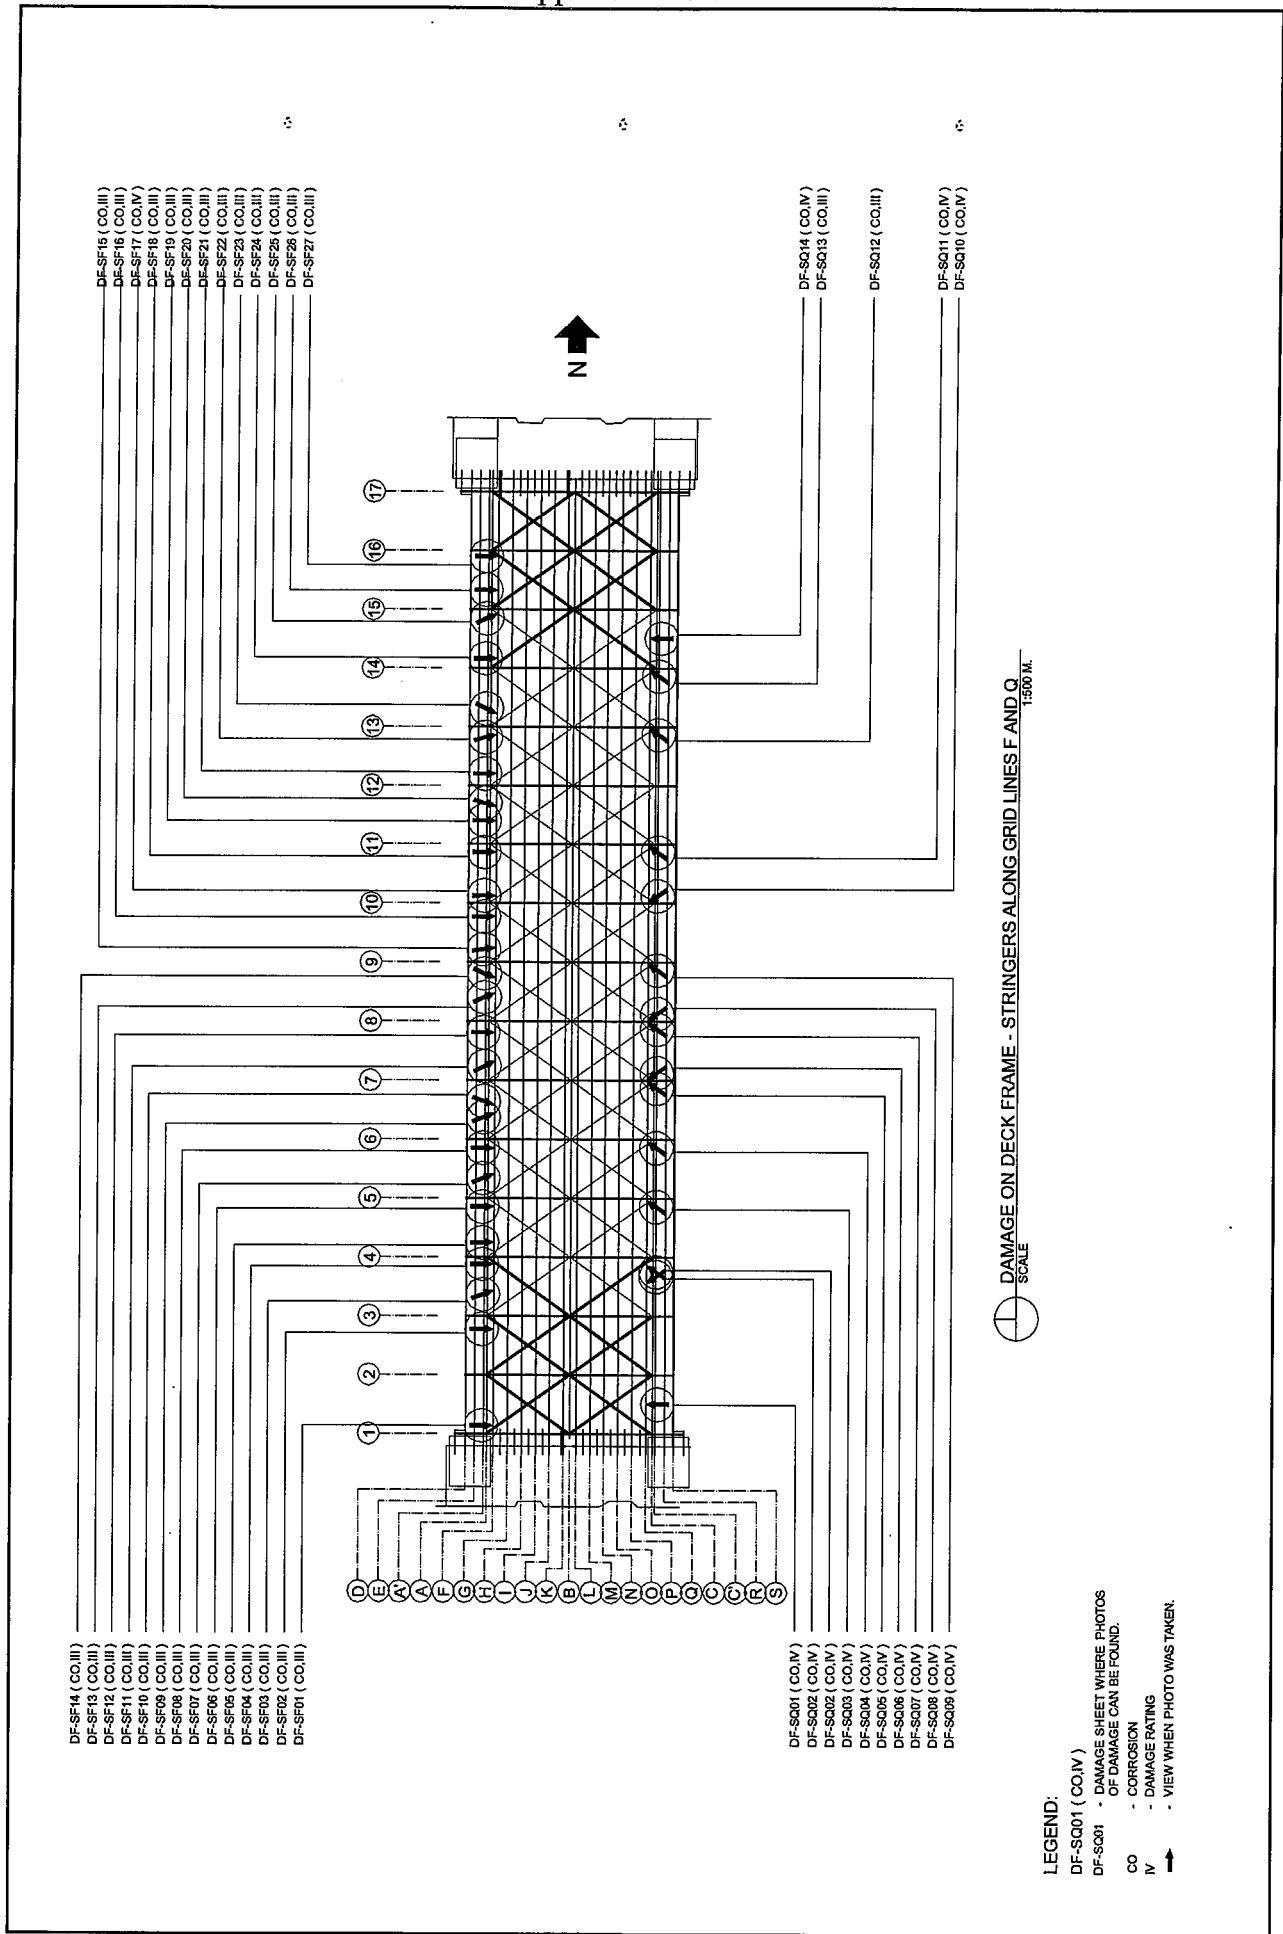
DAMAGE ON DECK FRAME - STRINGERS ALONG GRID LINES F AND Q

DF-SF16 (CO,III)
 DF-SF16 (CO,III)
 DF-SF17 (CO,IV)
 DF-SF18 (CO,III)
 DF-SF19 (CO,III)
 DF-SF20 (CO,III)
 DF-SF21 (CO,III)
 DF-SF22 (CO,III)
 DF-SF23 (CO,III)
 DF-SF24 (CO,III)
 DF-SF25 (CO,III)
 DF-SF26 (CO,III)
 DF-SF27 (CO,III)

DF-SF14 (CO,III)
 DF-SF13 (CO,III)
 DF-SF12 (CO,III)
 DF-SF11 (CO,III)
 DF-SF10 (CO,III)
 DF-SF09 (CO,III)
 DF-SF08 (CO,III)
 DF-SF07 (CO,III)
 DF-SF06 (CO,III)
 DF-SF05 (CO,III)
 DF-SF04 (CO,III)
 DF-SF03 (CO,III)
 DF-SF02 (CO,III)
 DF-SF01 (CO,III)

DF-SQ14 (CO,IV)
 DF-SQ13 (CO,III)
 DF-SQ12 (CO,III)
 DF-SQ11 (CO,IV)
 DF-SQ10 (CO,IV)

DF-SQ01 (CO,IV)
 DF-SQ02 (CO,IV)
 DF-SQ02 (CO,IV)
 DF-SQ03 (CO,IV)
 DF-SQ04 (CO,IV)
 DF-SQ05 (CO,IV)
 DF-SQ06 (CO,IV)
 DF-SQ07 (CO,IV)
 DF-SQ08 (CO,IV)
 DF-SQ09 (CO,IV)
