グアシロペ橋の技術的考察

Technical Paper on Puente Agua Caliente

CA-5 道路の橋梁 2 案件 (11 橋) の現況

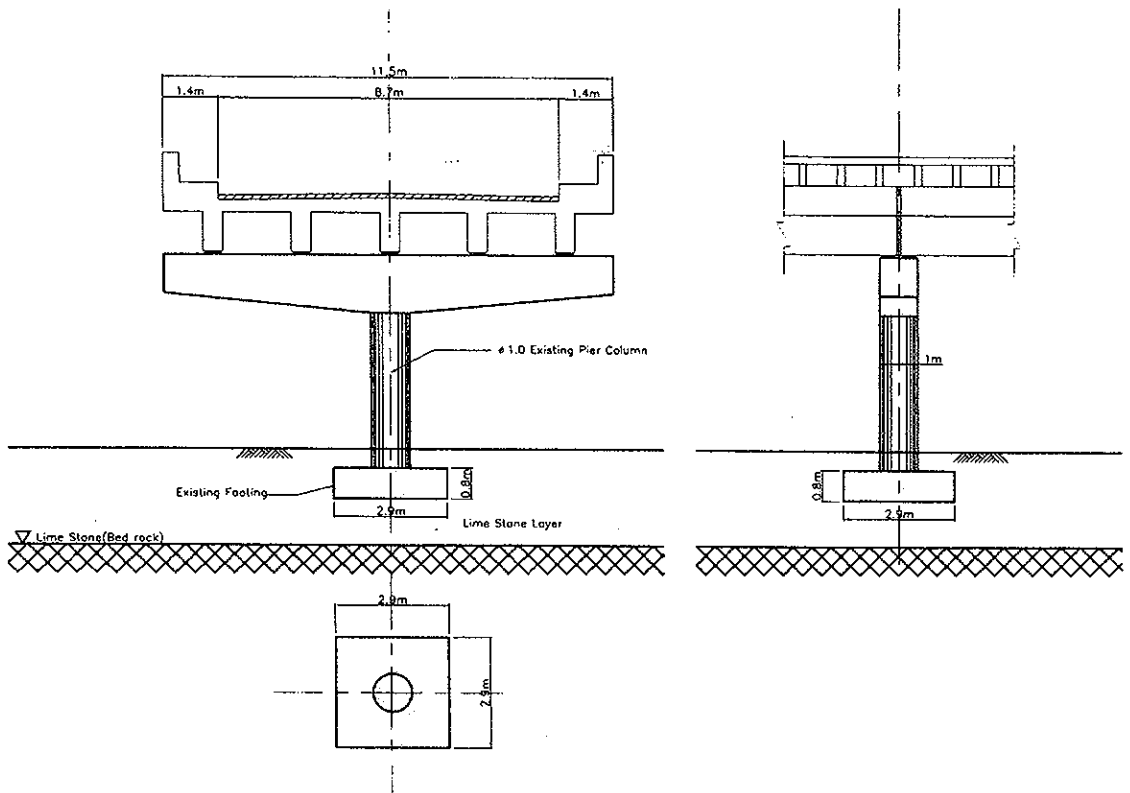
現況断面図

Pier column diameter is only 1.0m and the footing is 2.9m square and 0.8m thick. The footing is supposed to be founded on the top of lime soil layer, not penetrated directly into lime stone bedrock. Furthermore, the lime layer has been weakened by hot spring erupted around pier.

Accordingly, there are many problems such as buckling and shear strength on pier column and also stability on the footing. Pier and footing may be collapsed and fallen by the live load of 37ton semi-trailer over the bridge. It seems very dangerous since nobody can see underground.

Pier column and footing shall be enlarged in the way as shown in the following page:
