**THE STUDY
ON
MEKONG RIVERBANK PROTECTION AROUND
VIENTIANE MUNICIPALITY
IN
THE LAO PEOPLE'S DEMOCRATIC REPUBLIC**

**FINAL REPORT
VOLUME 2
MAIN REPORT**

DECEMBER 2004

**NIKKEN Consultants, Inc.
NEWJEC Inc.**

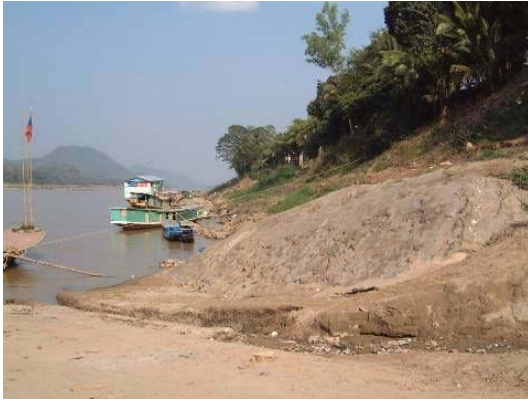
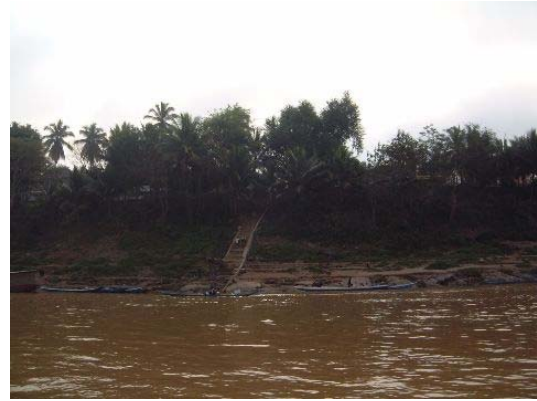
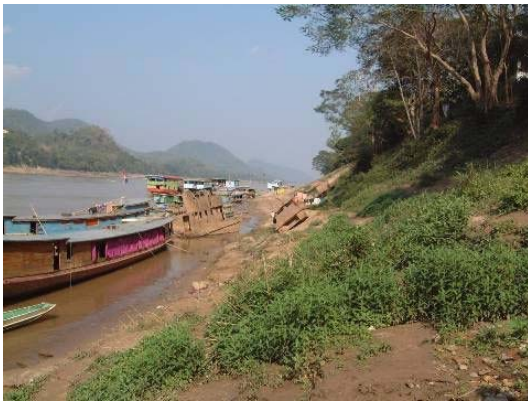
Figure 2.3 Mekong Riverbank along Luang Phabang City
- Condition in January 2002-

- In the urban area of Luang Phabang, riverbanks are rather stable and keep some gentle slope and the extent and damage of erosion is relatively small as shown in Figure 2.3.
- In Bokeo province, the riverbanks, most notably existing groin site at Ban Tonpheung form vertical cliffs at many places as shown in Figure 2.4 as can be seen in the Study Area.

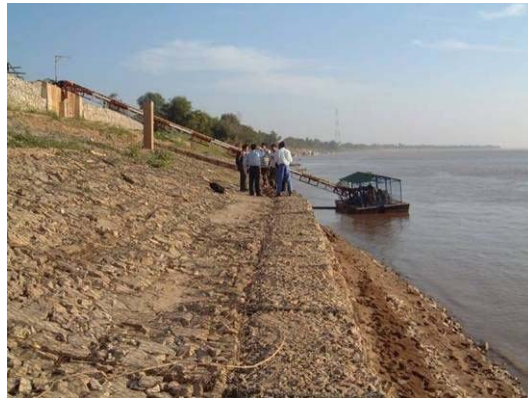
Figure 2.7 Soda Mattress Installed Site at Thakhek
- Condition in December 2001-

- At Thakhek, gabion works protect a water intake facility with concrete piles supported by “Soda mattress” and wooden pile works (refer to Figure 2.7).

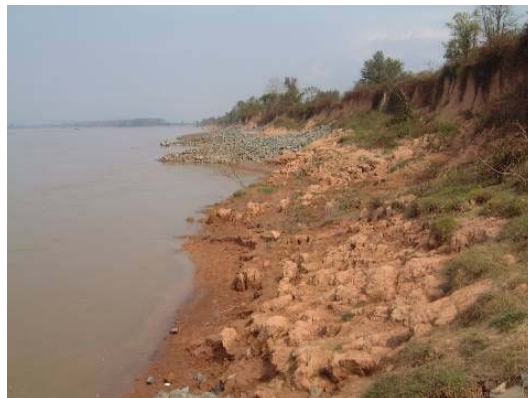
Figure 2.8 On-going Riprap Groin Works in Bokeo Province
- Condition in December 2001-

- Around Luang Phabang city, riverbank slope of the Mekong is rather stable except the drainage treatment on the slopes.
- In Luang Phabang city, along the Nam Khan river near the confluence with the Mekong, riverbank is protected by gabion box. Some amount of silt deposit is found on the gabions.
- Along Ban Tonephueng in Bokeo province, riprap groin works being executed by GOL with the technical assistance of JICA Expert to MCTPC since 1998 as shown in Figure 2.8. Amount of sedimentation is found between groins, resulting to protect the riverbank slopes. MCTPC constructed 14 groins by 2003 and will continue further extension until 2008, every 2 groins a year.

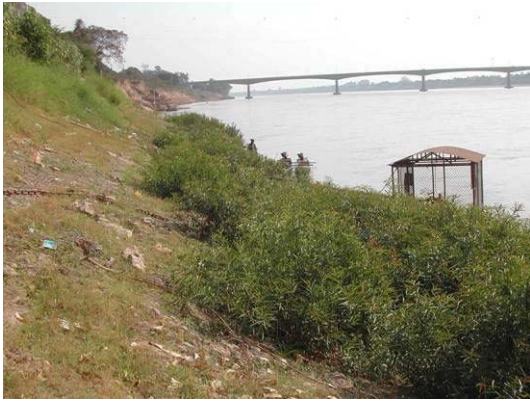
National Culture Park

- Distribution of willow:
 - Many communities of the willow are found at existing bank protection works after 5 years or more from the completion as shown in Figure 2.12.
 - Few willows are found on natural riverbanks
 - Massive communities are found at the sandbar in front of Buddha Park.
- Characteristics of willow:
 - The kind of soil has little influence on the growth of willow.
 - Moisture has strong influence on the growth of willow
 - Community of willow can hold the soil of riverbank

Figure 2.12 Community of Willow on Existing Bank Protection Works

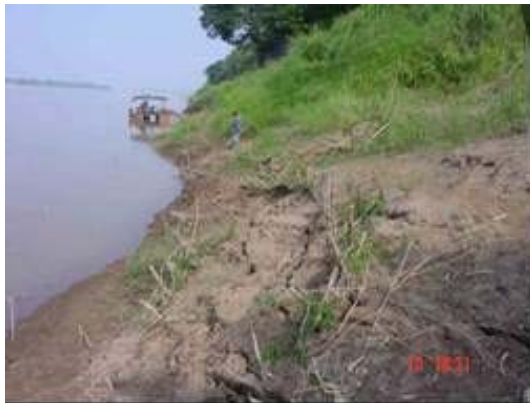
Chom Cheng site

Soda-net eroded due to too soft earth
