**TECHNICAL NOTE**  
**on the Basic Design Study**  
**on the Project for Rehabilitation of Betio Port**  
**in the Republic of Kiribati**

**Minutes of Discussions  
on the Basic Design Study  
on the Project for Rehabilitation of Betio Port  
in the Republic of Kiribati  
(Explanation of Draft Final Report)**

## 資料-6 事業事前計画表(基本設計時)

### A-1 現地損傷状況調査内容

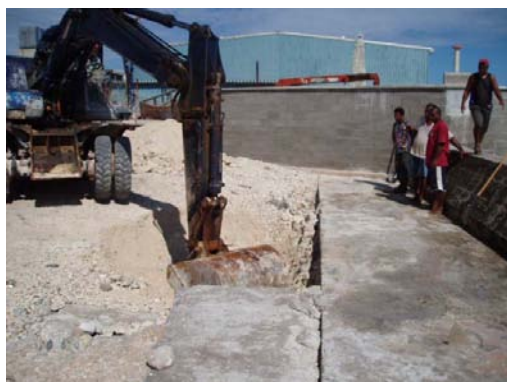
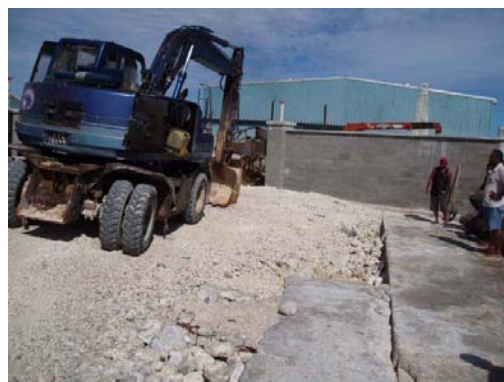
写真 A-5-1 掘削調査状況

背後の埋立土砂の流出、吸出し状況を確認するため、新港護岸の背面道路部において掘削調査を実施した。掘削は小型タイヤバックホーを用い、護岸背後の道路部の土砂を、幅 1m 程度・深さ約 1.7m 程度まで掘削した。掘削箇所は、ファブリマツ護岸が崩壊している 4 ヶ所 (No.1、No.5、No.7、及び No.9 付近) とした。

調査に用いたタイヤバックホー

掘削状況
