TECHNICAL NOTE
on the Basic Design Study
on the Project for Rehabilitation of Betio Port
in the Republic of Kiribati

**Minutes of Discussions
on the Basic Design Study
on the Project for Rehabilitation of Betio Port
in the Republic of Kiribati
(Explanation of Draft Final Report)**

APPENDIX 6.A FIELD INVESTIGATIONS ON DAMAGED FACILITIES

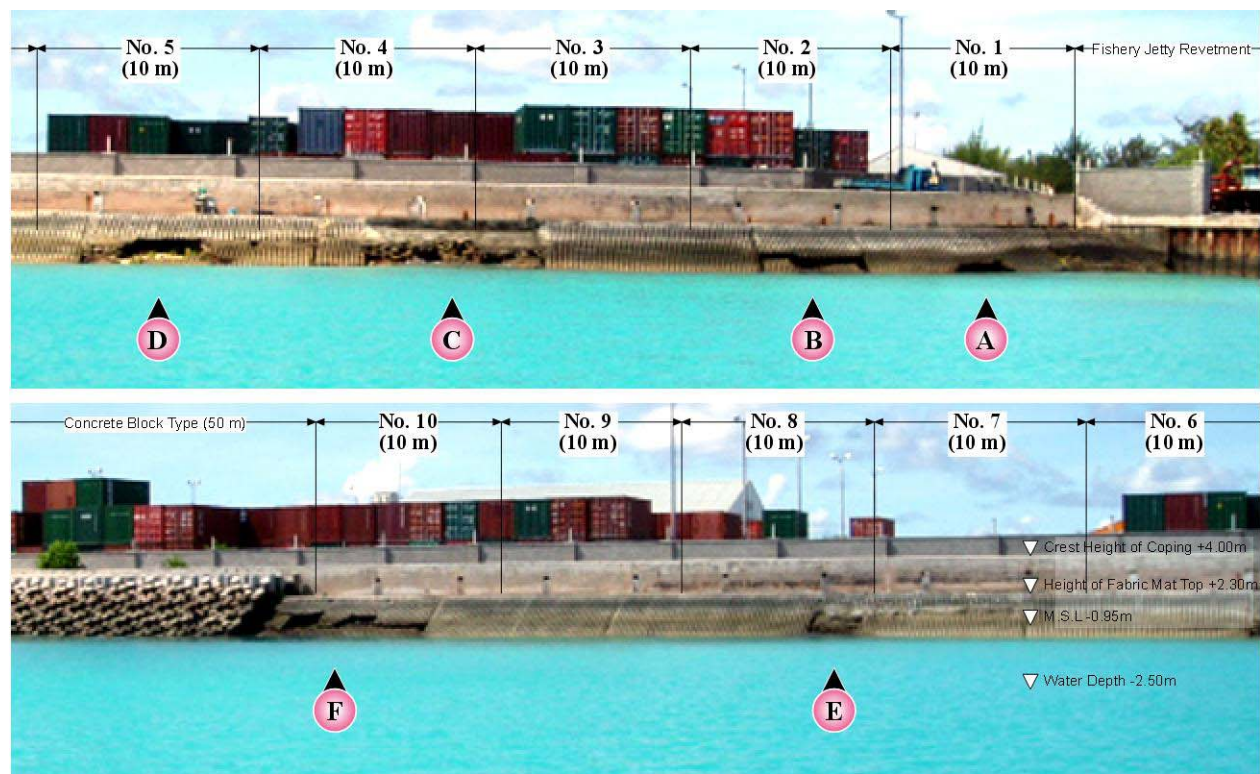
- a) The most severe damages of mat are observed at Sections No.1~2, No.4~5, No.7 and No.10 of fabric mat type revetment. At these Sections the damages are caused at the lower part below LWL. The bagged concrete used for urgent repair on the damaged parts were scattered on the seabed. (see Photo A-2-1 ①)

- d) At the toe part of the slope, gabions for toe protection were scattered and it was observed opening of 30 to 50 cm under the gabions.

- Considerable amount of rock and bagged concrete displaced.
- Toe protection gabion scattered.
- Opening under gabion due to scouring.

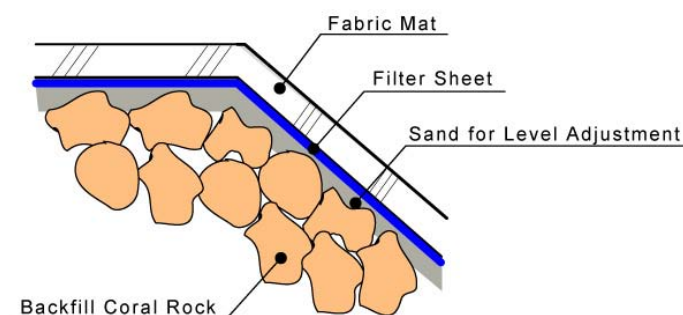
Figure A-3-1 Composition of fabric mat at New Wharf Revetment

- a) The structure of fabric mat, as shown in Figure A-3-1, is composed of fabric mat → filter sheet → sand for level adjustment → backfill coral rock (5~20kg/pc). At the location behind container terminal, bagged cement had been applied for backfill. The sand for level adjustment had been used to obtain smooth surface in avoiding damage to the fabric sheet during construction.
- b) The sand at the damaged section of New Wharf Revetment has been leaked exposing coral rock behind.

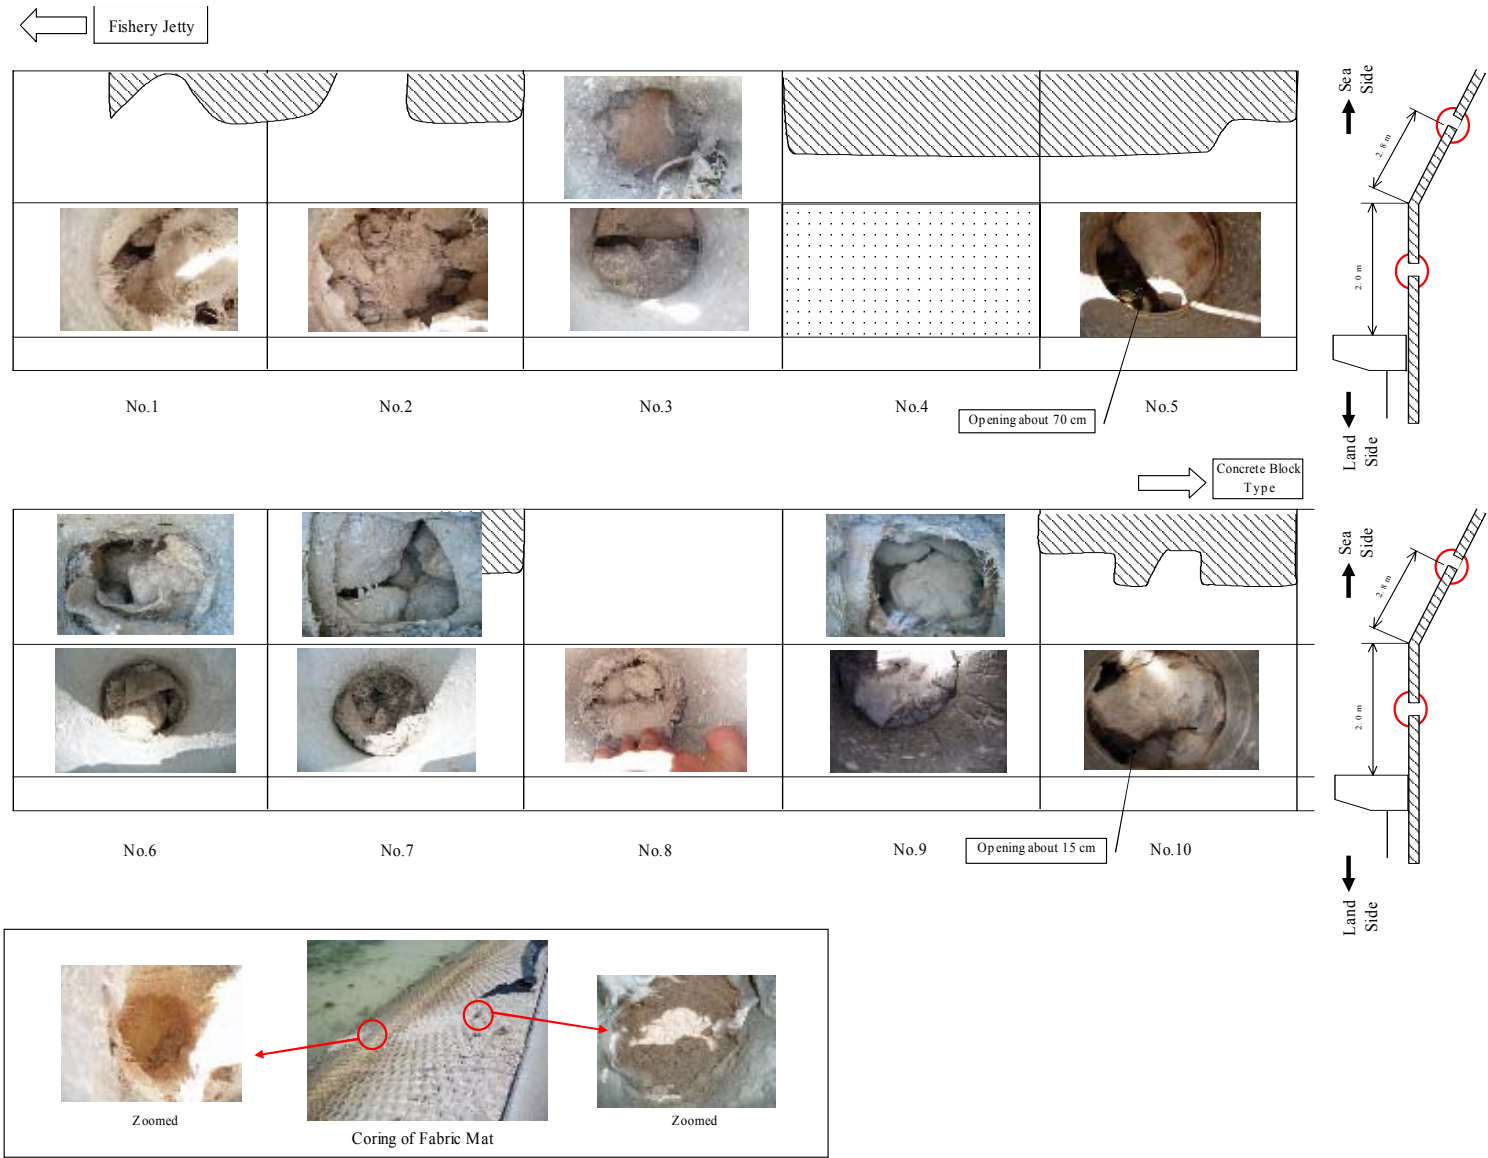
- c) As the feature of coral rocks varied, voids exist in between. Any displacement of coral rock has been observed for the undamaged section of revetment. While, displacement of rocks and existence of voids have been noticed for the damaged section. At the Section No. 5, where the damage of fabric mat is obvious, a large void with depth of 70 cm approximately has been seen.
- d) Spurting of air from cored holes has been observed due to phase difference of waves acting to the revetment and spurting of sea water as well during HWL. It is concluded that transmission of air due to phase difference exist regardless of damage to the fabric mat.
- e) At the undamaged revetment east of the container terminal, the sand for level adjustment exist at the position in two locations and bagged cement could be seen about 20cm underneath.

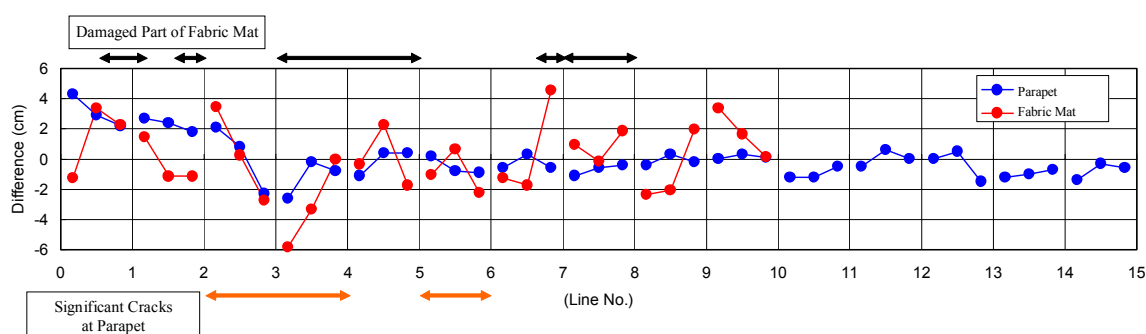
Figure A-3-1 Settlement Measurement at Parapet and Fabric Mat

Figure A-4-1 shows comparative difference of settlement at crest of parapet and top of fabric mat. Leveling survey has been carried out at both end and center of all 15 sections. Vertical ruler indicates each settlement from average value. Judging from the graph, settlement value and damages to fabric mat correlate well. It is noticed that the settlement at Section Nos. 3 to 4 indicates high value and subsidence observed near to the boarder of these sections. Settlement measured at parapet wall is less than that in fabric mat, but tendency of subsidence is noticeable at Section Nos. 3 to 4. It is difficult to evaluate the result of settlement measurement, however it is revealed that the settlement is correlated to damage of fabric mat and significant settlement is seen at the Section Nos. 3 to 4.

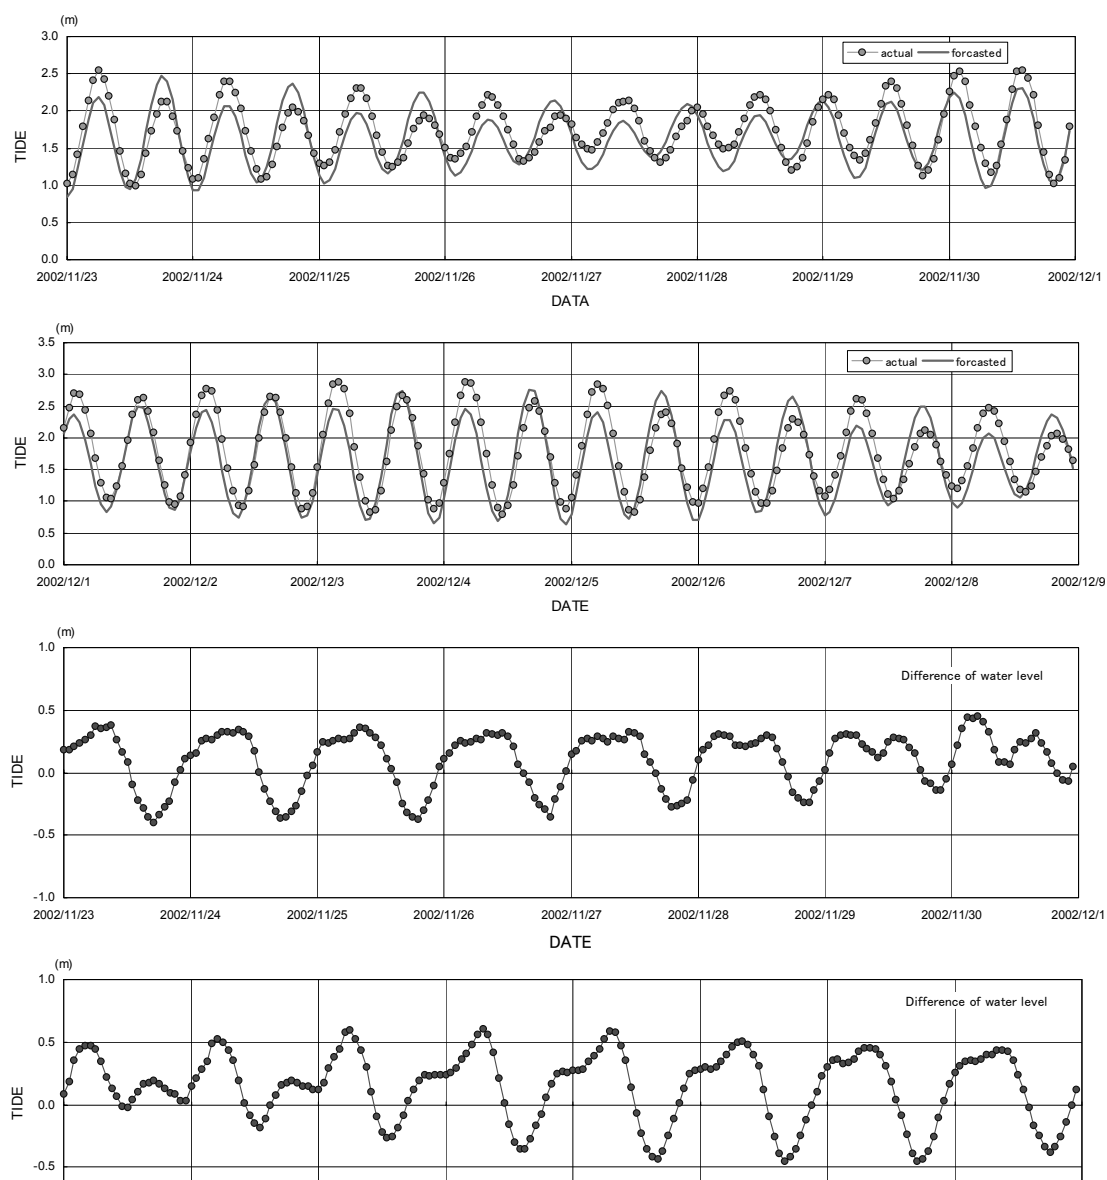
Figure B-1-1 Forecasted/Actual and difference of Water Levels during Disaster

Figure B-1-1 shows difference of forecasted and actual water levels before and after disaster caused for the revetment. Water setup has been observed between 29 November and 6 December 2002 due to wind-drift effect inside lagoon while the strong westerly wind blows. The maximum water level of +2.88 m has been recorded on December 3.
