THE BASIC DESIGN STUDY ON CONSTRUCTION OF EASTERN ARTERIAL ROAD IN MONGOLIA

JAPAN INTERNATIONAL COOPERATION AGENCY (JICA)

PACIFIC CONSULTANTS INTERNATIONAL
JAPAN OVERSEAS CONSULTANTS

D-53

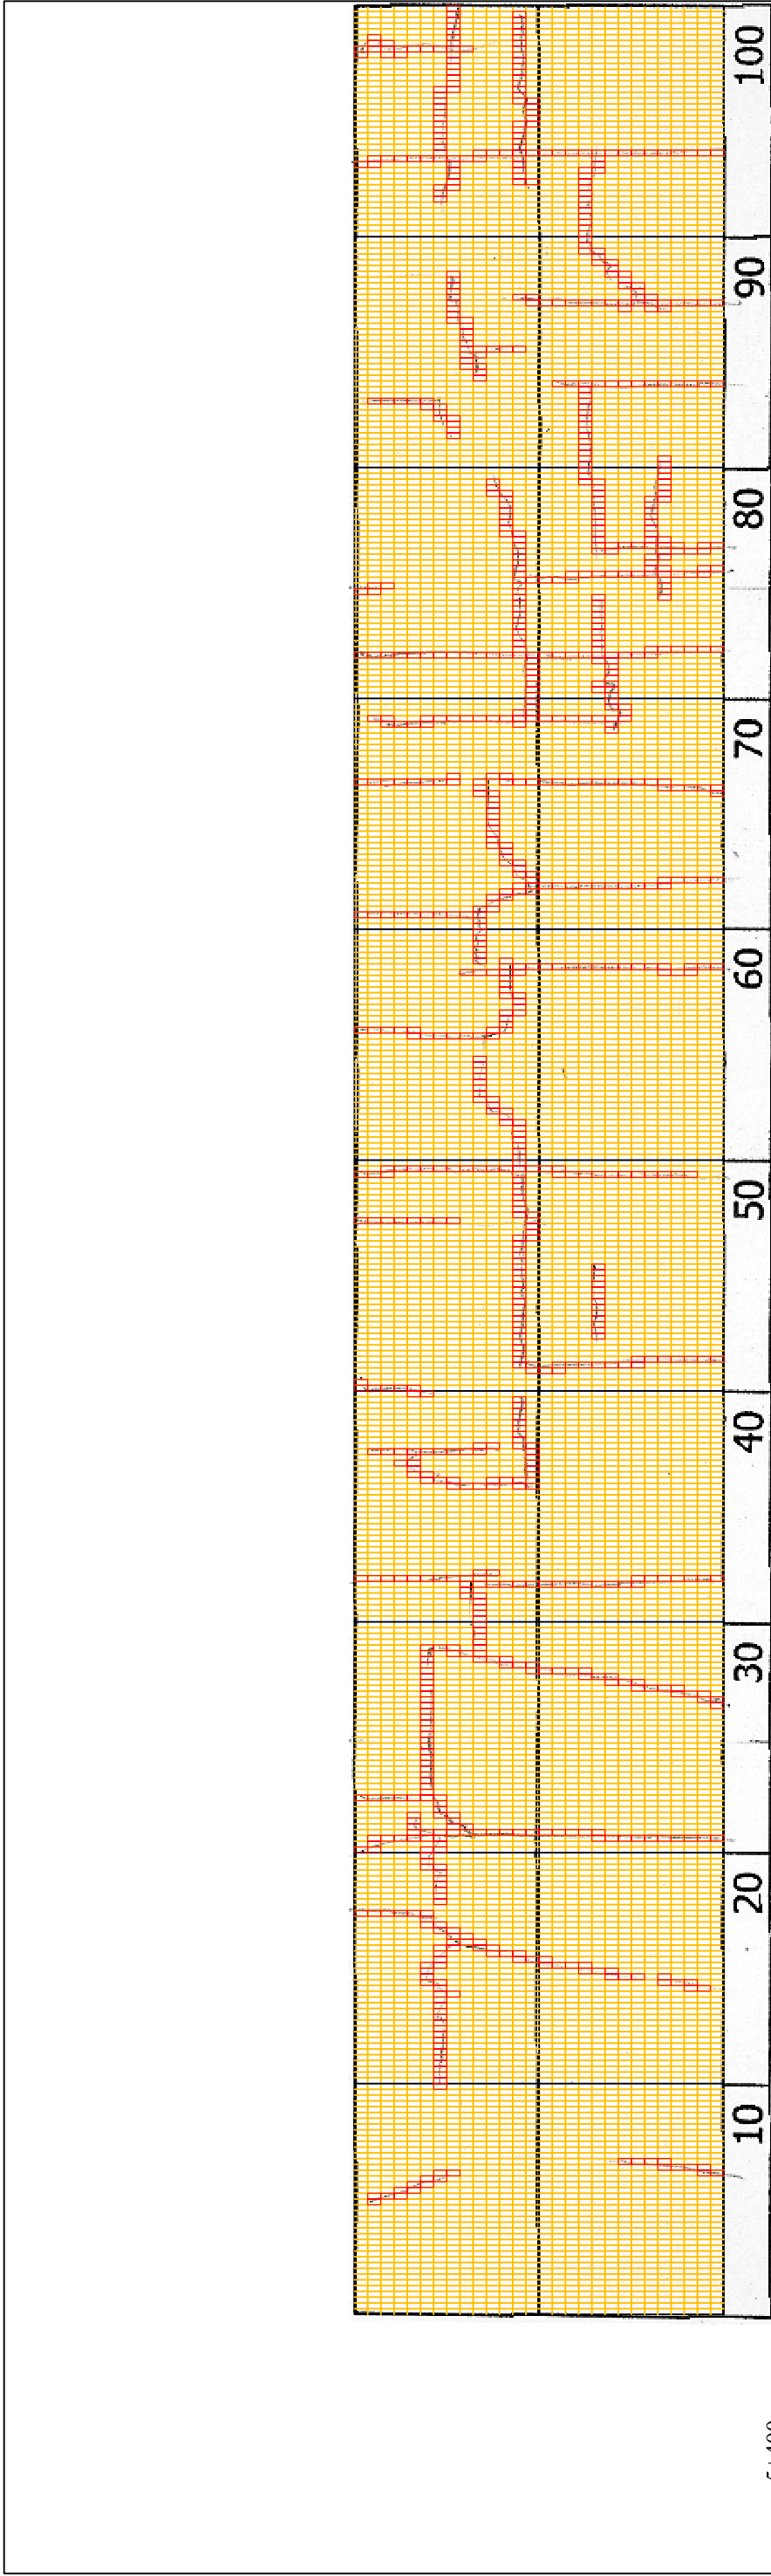
5+400

COMMENT	Volume of crackle: less Width of crackle: 05-10mm 165 / 2800 * 100 = 5.89%	Volume of crackle: less Width of crackle: 05-10mm 249 / 2800 * 100 = 8.89%	Volume of crackle: less Width of crackle: 05-10mm 274 / 2800 * 100 = 9.79%	Volume of crackle: less Width of crackle: 05-10mm 317 / 2800 * 100 = 11.32%
SUBJECTIVE EVALUATION	3	3	3	3
OBJECTIVE EVALUATION	b	b	b	b
TYPE OF PAVEMENT REHABILITATION	B	B	B	B

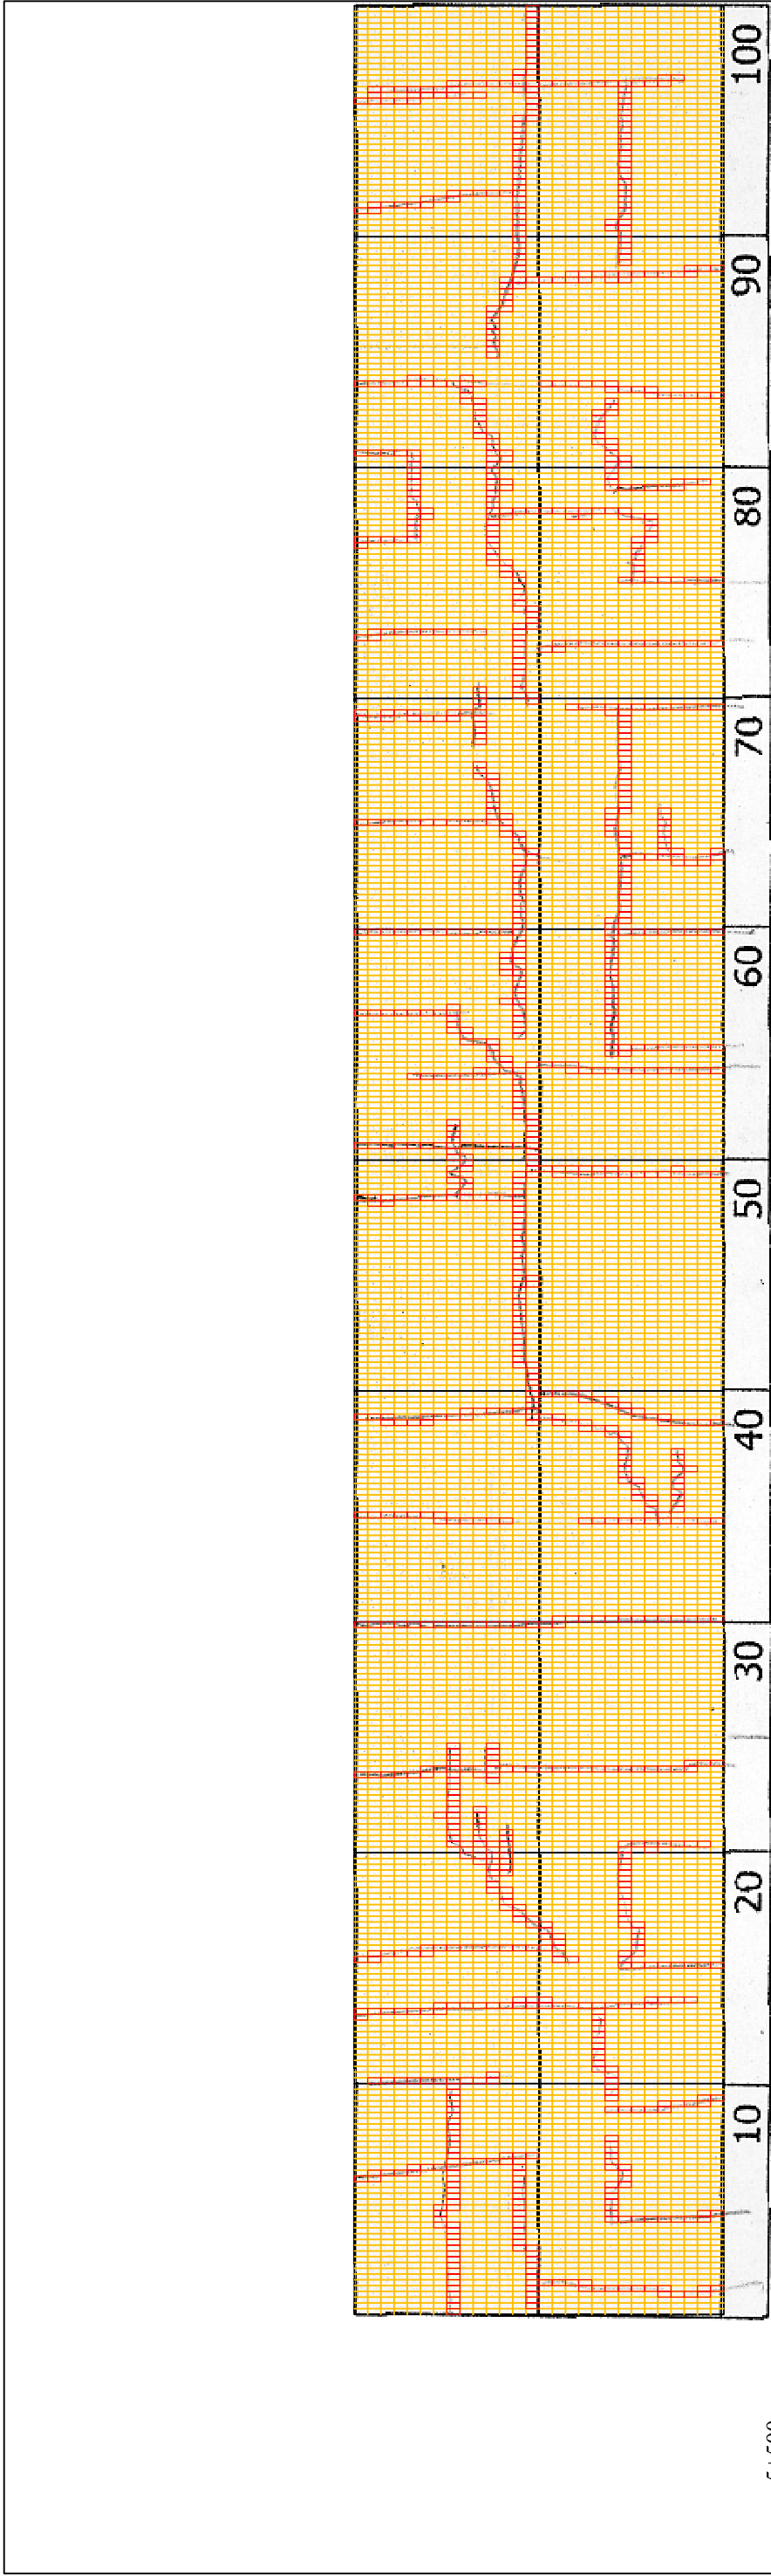
5+500

COMMENT	Volume of crackle: less Width of crackle: 05-10mm 356 / 2800 * 100 = 12.71%	Volume of crackle: less Width of crackle: 05-10mm 220 / 2800 * 100 = 7.86%	Volume of crackle: medium Width of crackle: 05-30mm 350 / 2800 * 100 = 12.50%	Volume of crackle: medium Width of crackle: 05-15mm 333 / 2800 * 100 = 11.89%
SUBJECTIVE EVALUATION	3	3	4	3
OBJECTIVE EVALUATION	b	b	b	b
TYPE OF PAVEMENT REHABILITATION	B	B	B	B

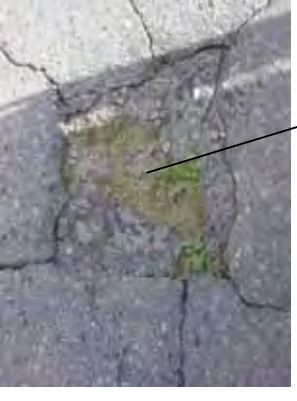
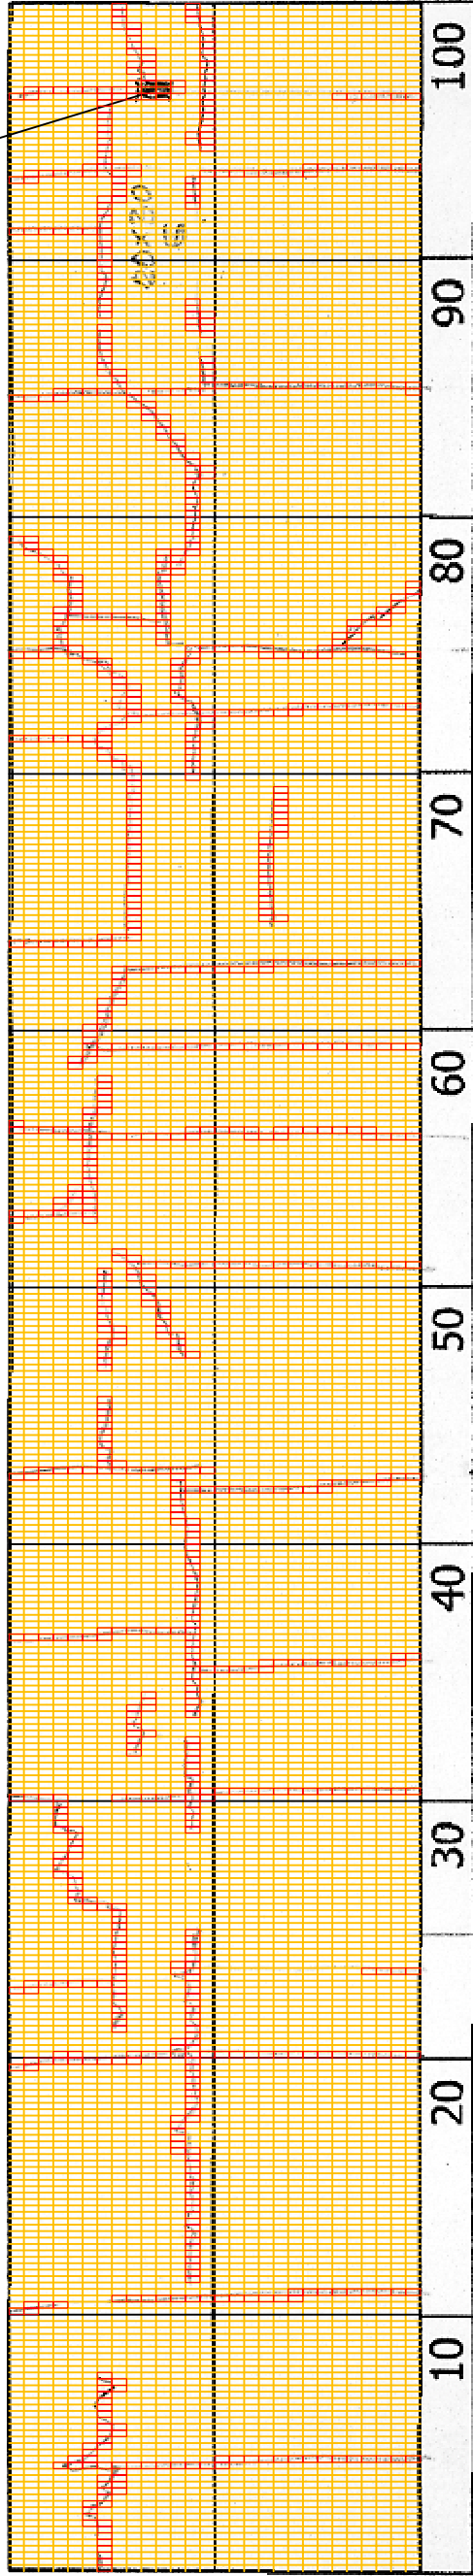
5+600

COMMENT	Volume of crackle: less Width of crackle: 05-10mm 212 / 2800 * 100 = 7.57%	Volume of crackle: less Width of crackle: 05-10mm 221 / 2800 * 100 = 7.89%	Volume of crackle: less Width of crackle: 05-15mm 322 / 2800 * 100 = 11.50%	Volume of crackle: medium Width of crackle: 05-20mm There is a pothole in + 5792 metre. (200*300*60mm) 294 / 2800 * 100 = 10.50%
SUBJECTIVE EVALUATION	3	3	3	3
OBJECTIVE EVALUATION	b	b	b	b, c
TYPE OF PAVEMENT REHABILITATION	B	B	B	B

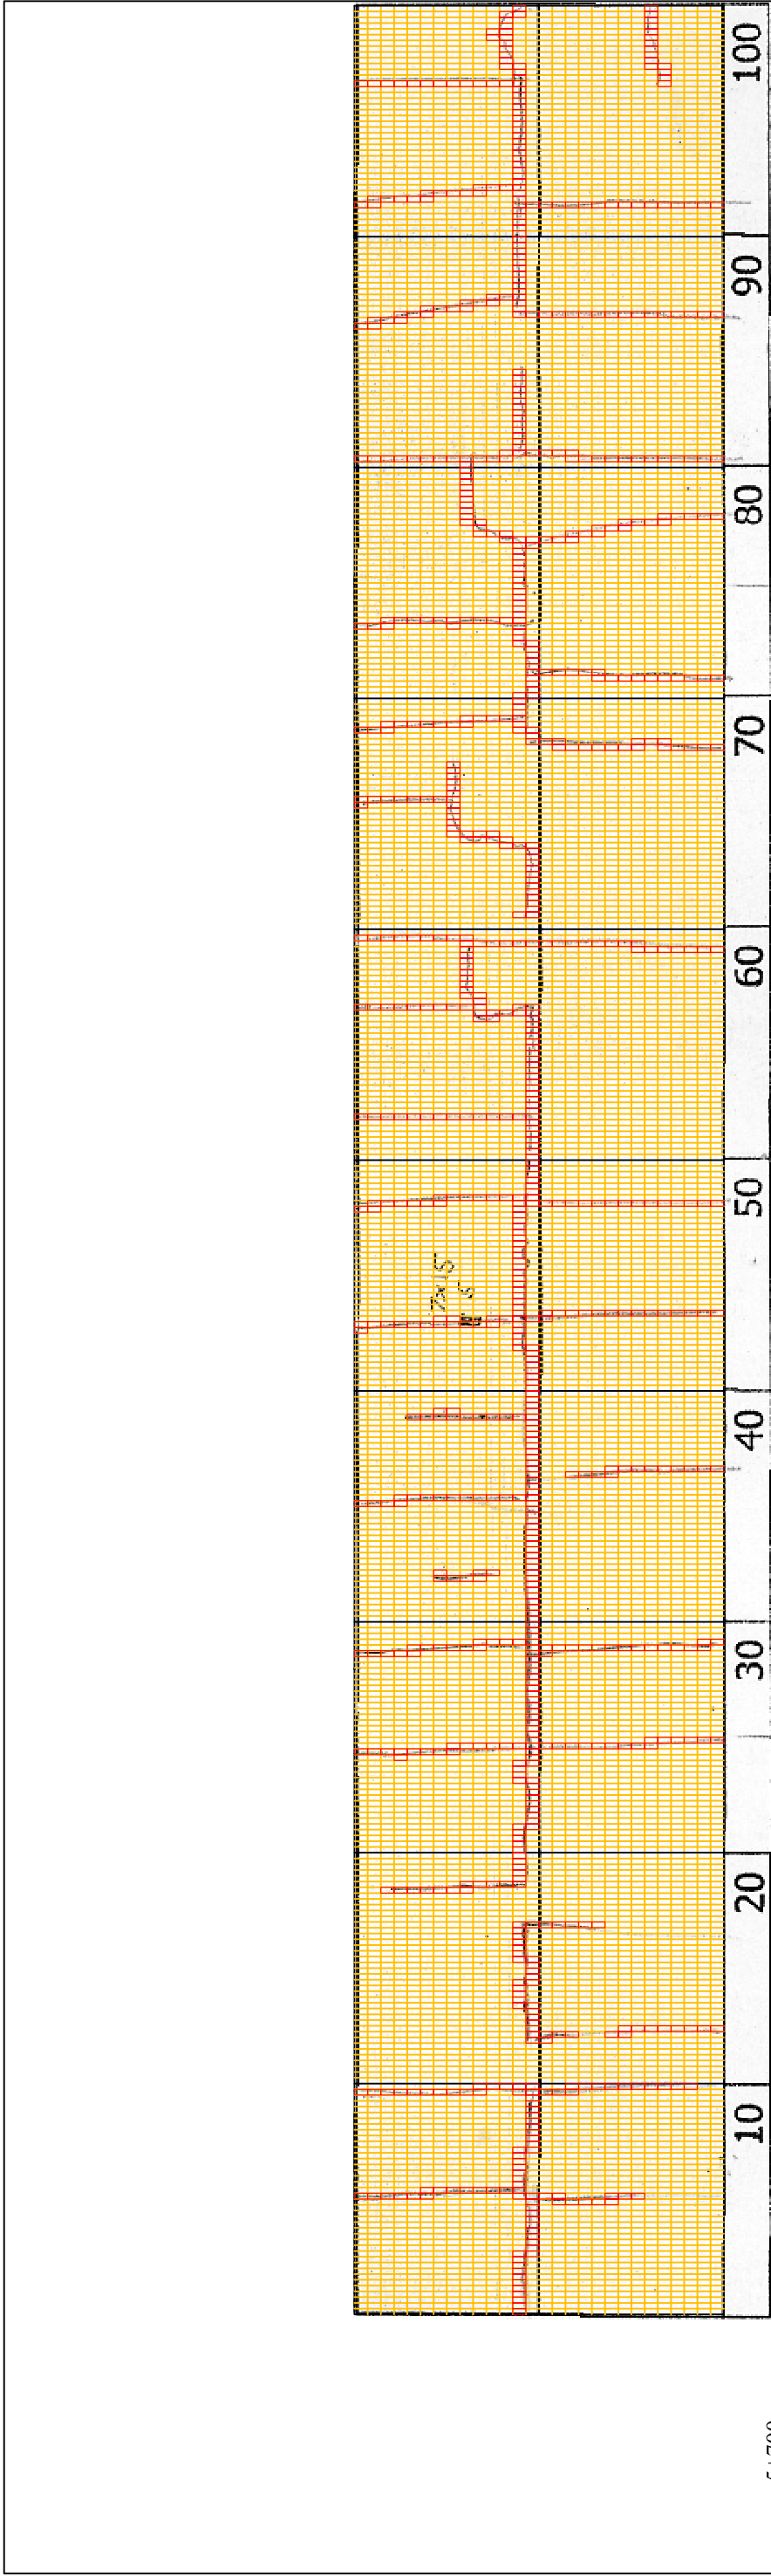
5+700	Volume of crackle: less Width of crackle: 05-10mm 208 / 2800 * 100 = 7.43%	Volume of crackle: medium Width of crackle: 05-15mm There is a pothole in + 5844 metre. (70*150*50mm) 239 / 2800 * 100 = 8.54%	Volume of crackle: medium Width of crackle: 05-20mm 233 / 2800 * 100 = 8.32%	Volume of crackle: medium Width of crackle: 05-25mm 236 / 2800 * 100 = 8.43%
COMMENT				
SUBJECTIVE EVALUATION	3	3	3	3
OBJECTIVE EVALUATION	b	b, c	b	b
TYPE OF PAVEMENT REHABILITATION	B	B	B	B

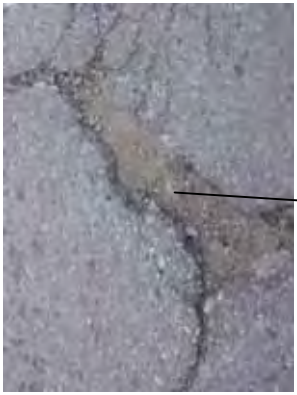
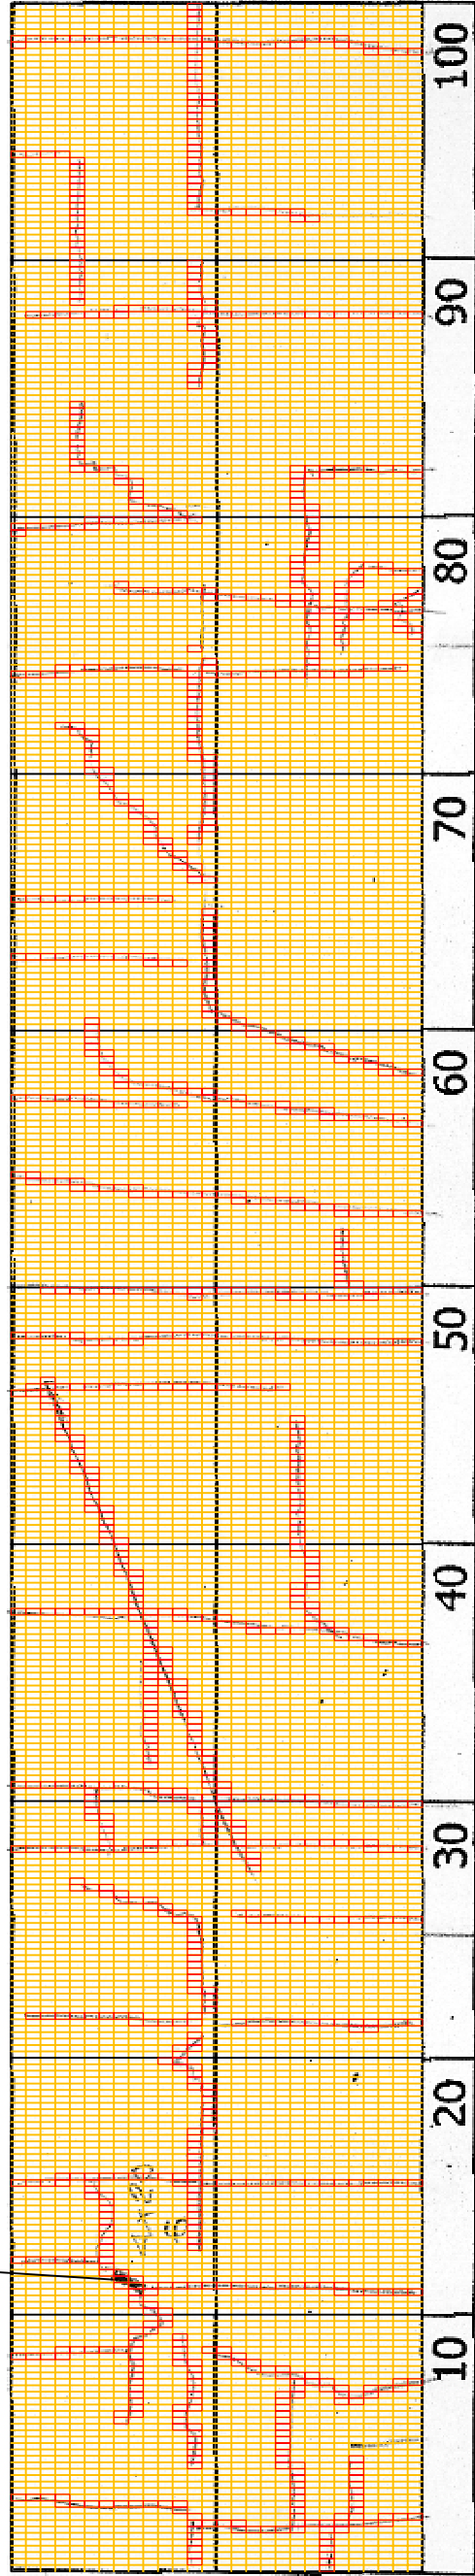
5+800

COMMENT	Volume of crackle: medium Width of crackle: 05-20mm 289 / 2800 * 100 = 10.32%	Volume of crackle: medium Width of crackle: 05-30mm 261 / 2800 * 100 = 9.32%	Volume of crackle: medium Width of crackle: 05-20mm 363 / 2800 * 100 = 12.96%	Volume of crackle: medium Width of crackle: 05-30mm 327 / 2800 * 100 = 11.68% There is a pothole in + 5912 metre. (40*200*60mm)
SUBJECTIVE EVALUATION	3	3	3	3
OBJECTIVE EVALUATION	b	b	b	b, c
TYPE OF PAVEMENT REHABILITATION	B	B	B	B
