CHAPTER 3. CONSTRUCTION OF MODELS

3.1 Construction Sequence

3.2 Aspects of Non-Engineering during Construction

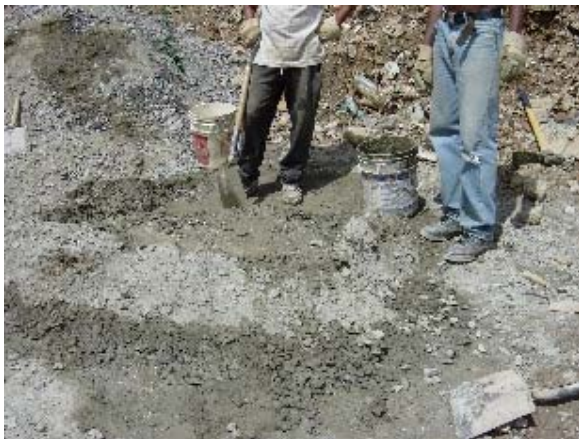
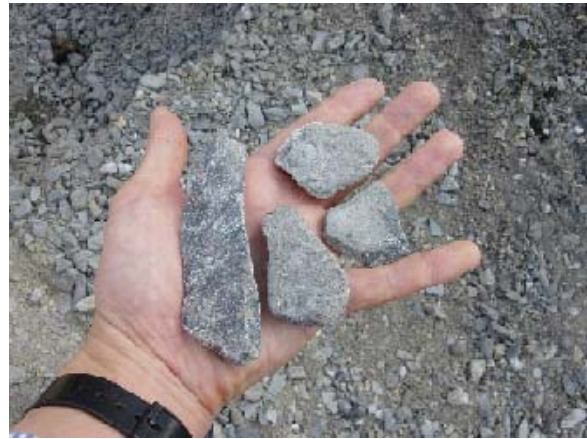
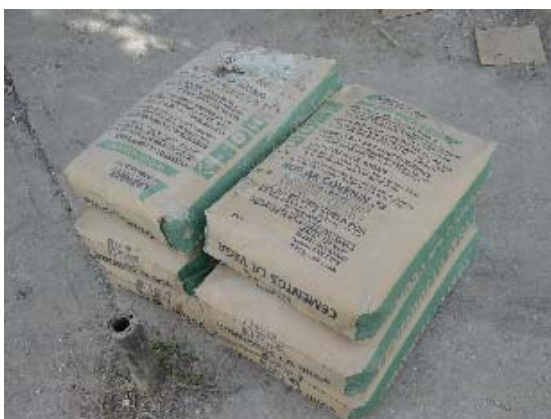
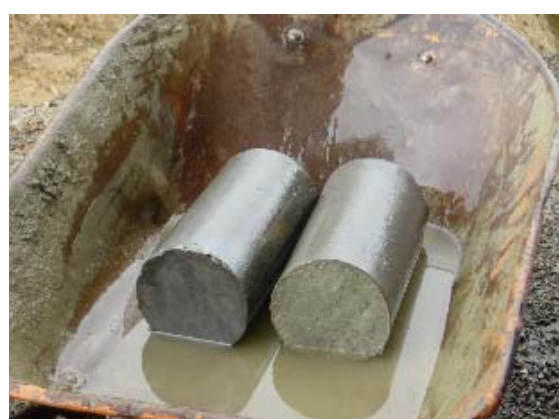
Photo 3.9 Concrete Mixing

Concrete mixing is 'homemade' and made by hand based on experience. General mix-proportion of concrete at the site is 24 carts for fine aggregate (sand), 12 carts for coarse aggregate (gravel), 4 bags (45kg per bag) of cement, and some water for 1m³ concrete. It is noted that mix proportion of sand and gravel is opposite compared to engineering mixing due to workability, and volume of water which decides strength of concrete is not measured. AE additive agent is not used. Concrete strength is unknown at the time of mixing accordingly. Test pieces of cylinder are taken for the test of 28 day strength of concrete. Sizes of coarse aggregate seem to be too big considering small sizes of members (photos 3.9, 3.10, 3.11, 3.12).

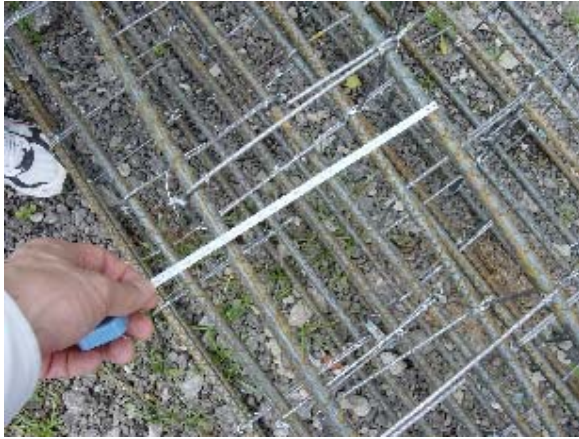
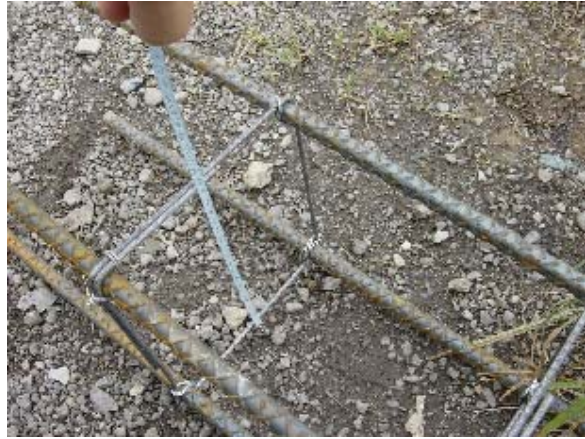
Photo 3.13 Fabrication of Re-bars(1)

Hook of hoop re-bar is 90 degree and is not 135 degree that is required for seismic performance (photo 3.13, 3.14).

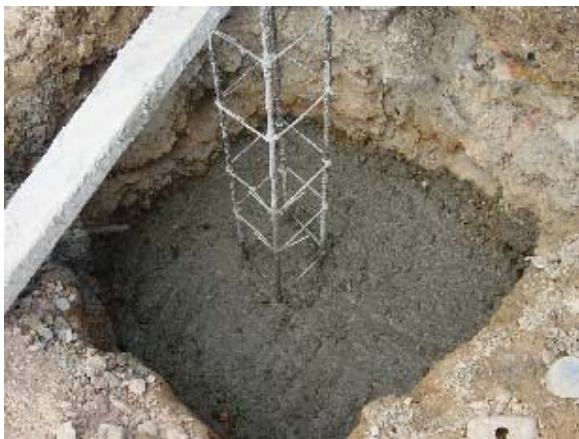
Photo 3.17 Concrete Casting for Foundation

The concrete of foundations is cast without perimeter framework. When mixing the soil into the concrete, it reduces the quality.

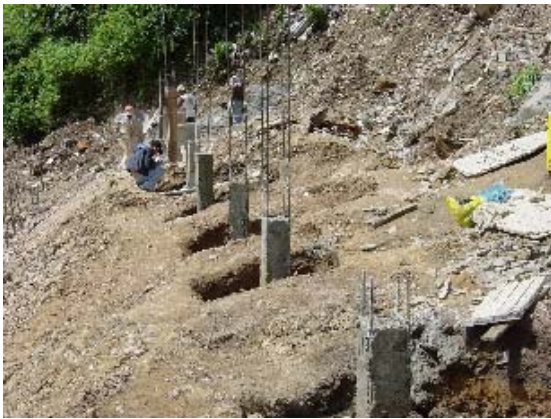
Photo 3.23 Short Column Concreted(2)

Twist of columns is observed. This is caused by the twisted installation of column re-bars by the lack of surveying before casting concrete of foundation (photo 3.23). Height difference of column joints is observed. This causes height adjustment of column by casting additional concrete or level difference of beams and floors later (photo 3.24).

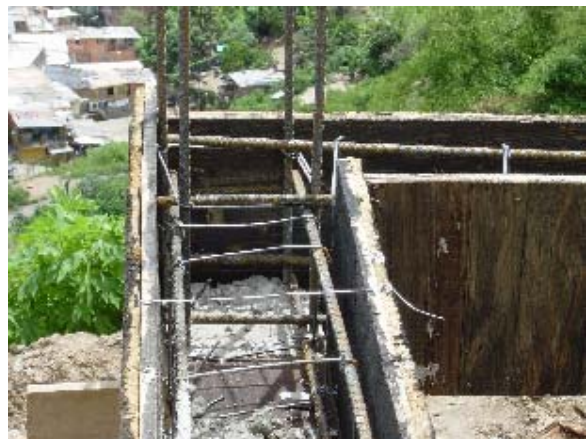
Photo 3.28 Beam Re-bar Installation

Shortage of beam re-bar anchor to column is observed. Beam main re-bars stop at the outer face of formwork. The main re-bars of the beams hit the external face of the framework. This is caused by no-understanding of importance of re-bar anchorage. Un-proper re-bar arrangement at joint of beam and column is also observed. Appearance of cast concrete shows this (photo 3.28).

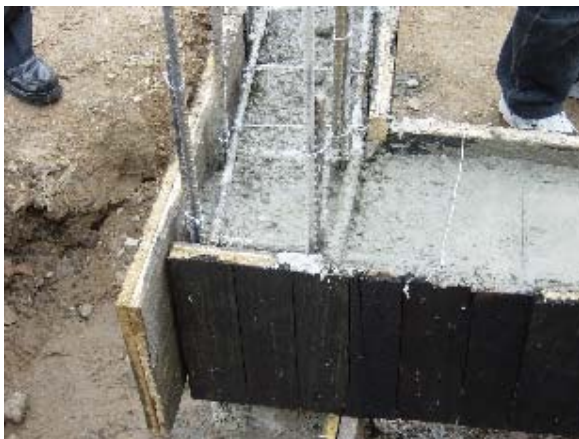
Photo 3.29 Construction Joint at beam

Un-proper horizontal joint of beam is observed. Horizontal construction joint of beam reduces strength of beam (photo 3.29).

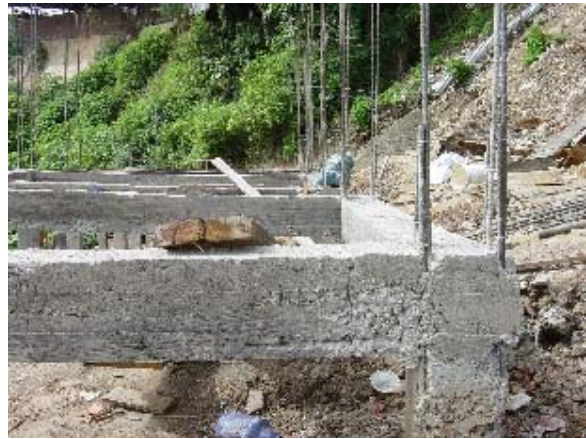
Photo 3.30 Removal of Form Work

Early removal of beam bottom formwork is observed. Bottom formwork of beam is removed in one or two days only after concreting. This may cause deflection and cracks of beams. Longer curing is required subject to confirmation of concrete strength at the removal (photo 3.30).

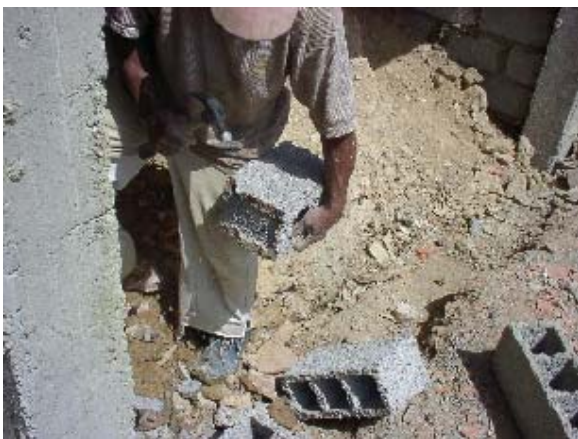
Photo 3.41 Concrete Block Wall Work(1)

Separation of hollow concrete block walls without re-bars from columns and beams starts at early stage of load 6~7ton. Yield strength appears at the load of 13.75 ton and deflection of 2.7mm, by the separation of hollow concrete blocks with re-bars from columns (photo 6.16~6.21). The maximum strength 15.25 ton is observed at deflection 12.8mm. Initial stiffness is increased by providing hollow concrete blocks, while strength is almost similar to those of Model 2 and 3. Horizontal deflection is increased after the max. strength and is provided more than 100mm as the final stage of loading. It is found that the strength of hollow concrete blocks is low for structural use and for seismic reinforcement. Concrete hollow block wall without re-bars is separated from column/beam at early stage, while wall with re-bars is not separated until lap joint of horizontal re-bars is broken. Strength of concrete block is low, and lower than that of mortar (photo 3.41, 6.21).

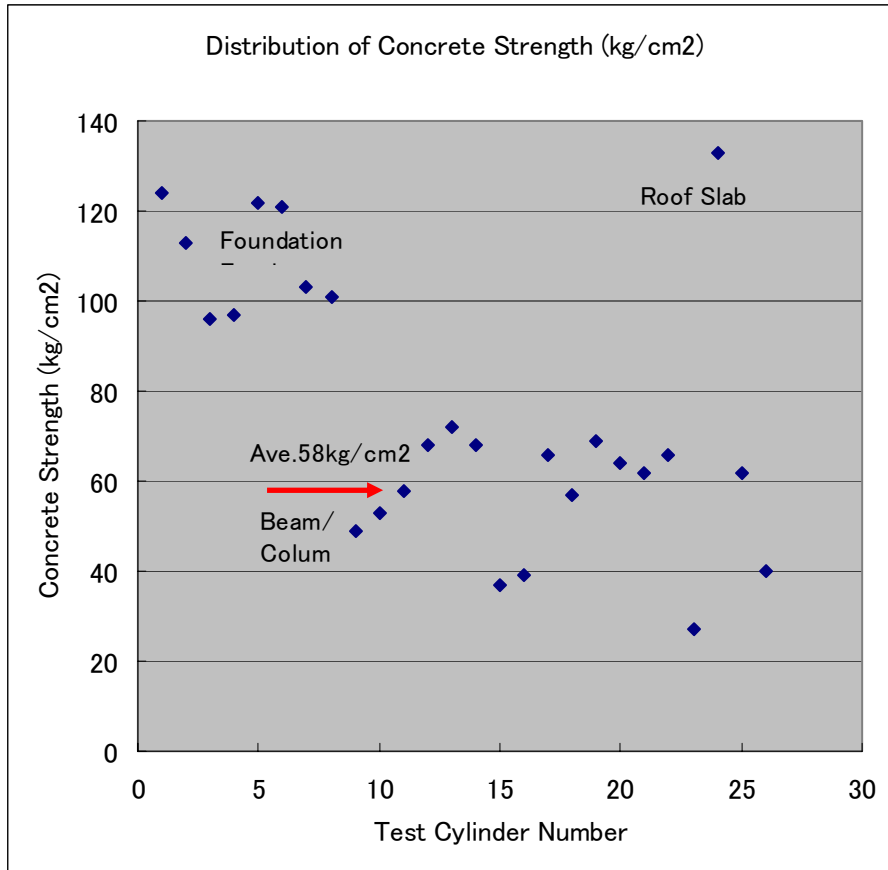
Cylinder	max. stress (kg/cm ² , for full section)	
1	124	Foundations
2	113	
3	96	
4	97	
5	122	
6	121	
7	103	
8	101	
9	49	Columns over foundation to beam
10	53	
13	58	
14	68	
15	72	Beams
16	68	
17	37	Grade beam
18	39	
19	66	Grade beam model 1
20	57	
21	69	Floor
23	64	Columns model 1 -2
25	62	Beam roof model 1
26	66	Column model 3 - beam model 2
28	29	roof
29	133	roof
40	62	wall
41	40	wall

Figure S7-4.2.1 Distribution of Concrete Strength by Cylinder Test, Tested by IMME

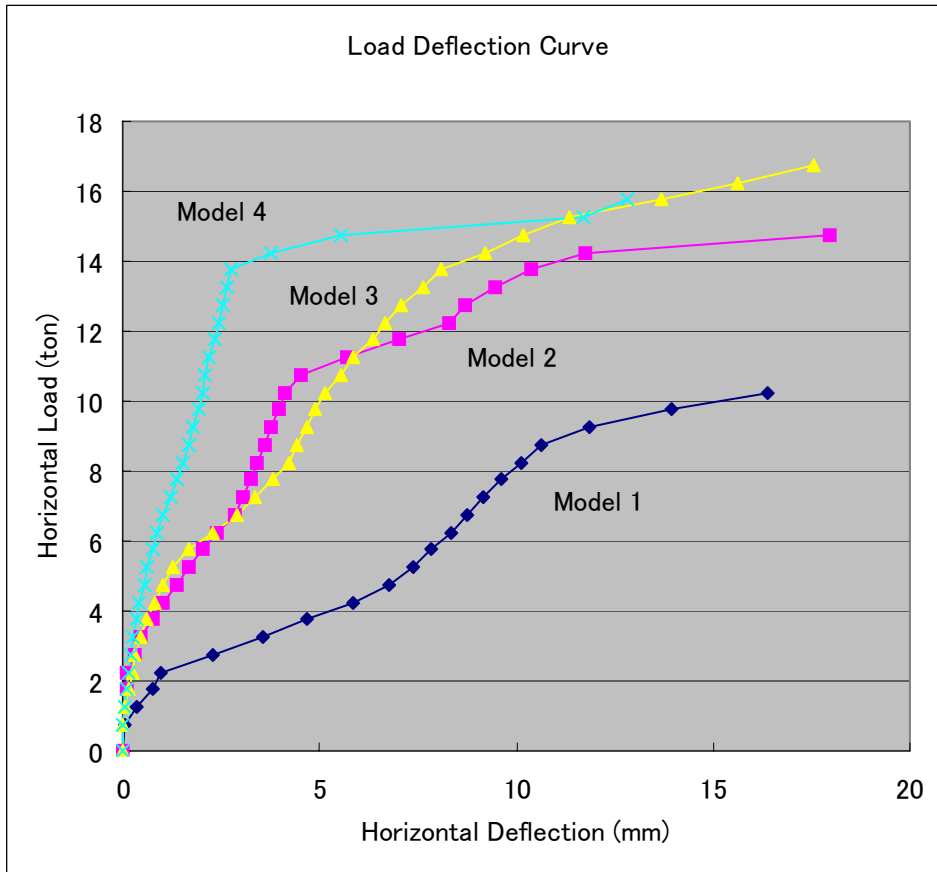
Failure mode of model 1 frame is column collapse mode and plastic hinges are provided at the top of columns. Floor beams are not damaged seriously. Elastic stiffness is 8.25t/cm, and yield strength is 8.75 ton. Maximum strength (max. load) is 10.25ton (photos 6.1~6.4). Deflection at yield strength is 10.6mm, and storey deflection is 1/170 (10.6/1,800) for short column and 1/226 (10.6/2,400) for long column respectively. Deflection at maximum strength is 16.4mm, and storey deflection is 1/110 (16.4/1,800) for short column and 1/207 (16.4/3,400) for long column respectively. Bending failure of columns is occurred at the beginning, and diagonal shear crack of short columns is also observed at mid-span at later stage (photo 6.2).

Figure S7-6.2.5 Load Deflection Curve

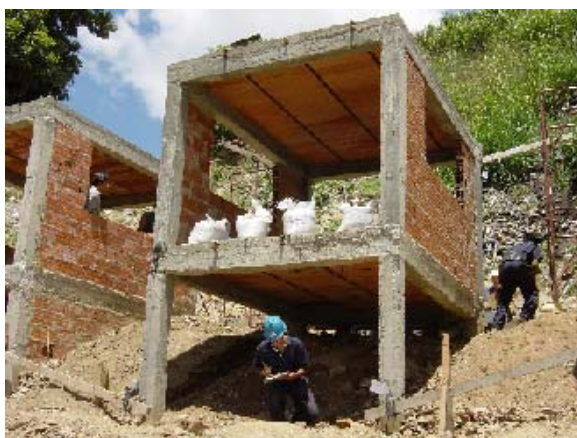
Failure mode of short columns is bending/shear mode at yield strength and shear failure occurs at final stage of test. Failure mode of long columns is bending failure mode, while shear diagonal crack is also observed (photos 6.5~6.10). Yield strength is 10.25 ton, which is 1.17 times of that of model 1. Maximum strength is 14.75 ton, which is 1.44 times of that of model 1. Initial stiffness is increased to 25.0ton/cm, which is 3.0 times of that of model 1. Deflection at yield strength is 4.1mm, and storey deflection is 1/439 (4.1/1,800) for short column and 1/829 (4.1/3,400) for long column respectively. Deflection at maximum strength is 17.6mm, and storey deflection is 1/102 (17.6/1,800) for short column and 1/193 (17.6/3,400) for long column respectively. Deflection at the ground surface (almost same to grade beam) at yield and maximum strength is 2.4mm (lower ground level) and 1.1mm (lower ground level) respectively.

Photo 6.5 Model 2

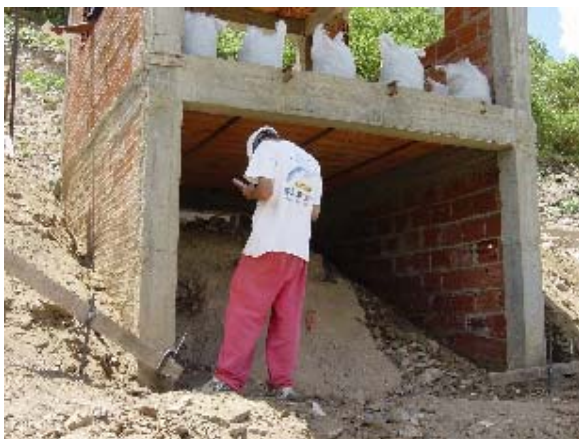
Load deflection curve is similar to that of Model 2. Separation of clay hollow brick walls from columns and beams appears from the beginning of loading and combined effect with frames is not expected. Maximum strength is 16.75 ton, which is 1.13 times only of that of model 2, at the deflection of 17.6mm. It is found that clay brick walls have no contribution to

stiffness and strength compared to those of model 2. Stiffness and strength of clay brick walls is very low for structural use and for structural reinforcement (photo 6.11~6.15). Cost impact is 10 % of the total cost of building.

Photo 6.11 Model 3

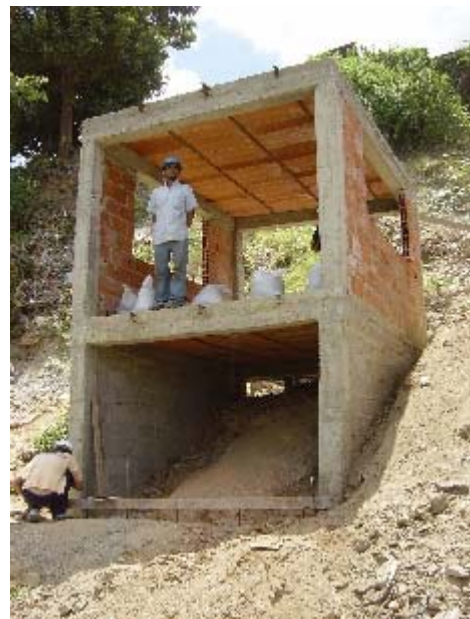
Photo 6.16 Model 4

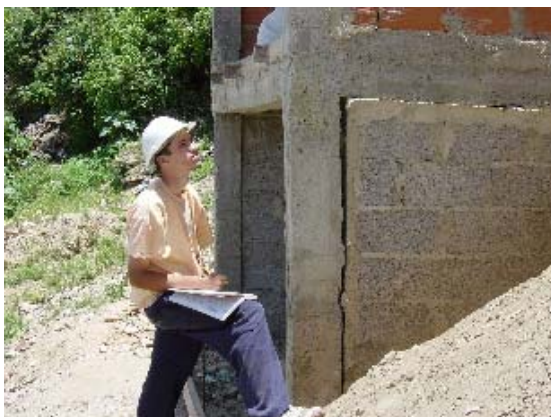
Photo 6.17 Separation of Concrete Block Wall without Re-bars from Frame
