Libro de Datos D

Hoja de Inspección de Pendientes

Tabla DB-2.1 Lista de los Sitios Inspeccionados

SLOPE INSPECTION SHEET

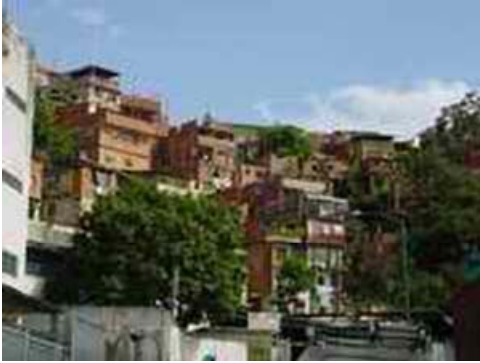
P-1 General View

| Hazard Score | 63 | Comment : There is unstable soil material on the step slope. | |

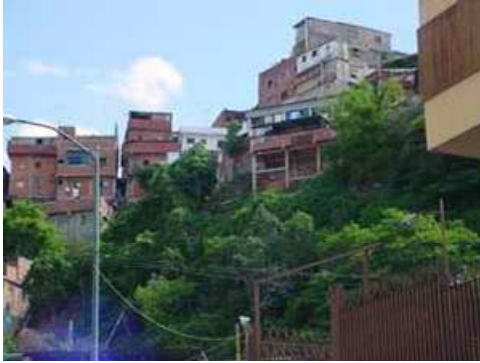
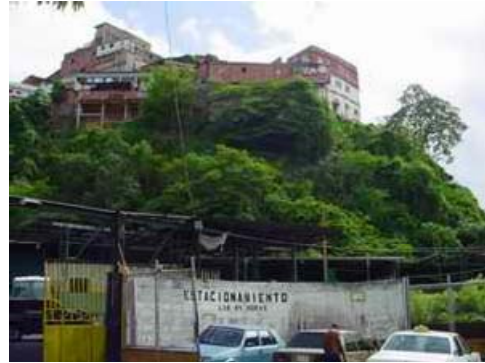
- Vegetation (tree and grass) cover almost all surface of the slope.
- Some traces of collapse are found on the slope.
- The surface of the slope is covered with unstable soil

| Hazard Score | 58 | Comment: There is the possibility that the trace of collapse extends more due to no countermeasure. | |

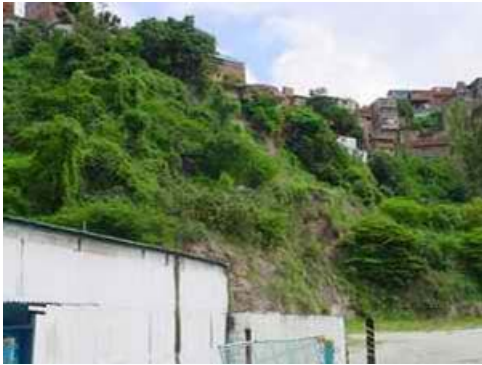
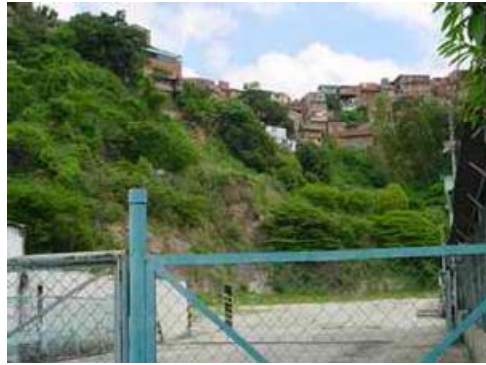
- The slope is consisted of moderate weathered schist
- The berm is made on middle of the slope. There is trace of collapse on the lower part of the slope.
- On the upper part of the slope, trace of collapse can not be found.

| Hazard Score | 39 | Comment: The lower part of the slope shall be stable. There is the possible that some small collapses occure behind the building. | |

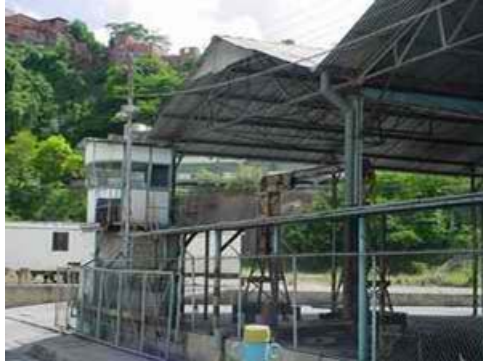
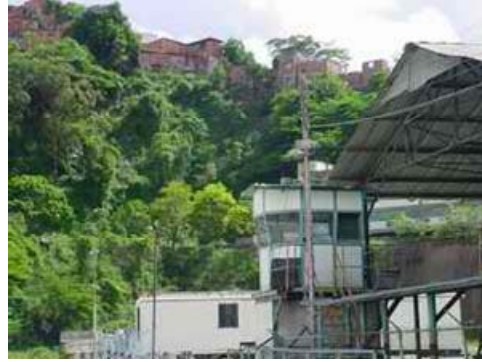
-Any deformations are not found on the surface of the lower part of the slope.

| Hazard Score | 15 | Comment: This cut slope is put shotcrete work and there are no deformations on the surface. | |
