## **6. *HYDRO-MECHANICAL EQUIPMENT***

The outline of the site survey results for hydro-mechanical equipment is as follows. Also, attached are the main features for the hydro-mechanical equipment.

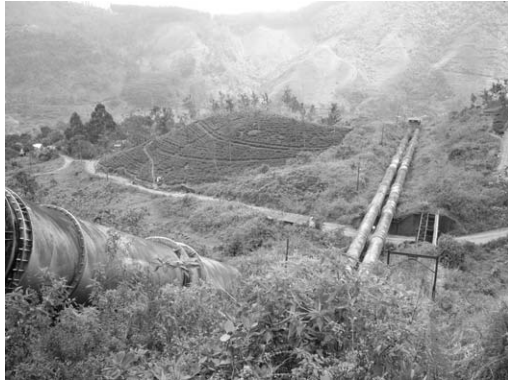
**Picture 6.1 Panorama view of penstock**

The collected data of the plate thickness for the penstock were consistent and reasonable. According to the data, there was no significant loss in metal due to corrosion. Also, there were no significant vibrations in the penstock.

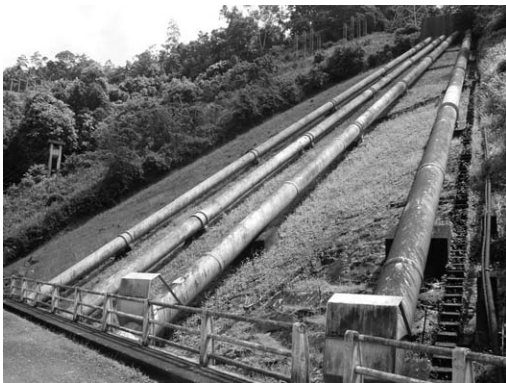
**Picture 6.5** Panorama view penstock

The penstock was constructed in 1950 and has been in operating for more than 54 years. No serious problems have been observed so far.

The collected data of the penstock's plate thickness was consistent and reasonable. According to the data, there was no significant loss of metal to corrosion and there were no significant vibrations discovered in the penstock.

Atomic Energy Authority inspected the penstock's thickness on October 2000 with an ultrasonic thickness gauge. There were no problems found.

Repainting of the inner side of the penstock is difficult due to narrow space and the penstock inclines. Therefore, a blasting robot and painting system will be considered. The purchase of the robot will be discussed by the CEB due to the expensive.

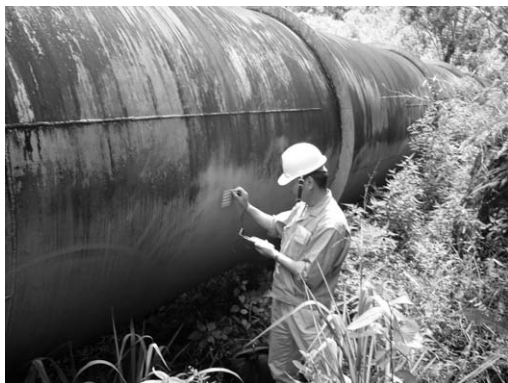
**Picture 6.10 Measuring for plate thickness**

The collected data of the penstock's plate thickness was consistent and reasonable. According to the data, there was no significant loss of metal to corrosion and there was no significant vibration present at penstock.

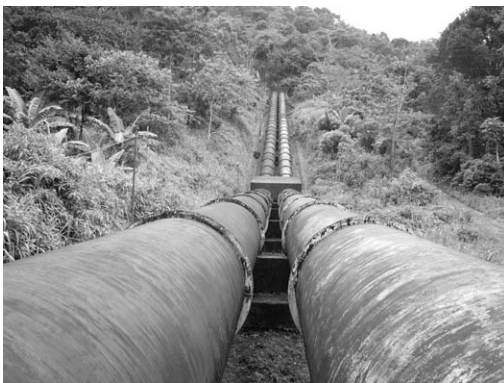
**Picture 6.15 Panorama view**

Penstock was constructed in 1974 and has been in operation for more than 30 years. No serious problems have been observed so far.

The collected data of the penstock's plate thickness were consistent and reasonable. According to the data, there was no significant loss of metal to corrosion and there was no significant vibrations present in the penstock.

Eroded drain gutters should be repaired immediately due to the high risk of concrete saddles sinking.

Deteriorated filler material between the concrete saddles and penstock should be changed due to the influence that is present to the expansion joint leak.

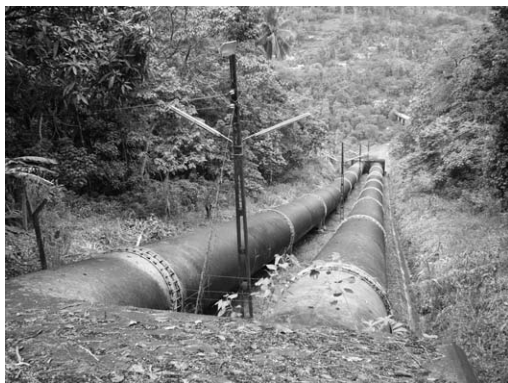
**Picture 6.21 Panorama view of penstock**

The penstock was constructed in 1969 and has been in operating for more than 35 years. No serious problems have been observed so far.

The collected data of the penstock's plate thickness were consistent and reasonable. According to the data, there was no significant loss of metal to corrosion, further, there were no significant vibrations present in the penstock.

Early touch up painting is recommended for extensively corroded areas on the welded joints and bottoms of the penstock.

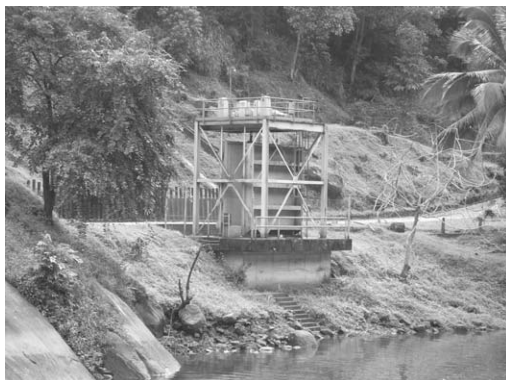
**Picture 6.29 Intake equipment**

The intake equipment is located on the right bank of the pondage. The intake equipment consists of intake service gates, bulkhead gates and intake trashracks. There is no intake trash rake machine.

Air-entraining caused by vortexes decreases turbine efficiency, vortexes pull floating debris into the turbine (or onto the trashrack) creating the turbine operation to be rough.

Though a rotary type trash rake machine is recommended due to its efficiency, the decision will be based upon the ability to conform with the existing structures.

A countermeasure against the vortex at the intake will be also investigated.

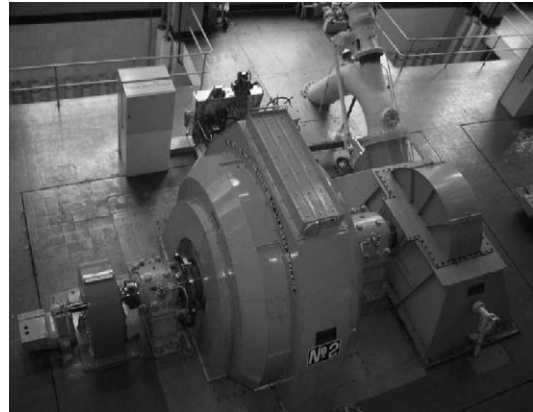
**Picture 7.2 Turbine and Generator of Old Laxapana Stage I (Unit 2)**

Old Laxapana P/S Stage I (Units 1 to 3):  
Picture 7.2 shows an overview of the turbine and generator of the Stage I (Units 1 to 3) at the Old Laxapana hydropower station. The Stage I (Units 1 to 3) turbines are equipped with a very obsolete mechanism for energy dissipation. Instead of a deflector, which is currently the most popular mechanism, a diffuser with a couple of vanes has been installed in the needle rod as shown in Picture 7.3. The diffuser will dissipate energy when the machine is quickly stopped.

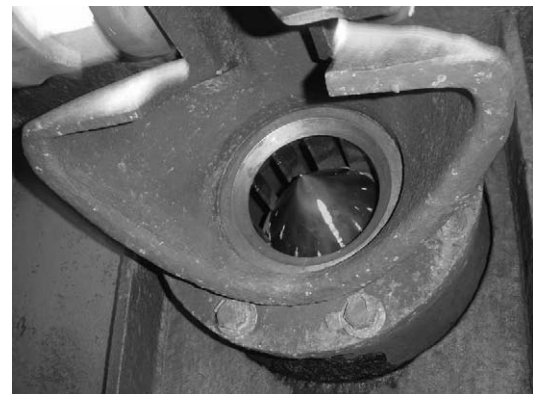
**Picture 7.3 Diffuser and Needle of Old Laxapana Stage I**

On twelve occasions, repairs have been performed on six runners of Stage I, i.e. three operating and three spare runners, over 12 years, according to the record. Repair work on the runners is carried out approximately once a year. However, individual detailed records on six runners are not available.
