JICA STUDY TEAM
 (ELECTRIC POWER DEVELOPMENT CO., LTD)
 INVESTIGATION WORKS FOR THE FOLLOW-UP STUDY ON
 HYDROPOWER STATIONS IN THE KELANI RIVER BASIN FOR
 HYDROPOWER OPTIMIZATION IN SRI LANKA
 GEOLOGICAL MAP
 POLPITIYA INTAKE AREA

This report presents the status of the headrace tunnel and the recommendation of the remedial works based on the inspection performed by the JICA study team.

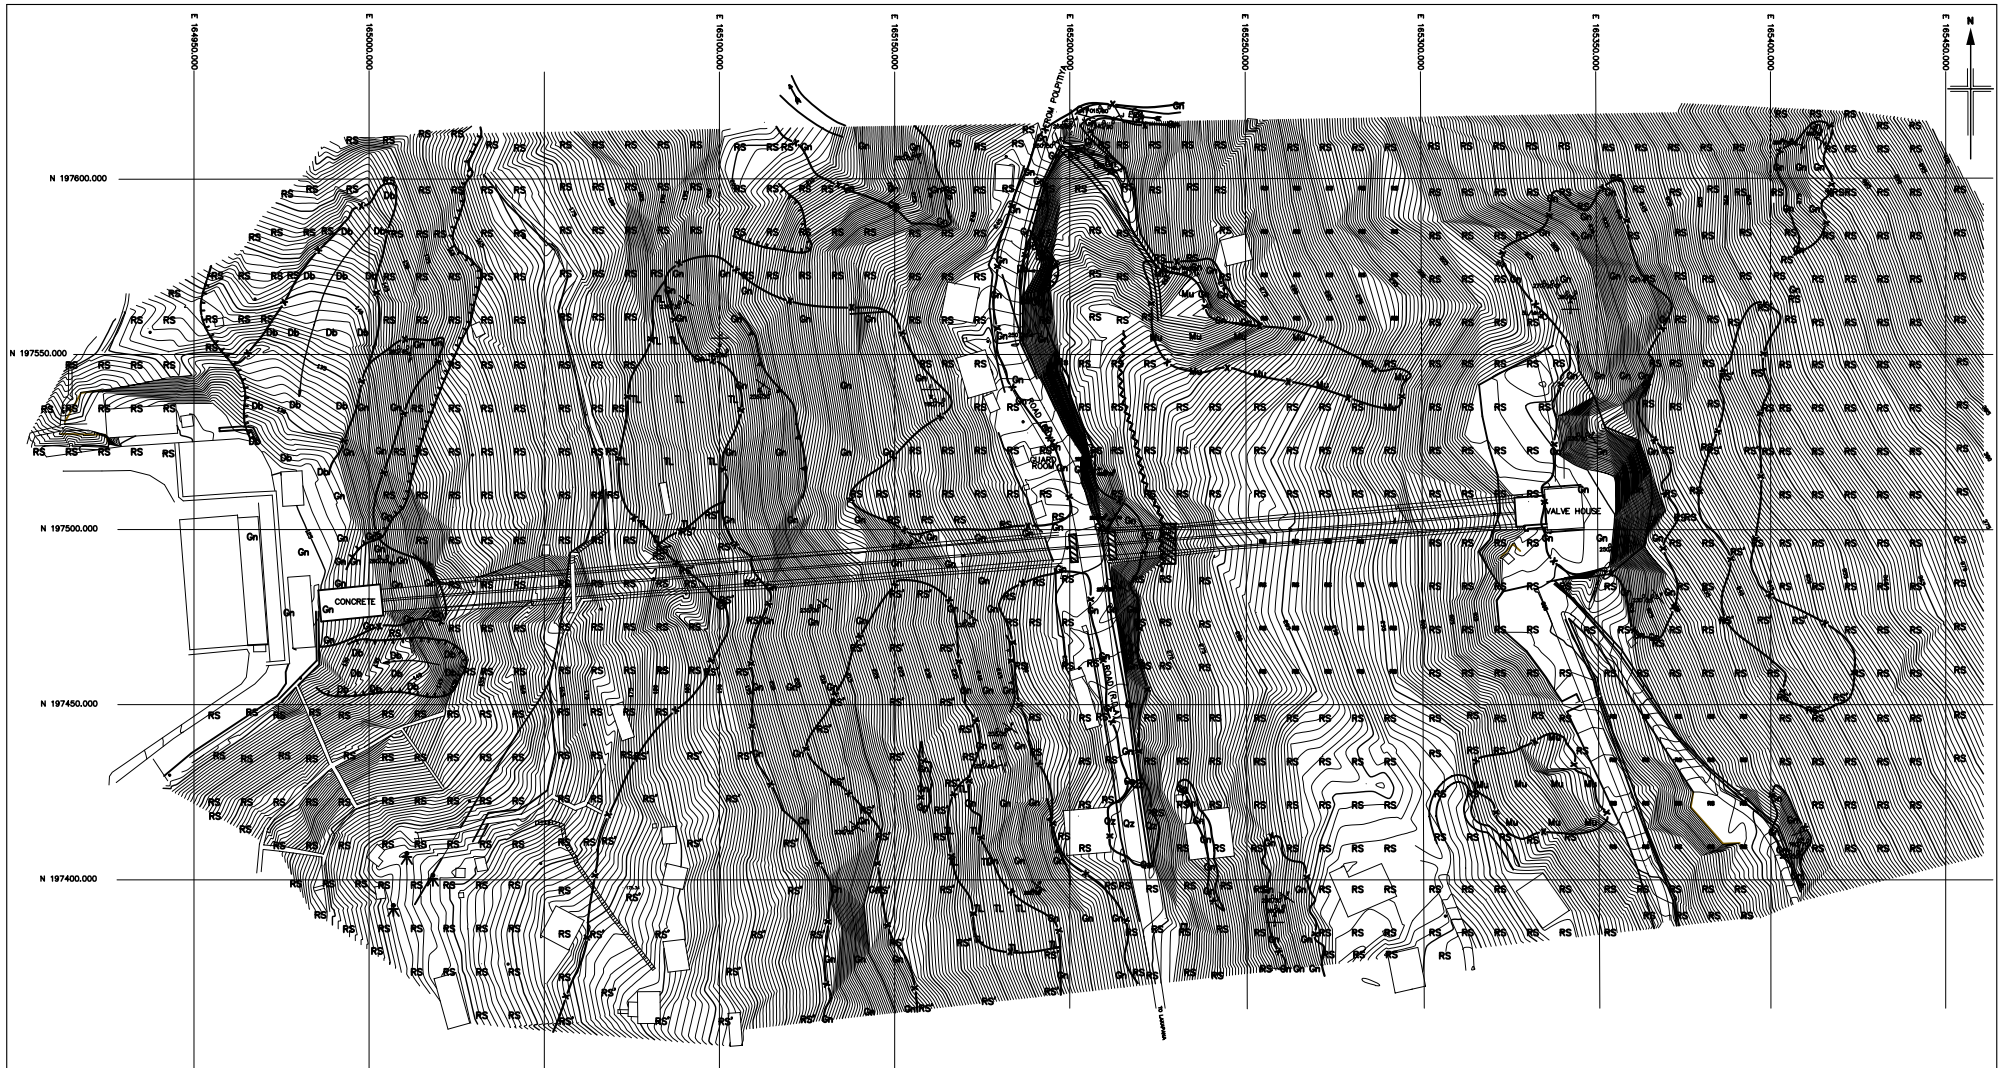
To prevent the landslide areas near the foot of the slope from becoming unstable, concrete drains have been constructed upslope of them. The absence of damage in these concrete drains indicates the areas surrounding landslide are stable. However, existing drains cannot stop the water flowing into the landslide areas. It is better to construct additional drains.

A crack on the slope above the paved road and extending parallel to the road was reported in 1989. This crack is at 10 to 40 m upslope of the shoulder of the road cut, where it is covered with residual soils, and is 70 m long and 30 m wide. An effective way to maintain the stability of the surface layer would be filling the crack with clayey materials and constructing drains to intercept the surface runoff .
