PAST EARTHQUAKES AND TSUNAMI IN INDONESIA

PROJECT ROAD DAMAGE BY TSUNAMI

4.1 MAGNITUDE OF DAMAGE

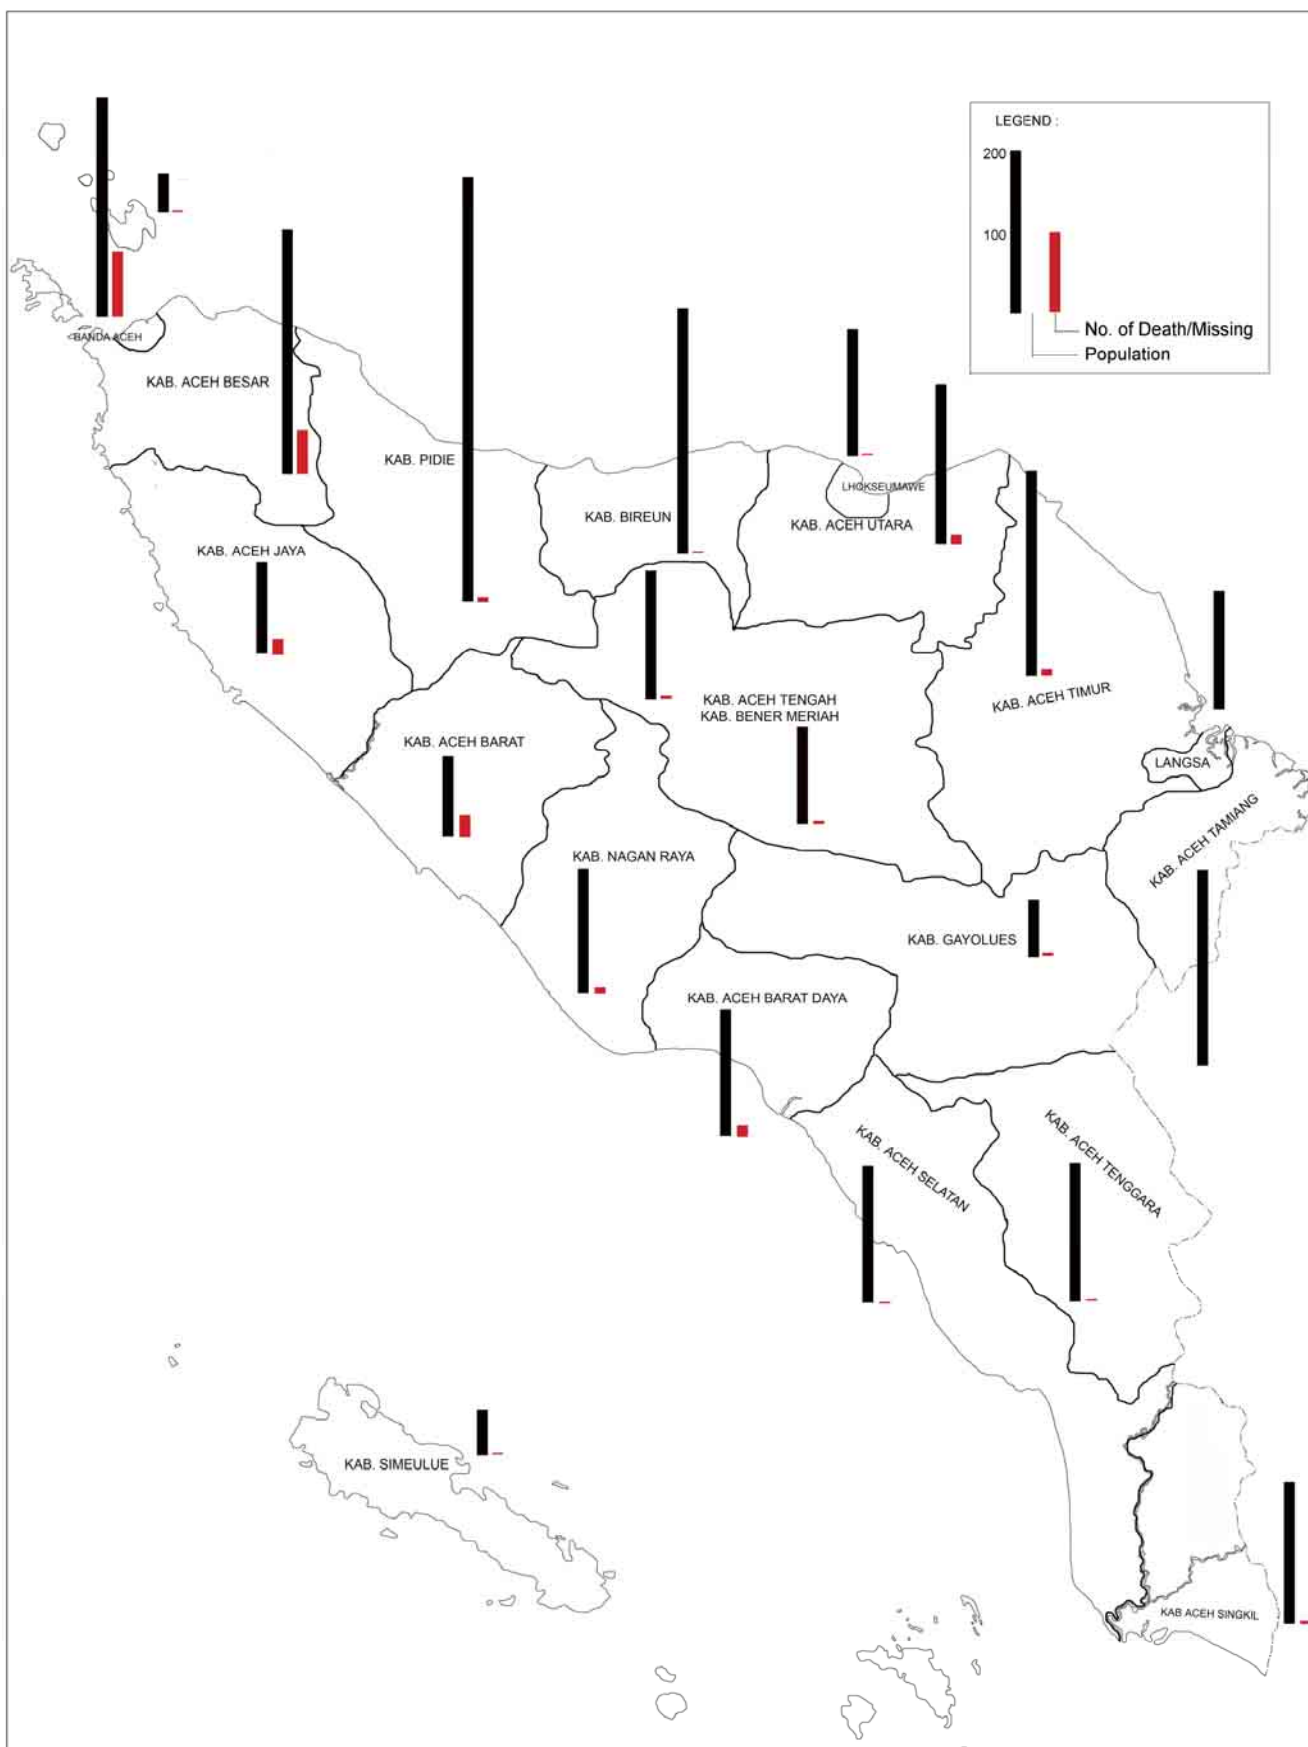
Figure 4.1 - 1 TSUNAMI FATALITIES IN THE PROVINCE OF NANGGROE ACEH DARUSSALAM

Victims of Tsunami reached to about 174,000 Aceh Province people as shown in **Table 4.1-1** and **Figure 4.1-1**. Worst affected is the West Coast Area, particularly Banda Aceh City where 29% of citizens were dead or missing followed by Kab. Aceh Besar and Kab. Aceh Jaya where more than 17% of residents were victimized.

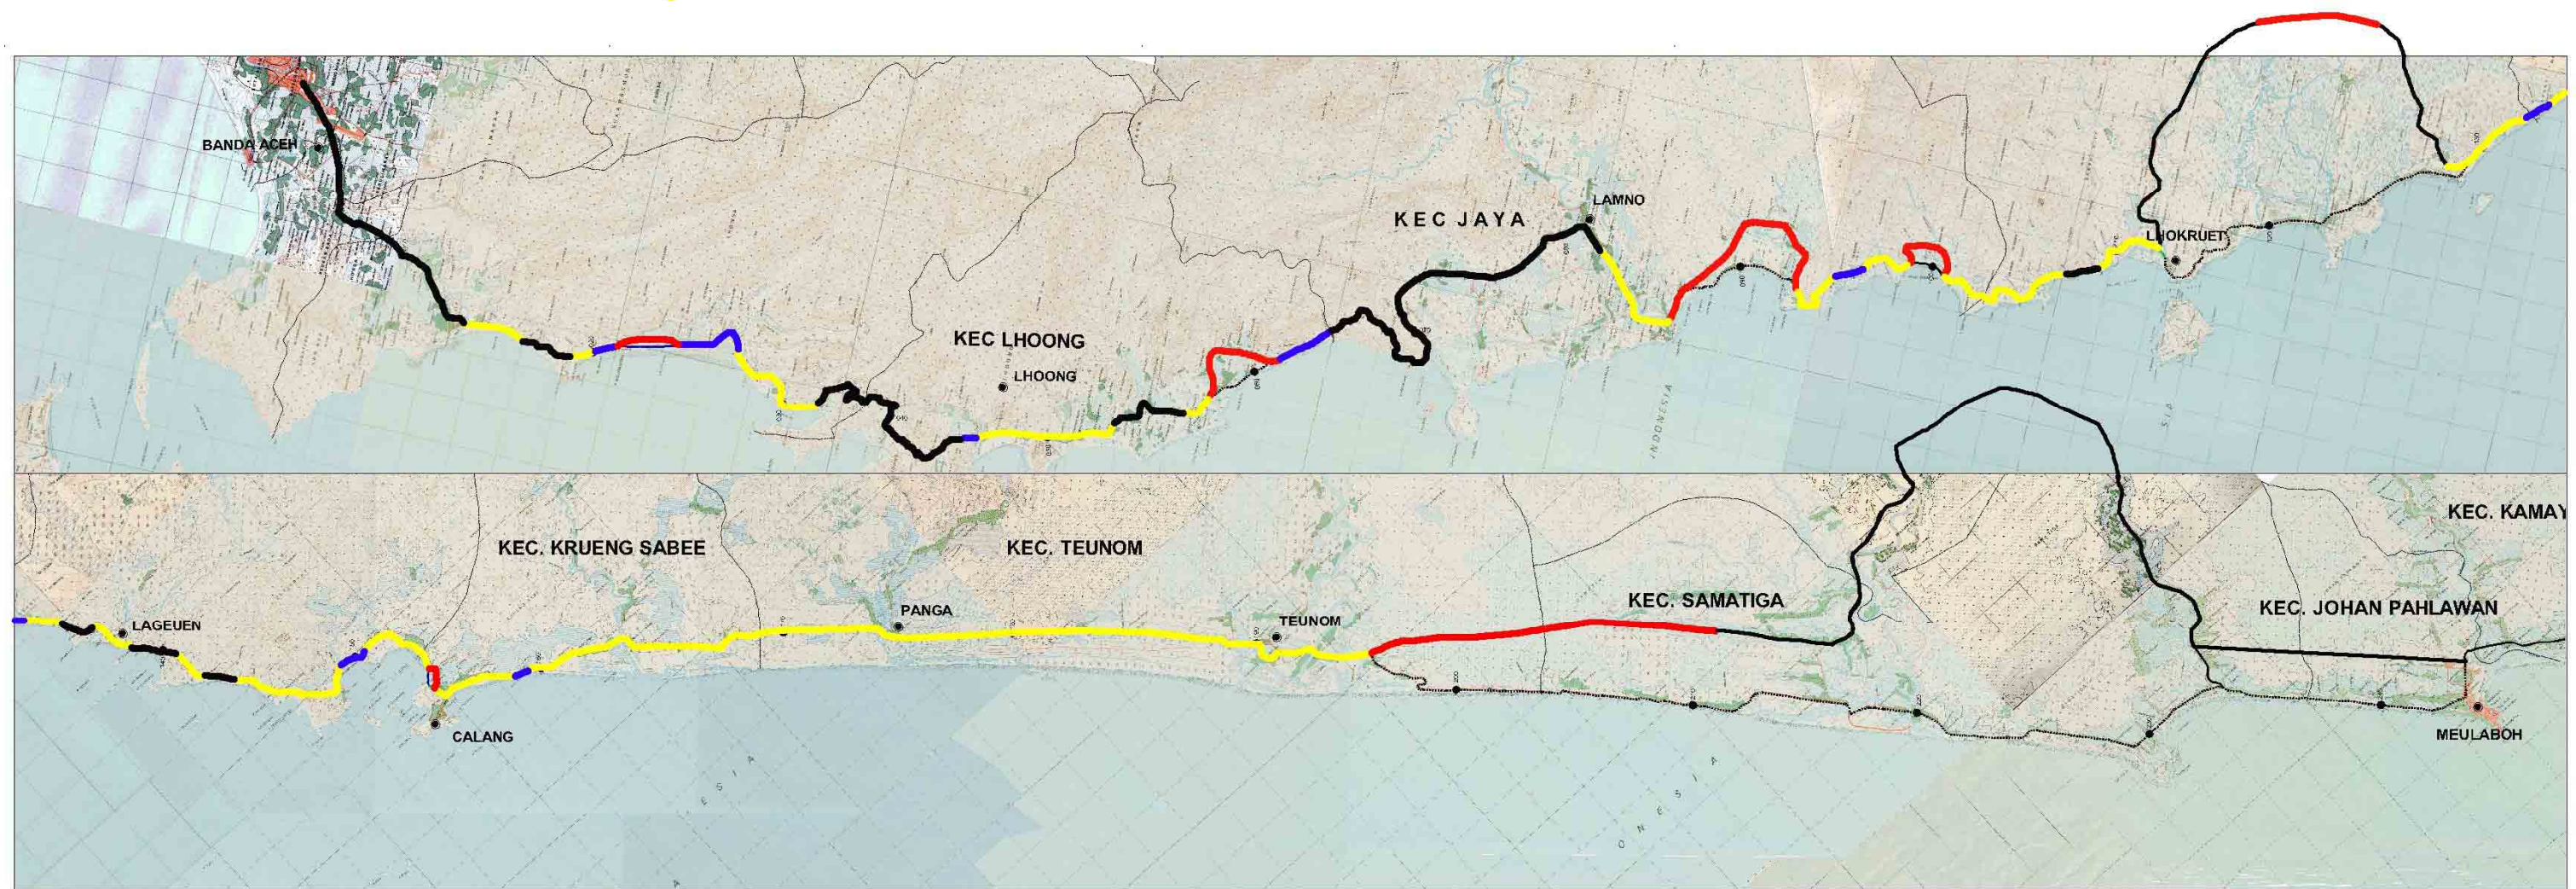
- Re-aligned Section : — 33.5 km
- Restored Section : — 11.9 km
- Repaired Section : — 83.7 km
