**National Pesticide  
Analytical  
Laboratory (NPAL)  
& PAL Satellite  
Pictures**

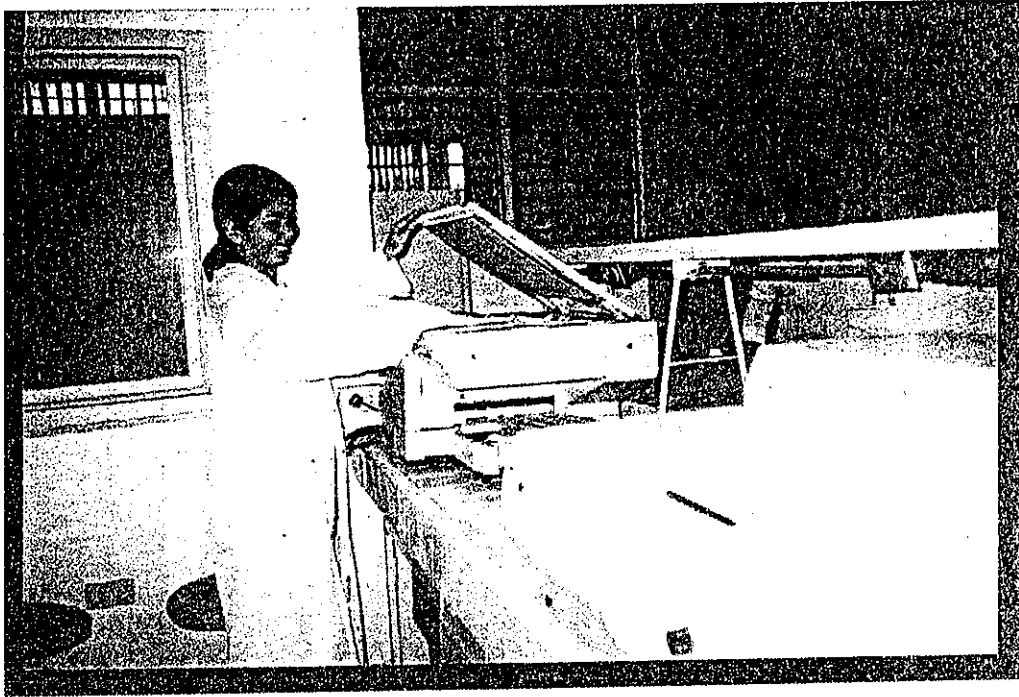
Figure 5 .

Bicol PAL Staff shows that the photo copier is still in good running condition.

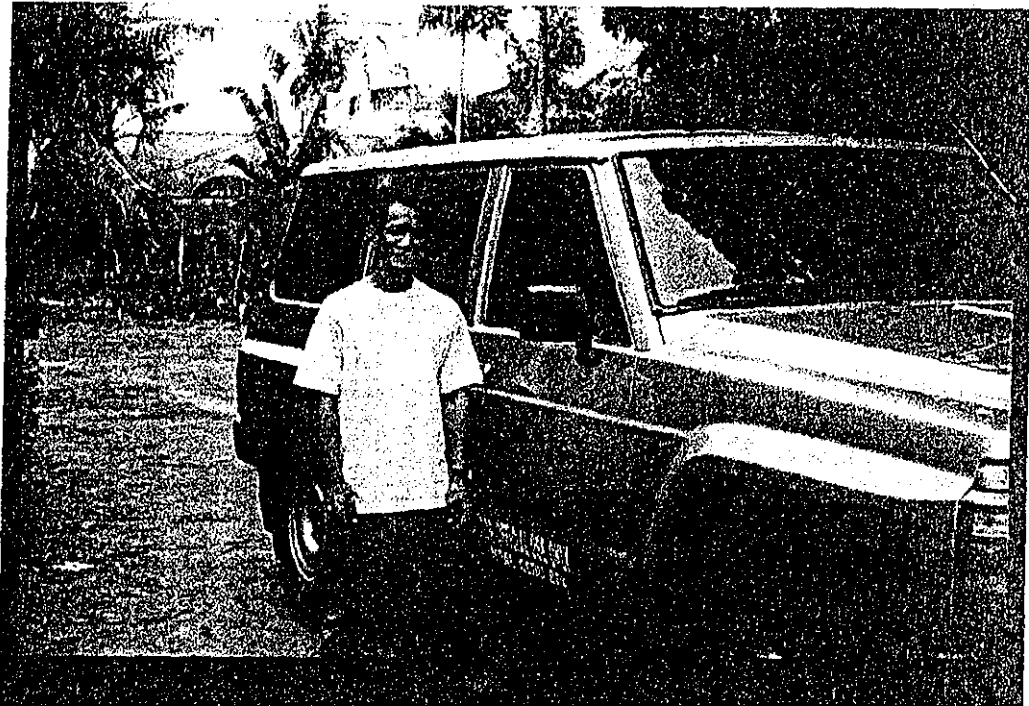
Figure 3 .

Cebu Pal vehicle is in good running condition.

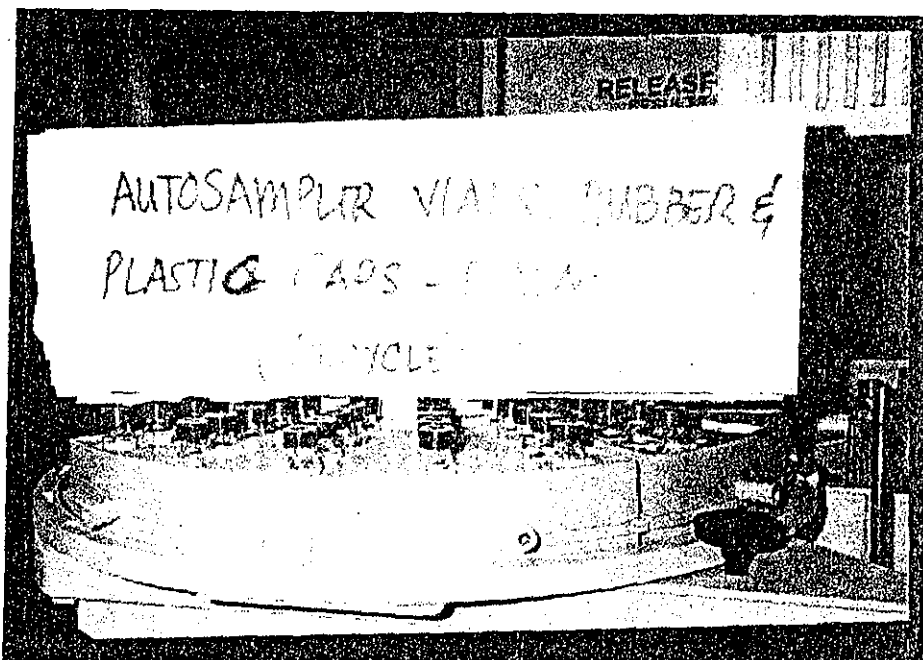
Figure 1 .

Davao PAL AUTOSAMPLER VIALS, RUBBER AND PLASTIC CAPS, Instead of disposing these accessories, we thoroughly clean them and recycle for saving purposes.

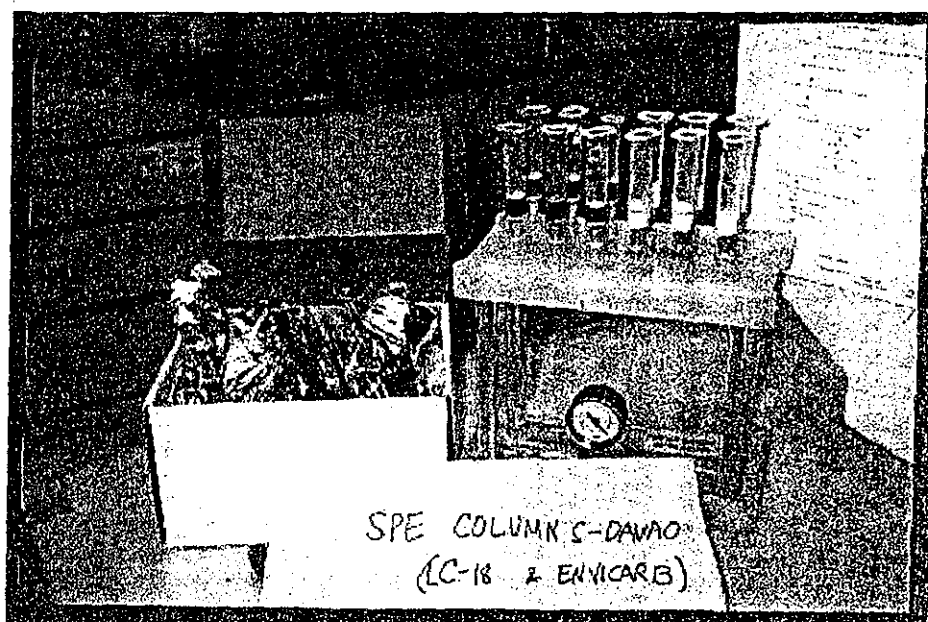
Figure 2 .

Davao Pal SPE COLUMNS (LC-18 and ENVICARB) , Necessary for cleaning up sample extracts in order to protect the capillary columns and detectors of gas chromatographs (GC's) However , these SPE cartridges / columns are very expensive ( Php 13,000/ 30 pcs. ) so instead of using them once , we recycle them 3 times after washing them with solvents.
