**THE STUDY ON IMPROVEMENT OF  
WATER SUPPLY SYSTEM  
IN MANAGUA IN THE REPUBLIC OF  
NICARAGUA**

**FINAL REPORT**

**Supporting Report No.4  
Leakage Survey**

**DECEMBER 2005**

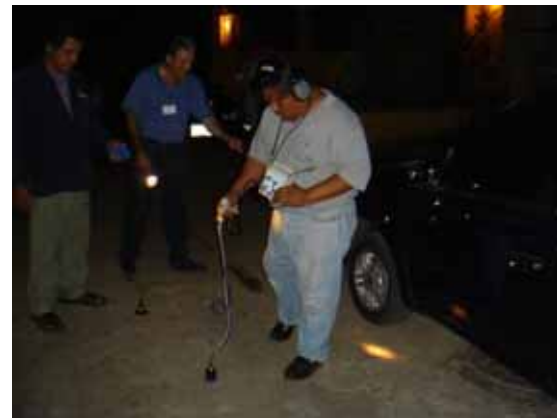
Photo-10 Pinpointing Leaking Point

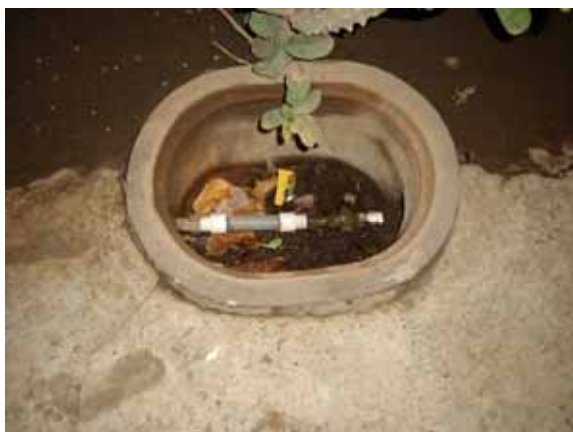
Photo 11 Direct Illegal Connection

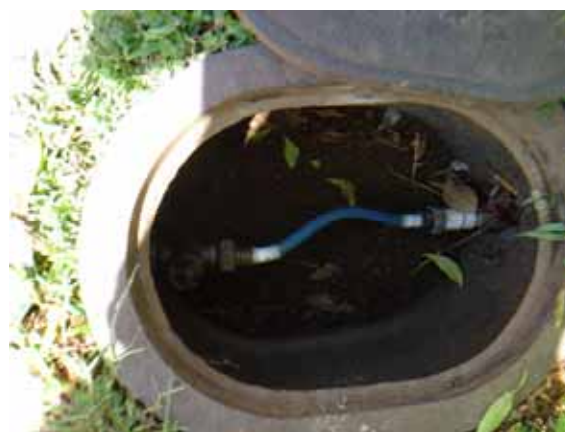
Photo 12 Direct Illegal Connection with hoses
