5.5 RESULTS OF PRESSURE MEASUREMENT

5.6 FLOW PATTERN IN THE STUDY AREA, EVALUATION OF WATER SUPPLY CONDITIONS AND IDENTIFICATION OF PROBLEMS

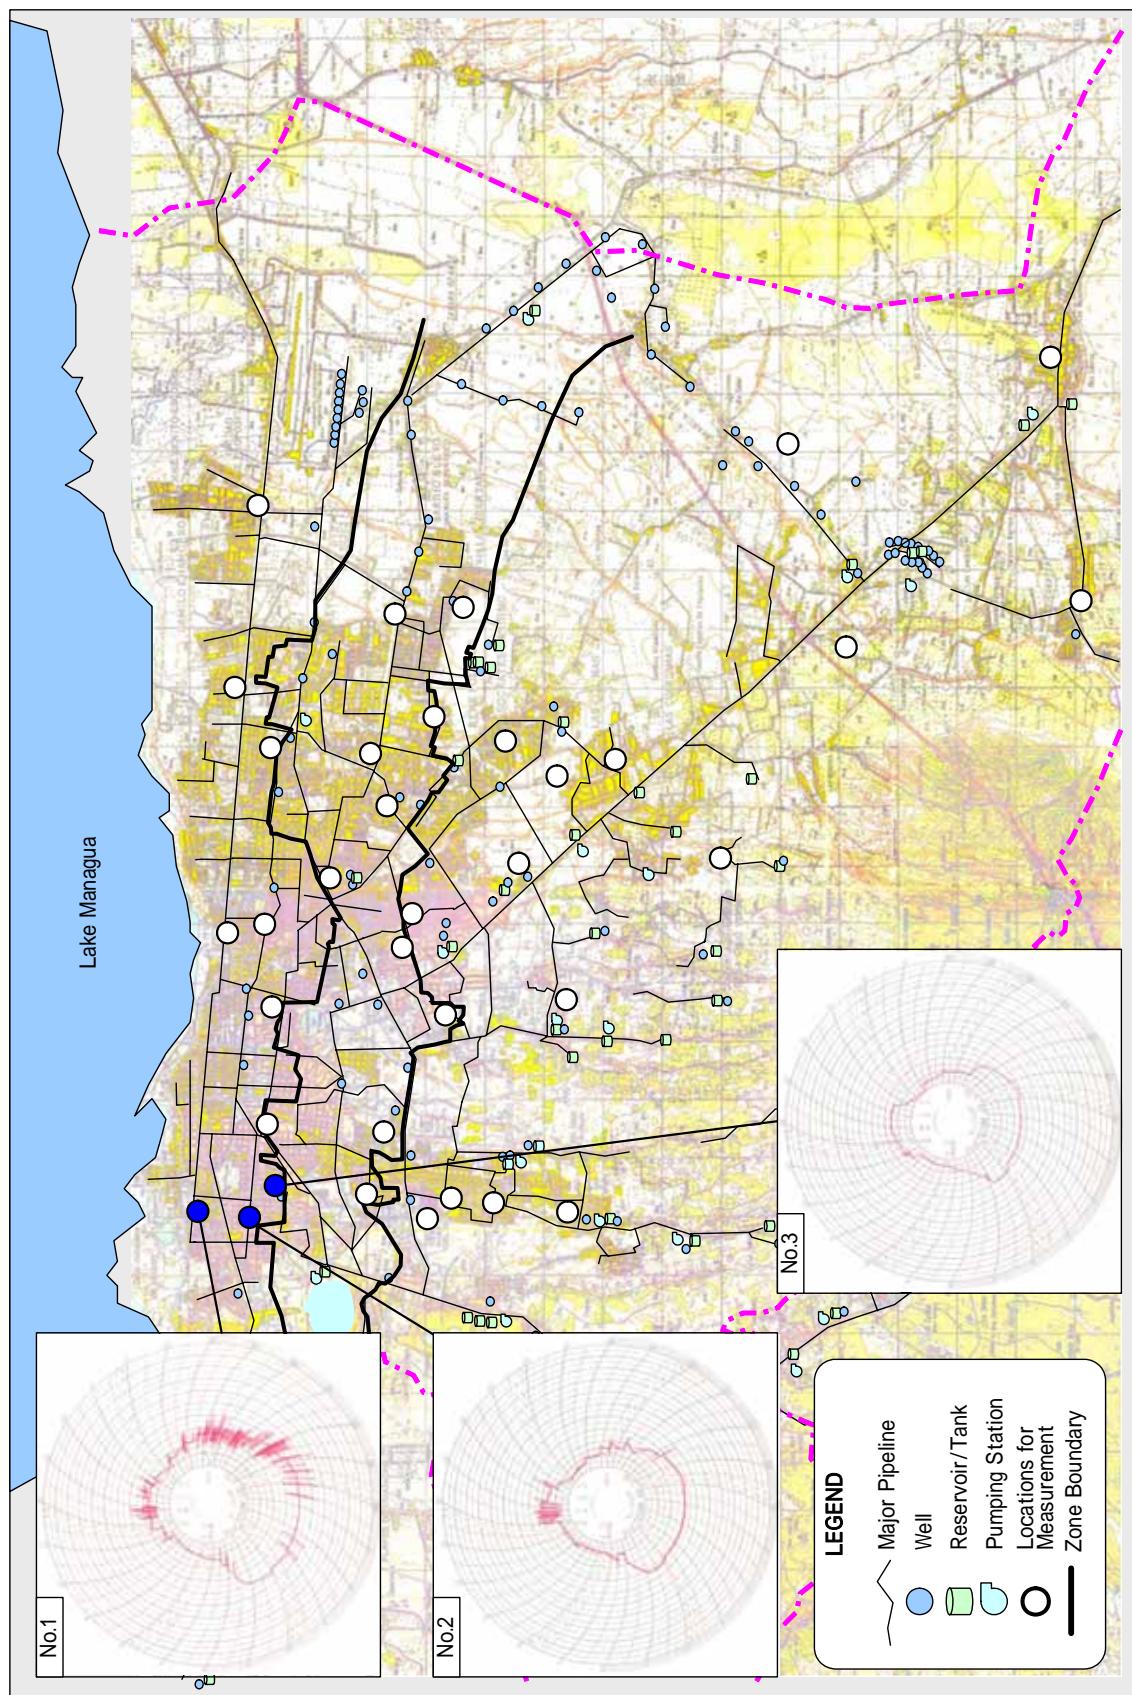
Figure 5.5.2 Results of Pressure Measurement in Zona Baja Oeste

Water pressures were measured at three locations in Zona Baja Oeste and the results are shown in **Figure 5.5.1** and **Figure 5.5.2**.

As shown in **Figure 5.5.1** Zona Baja Oeste has relatively enough water pressure except in the morning and in the evening. In general it is an ideal to maintain water pressure of about 0.10 – 0.15 MPa at tap.

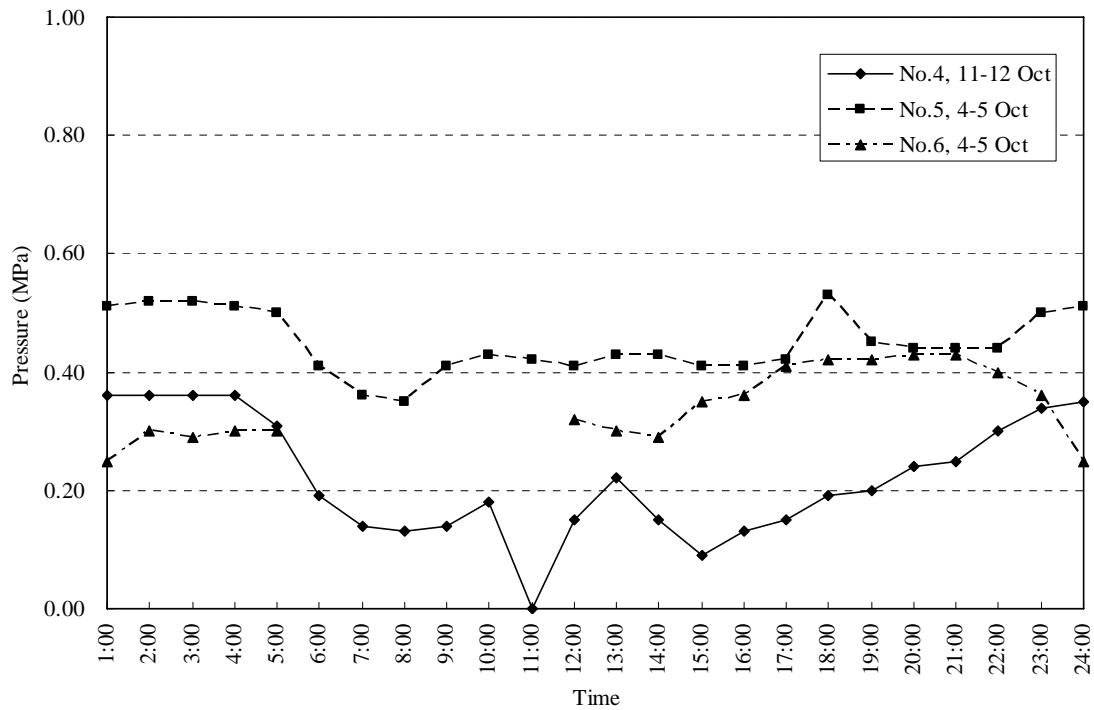
Figure 5.5.3 Water Pressure in Zona Baja Centro

As shown in **Figure 5.5.3** Zona Baja Centro has relatively enough water pressure throughout a day.

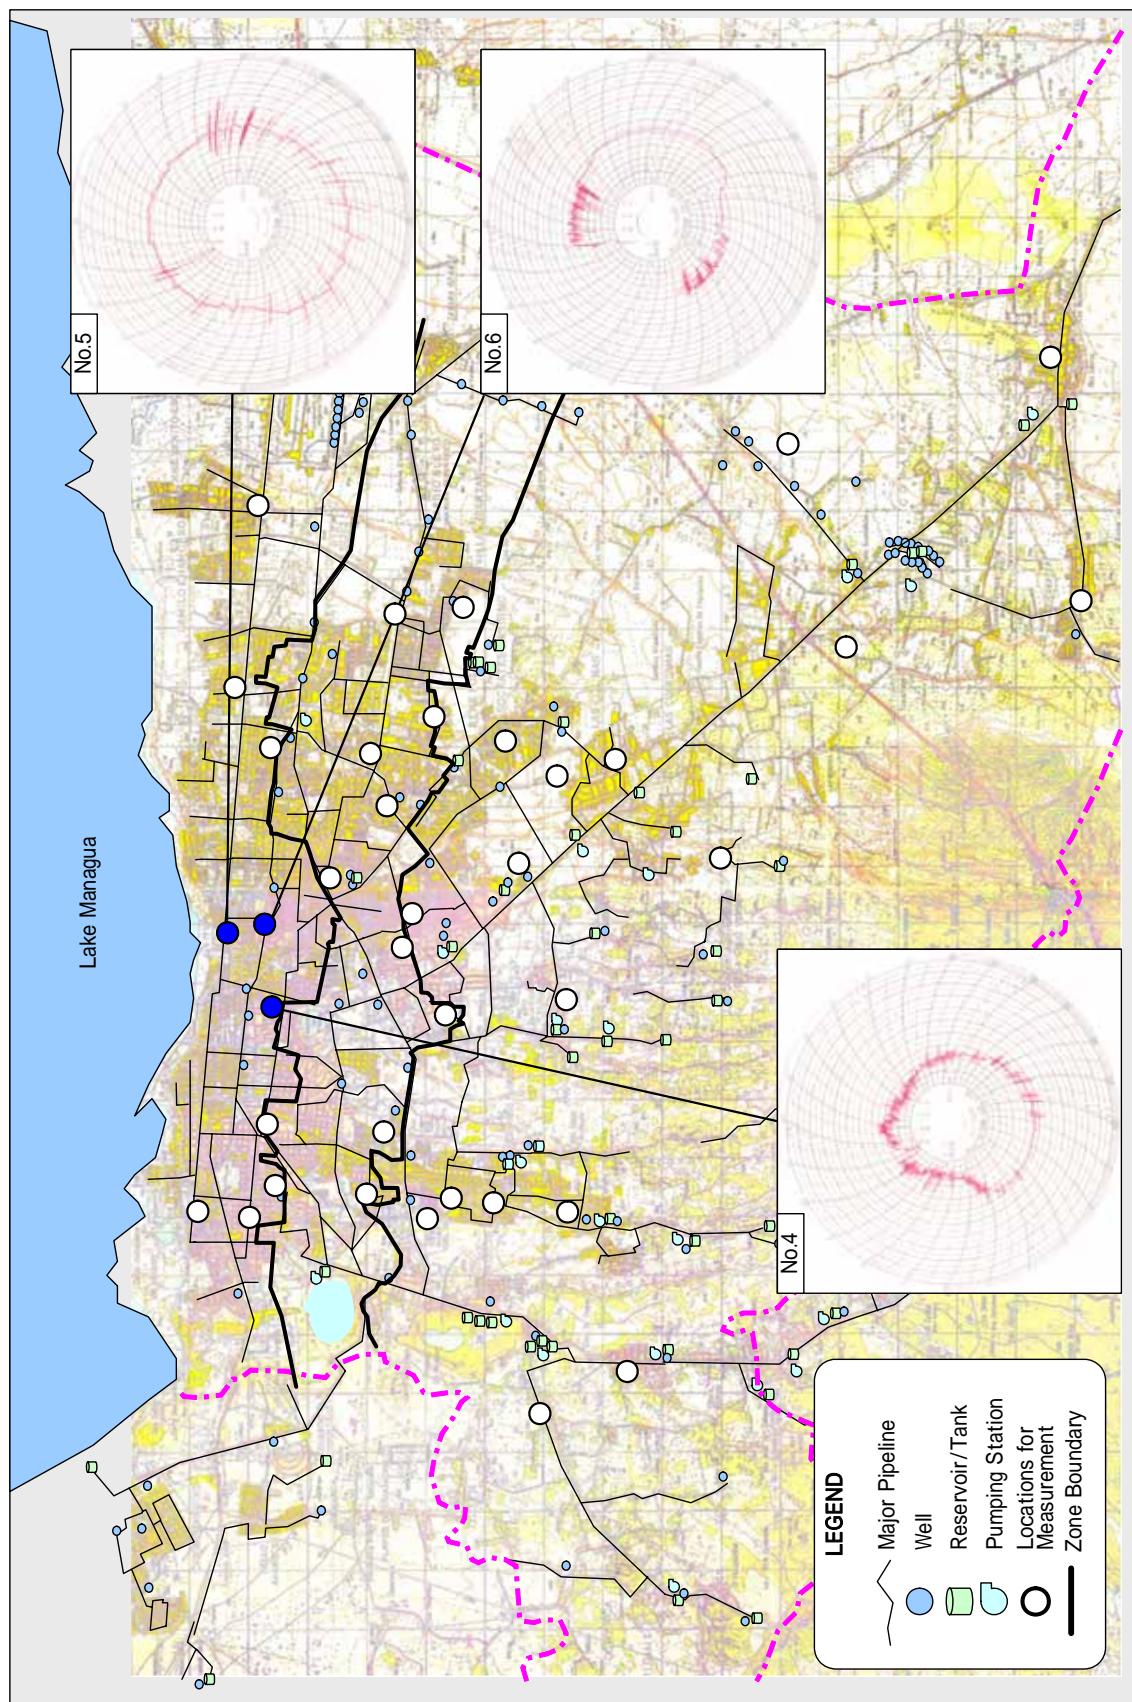
Figure 5.5.4 Results of Pressure Measurement in Zona Baja Centro

Water pressures were measured at three locations in Zona Baja Centro and the results are shown in **Figure 5.5.3** and **Figure 5.5.4**.

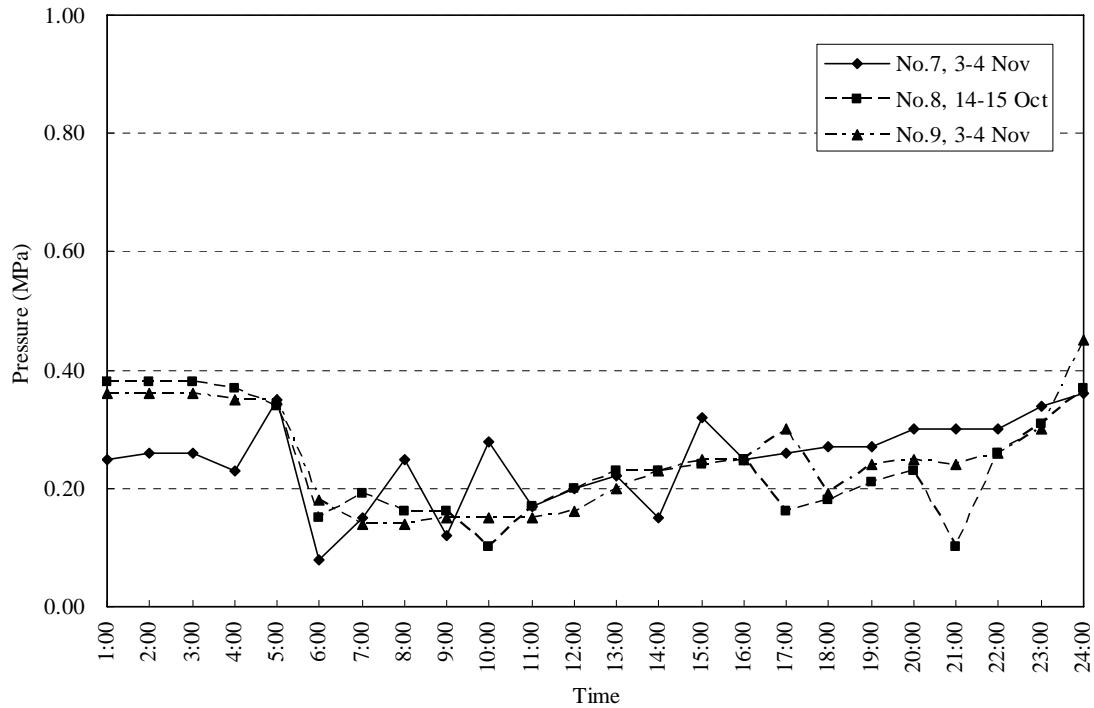
Figure 5.5.5 Water Pressure in Zona Baja Este

As shown in **Figure 5.5.5** Zona Baja Este has relatively enough water pressure throughout a day.

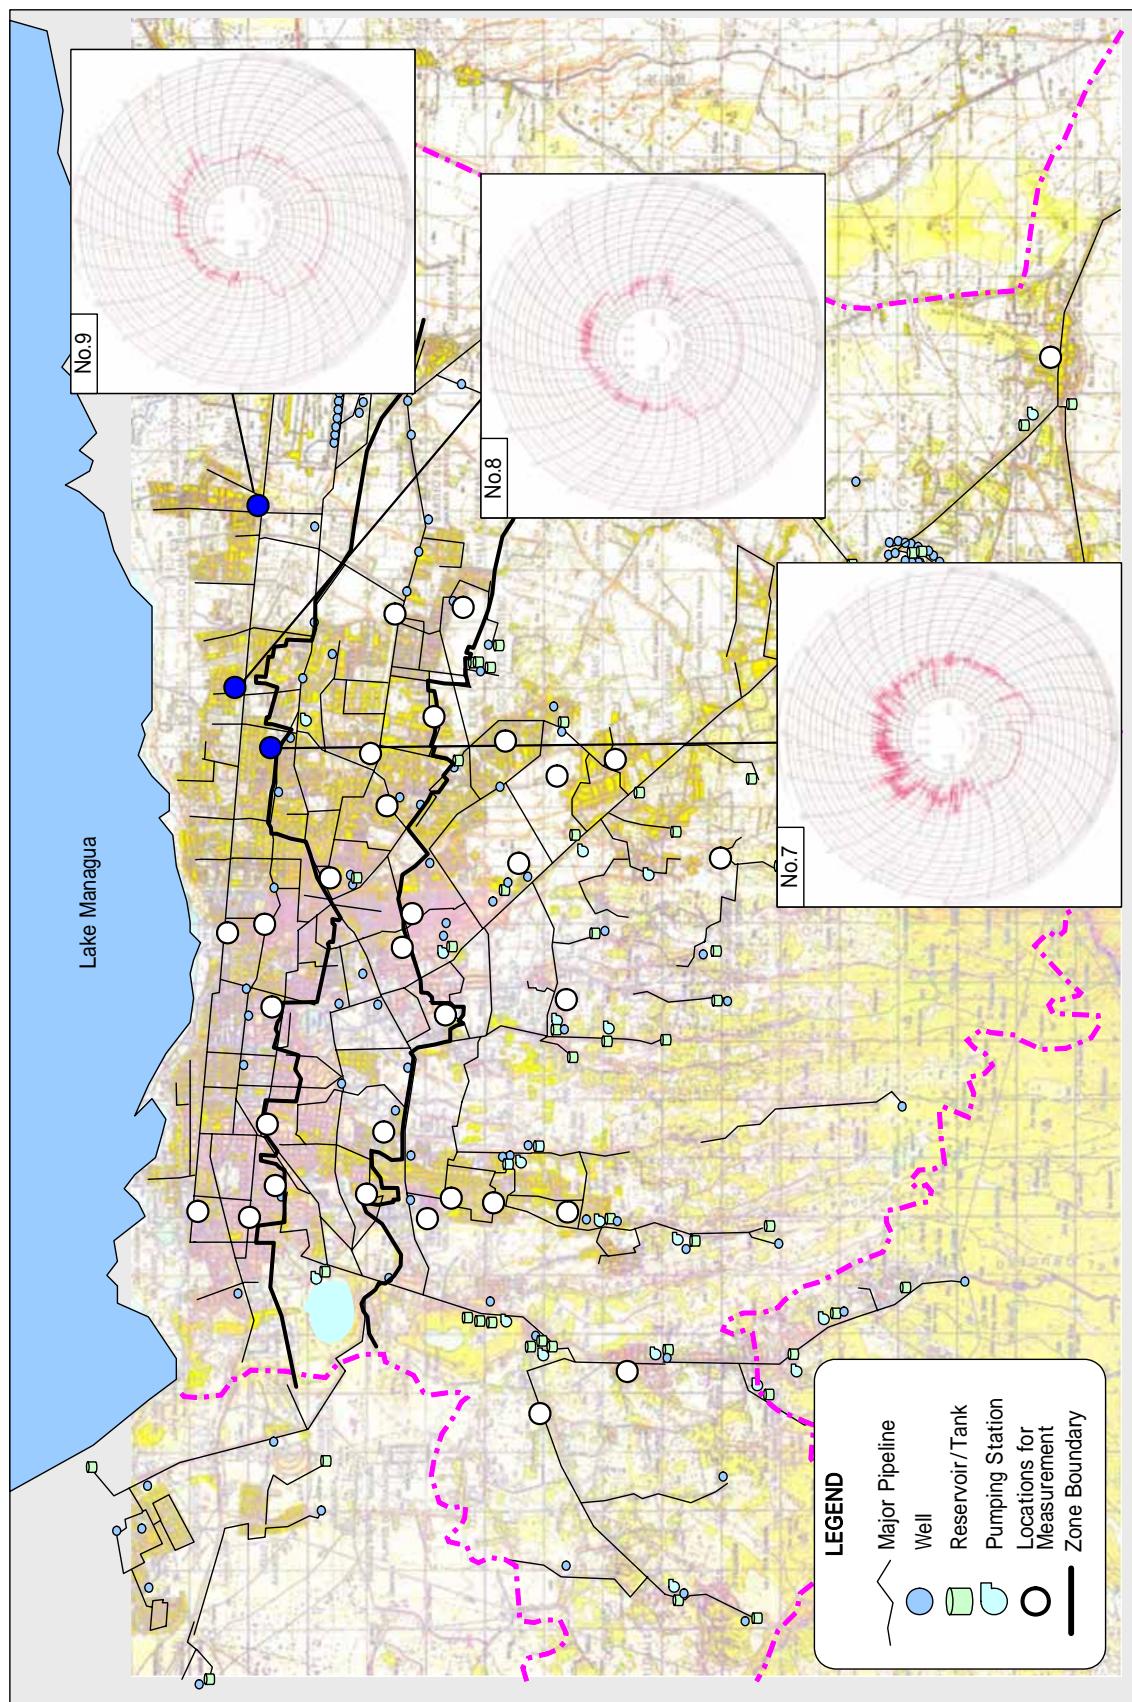
Figure 5.5.6 Results of Pressure Measurement in Zona Baja Este

Water pressures were measured at three locations in Zona Baja Este and the results are shown in **Figure 5.5.5** and **Figure 5.5.6**.

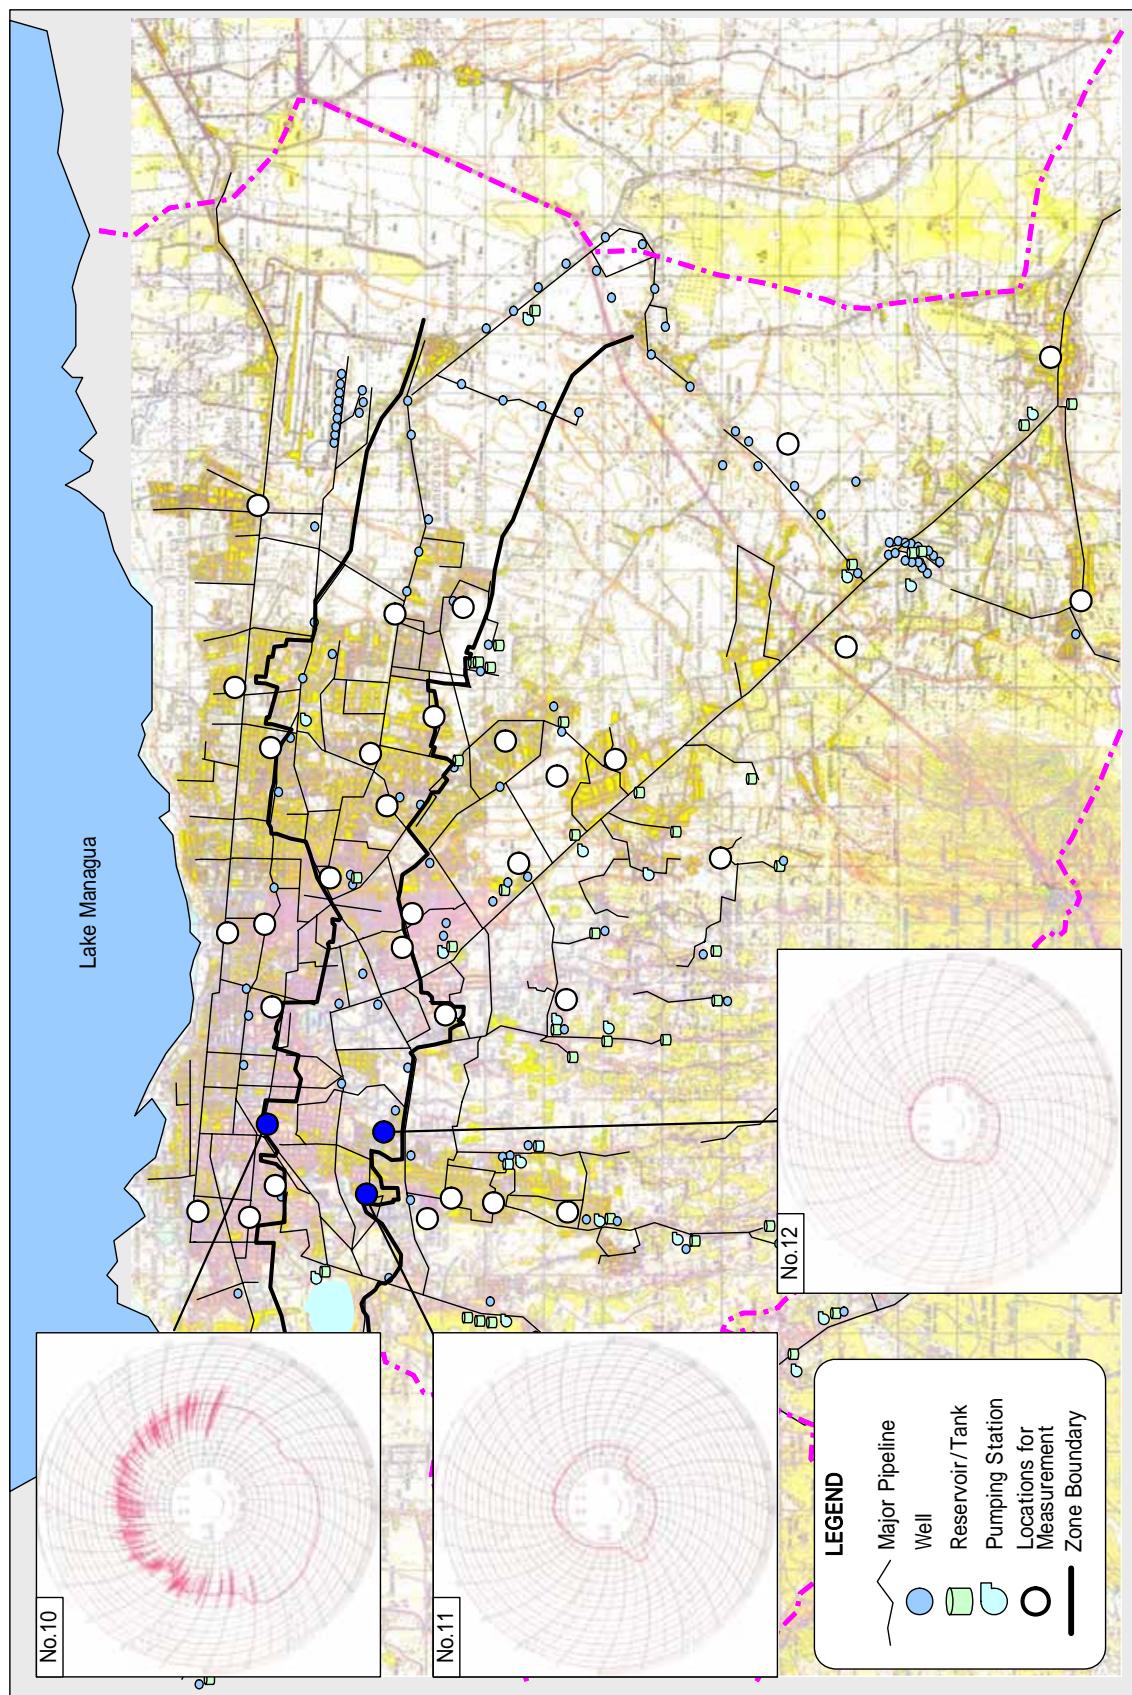
Figure 5.5.8 Results of Pressure Measurement in Zona Alta Oeste

As shown in **Figure 5.5.7** lower area of Zona Alta Oeste (Location No.10) has enough water pressure throughout a day. On the other hand higher area of Zona Alta Oeste (Locations No.11 and No.12) has not enough water pressure. Especially Location No.12 has no water during daytime and there is not enough water pressure even night time.

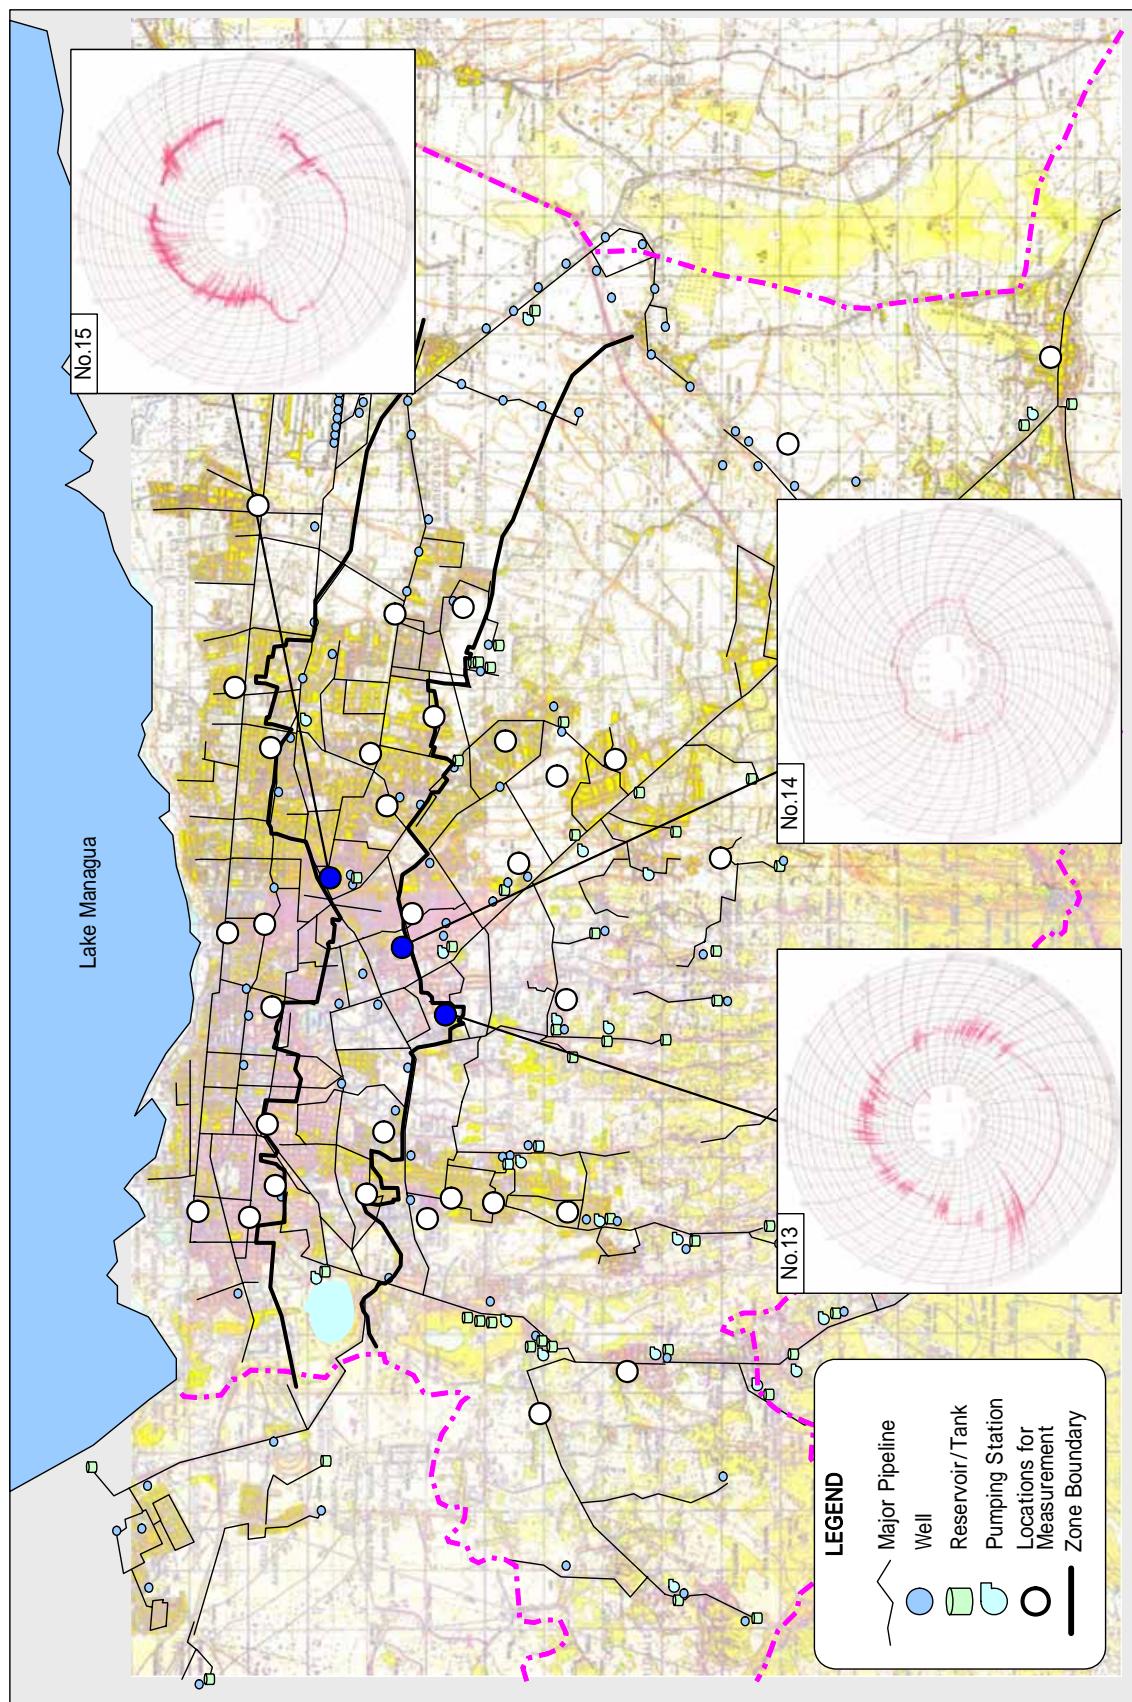
Figure 5.5.10 Results of Pressure Measurement in Zona Alta Centro

Water pressures were measured at three locations in Zona Alta Centro and the results are shown in **Figure 5.5.9** and **Figure 5.5.10**.

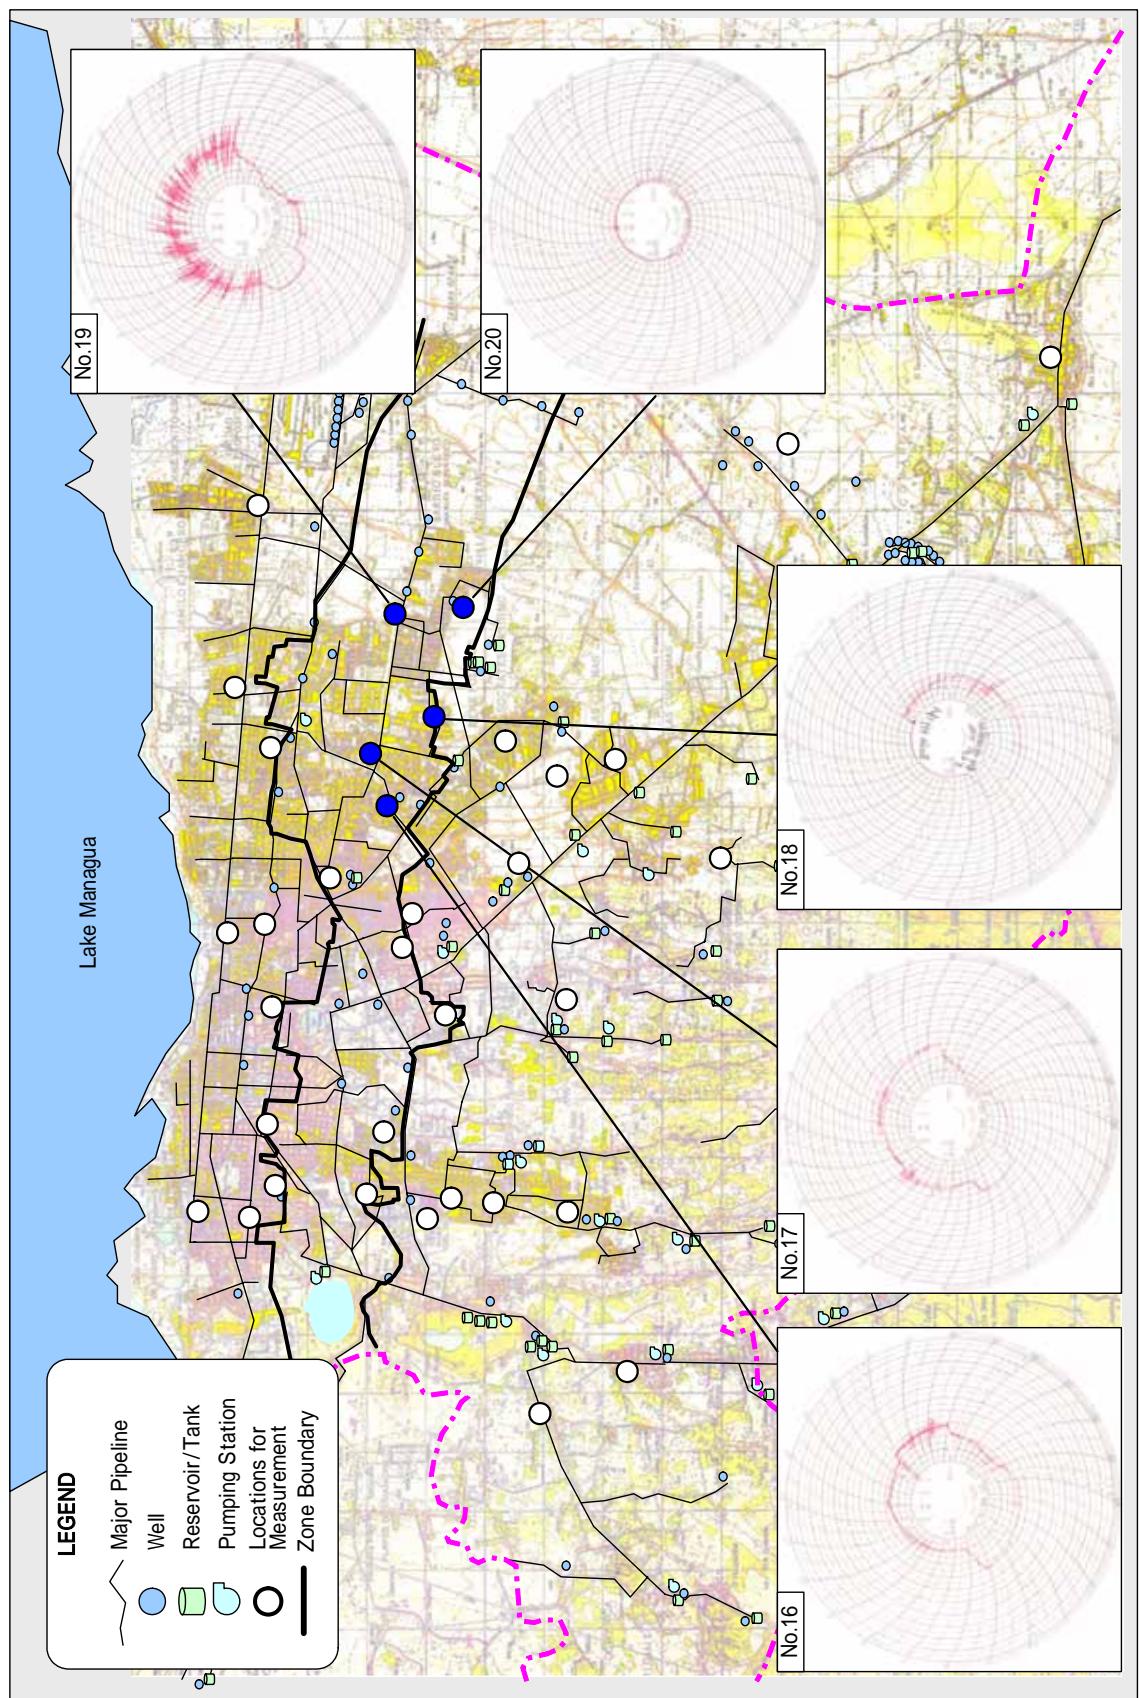
Figure 5.5.12 Results of Pressure Measurement in Zona Alta Este

As shown in **Figure 5.5.11** Zona Alta Este except Location No.20 has relatively enough water pressure throughout a day. Las Americas Tank and Sabana Grande Well Field supply water to this area.

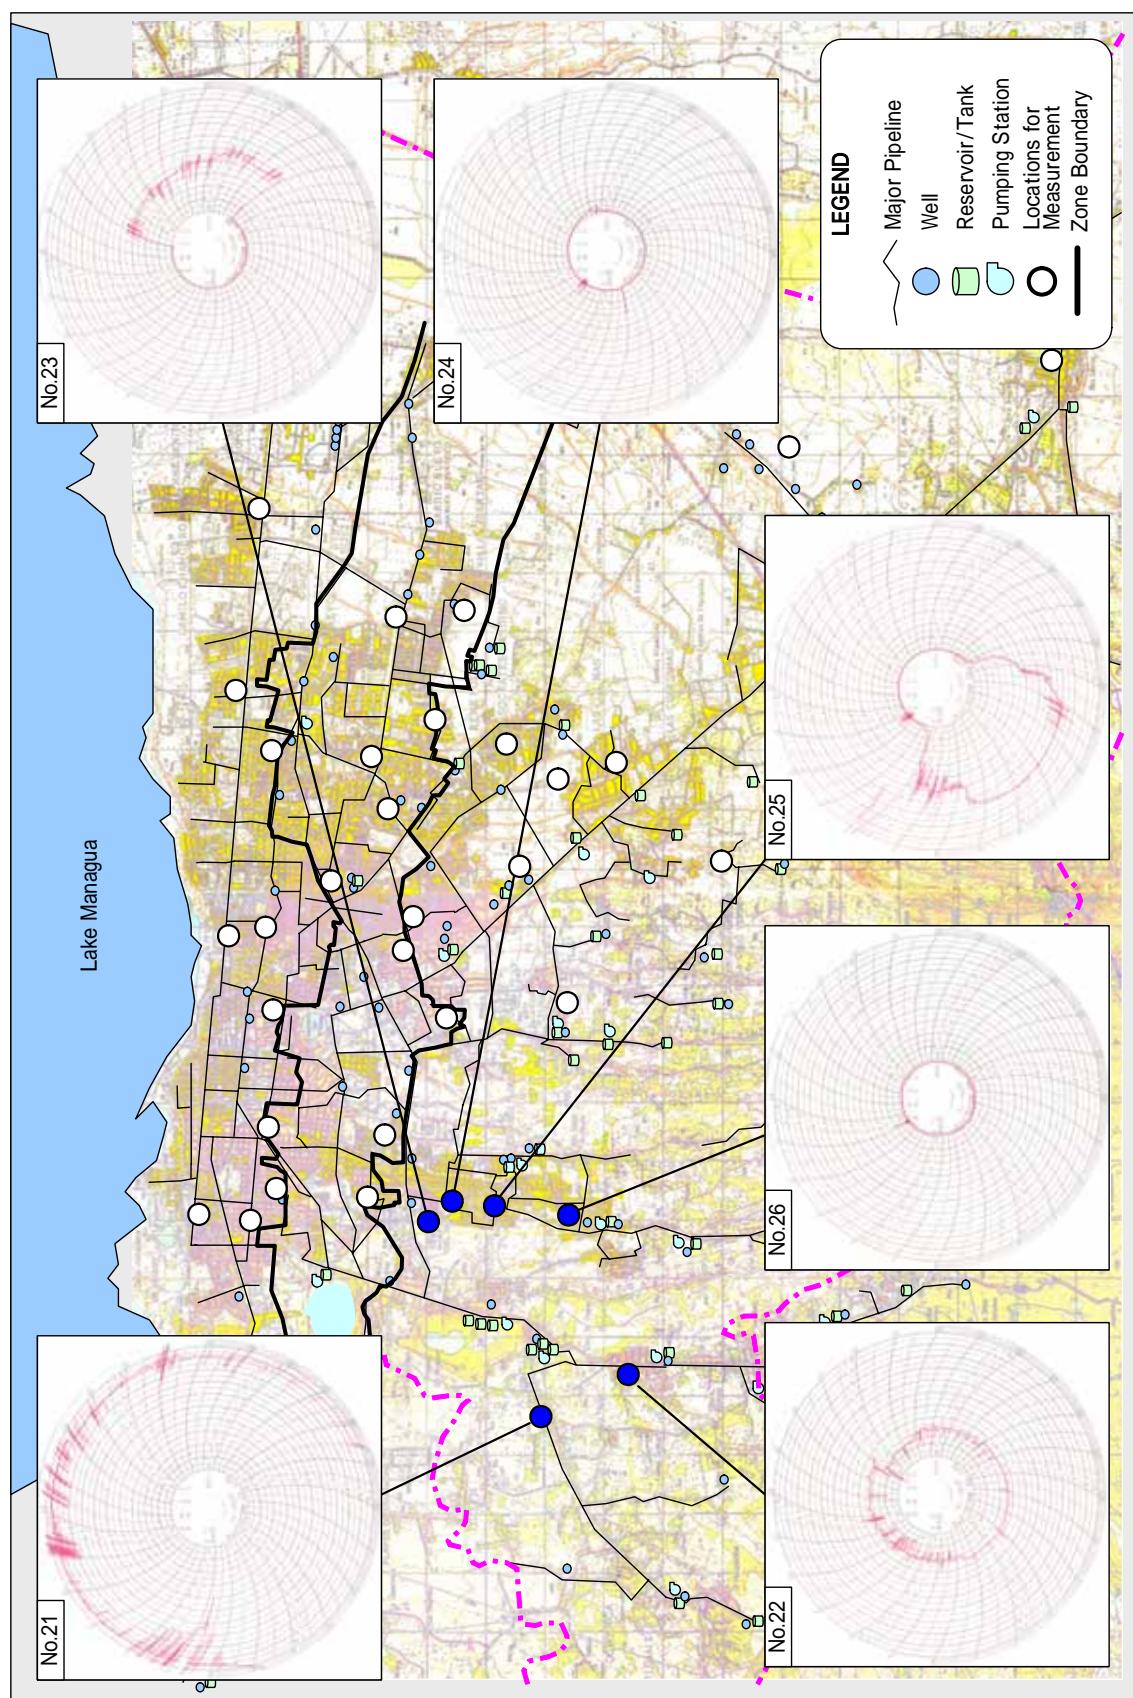
Figure 5.5.14 Results of Pressure Measurement in Zona Alta Superior Oeste

At Location No.21 along Carretera Vieja Leon located at the west of Km9.2 Carretera Sur Tank, extremely high water pressure of 1 MPa and more was observed. The height difference from well seems to cause. In general for water supply facilities it is undesirable that the water pressure exceeds 0.75 MPa. Location No.22 has relatively enough water pressure throughout a day.

As shown in **Figure 5.5.13** other three locations except No.23, Locations No.24 – 26, have been faced to the problem of bad water supply condition. Especially Locations No.24 and No.26 have no water all day long continuously. As for this area, water is supply from San Judas Tank. As described in previous section, “5.4 Results of Flow Measurement”, enough water which was planned by Managua I Project was not transmitted from Santo Domingo Tank to San Judas Tank. Therefore, there is not sufficient water to supply this area.

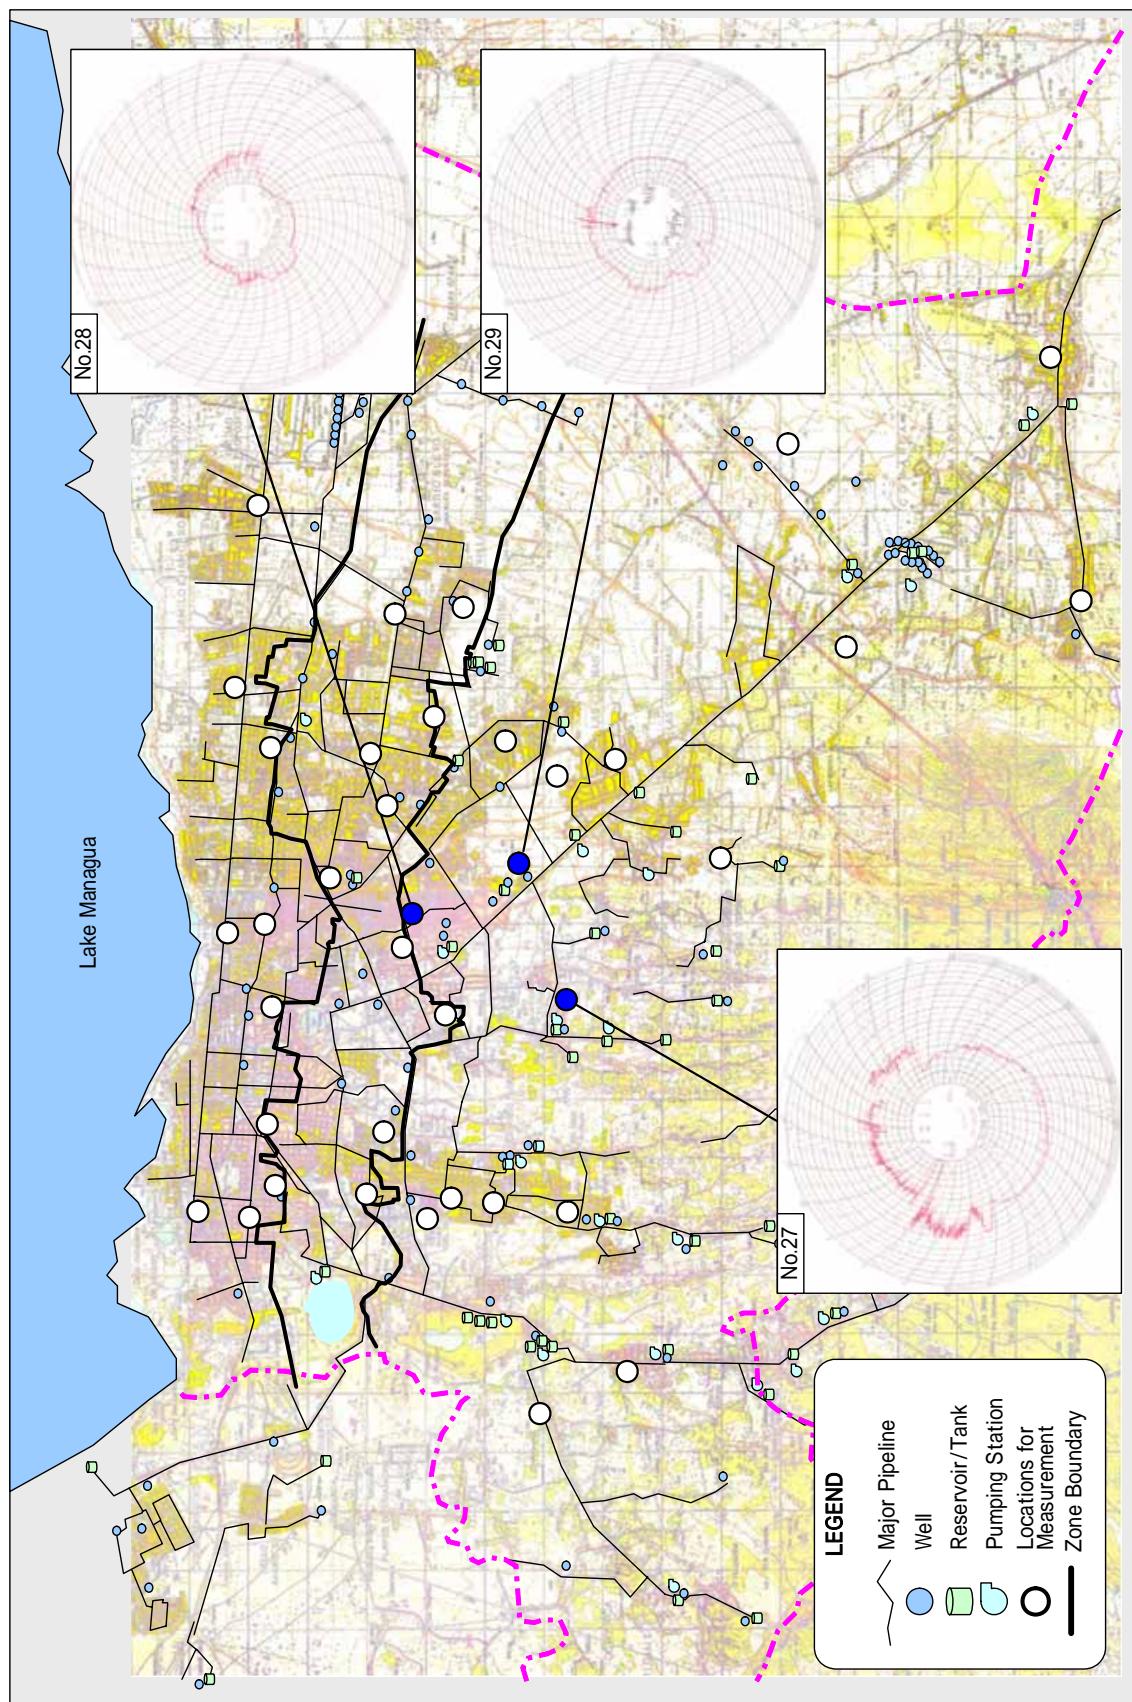
Figure 5.5.16 Results of Pressure Measurement in Zona Alta Superior Centro

As shown in **Figure 5.5.15** Locations No.27 and No.29 have relatively enough water pressure throughout a day. Location No.28 has little water according to time.

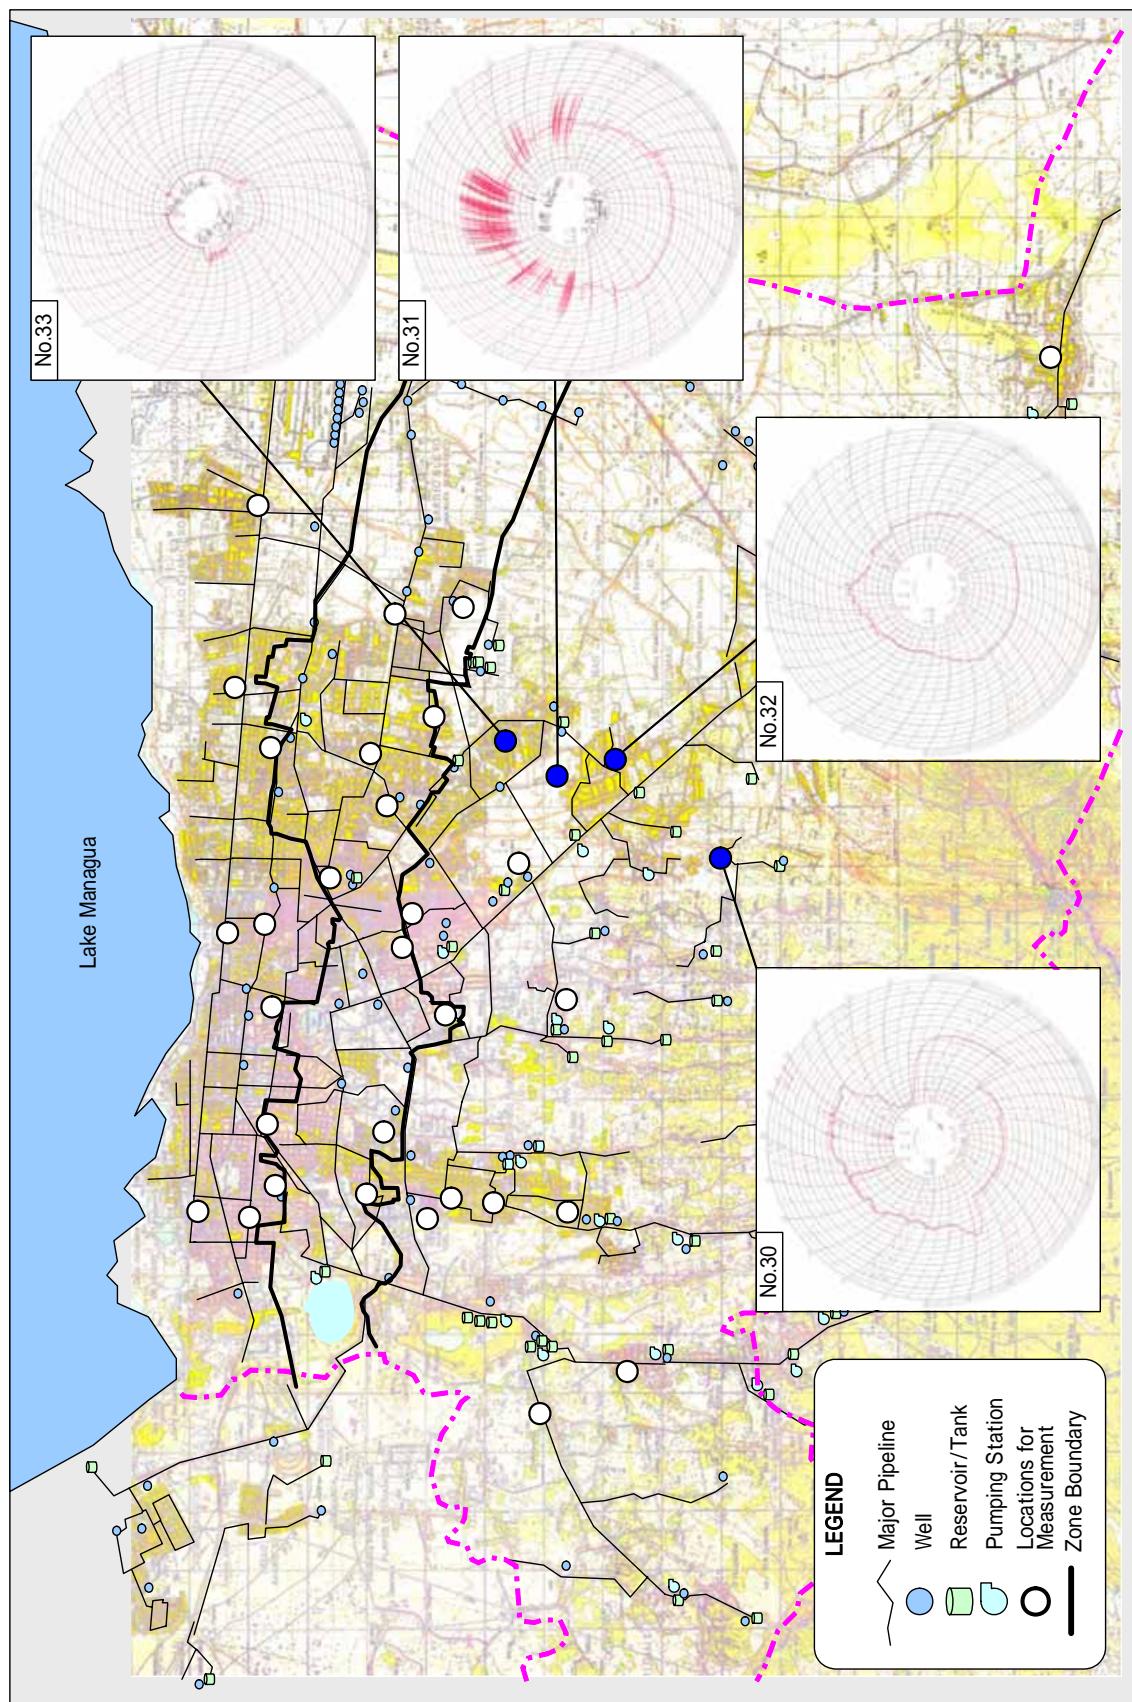
Figure 5.5.18 Results of Pressure Measurement in Zona Alta Superior Este

As shown in **Figure 5.5.17** Zona Alta Superior Este has relatively enough water pressure throughout a day except Location No.33. Location No.33 is supplied from Schick Tank planed and constructed by Managua I Project. As described in previous section, “5.4 Results of Flow Measurement”, enough water which was planned by Managua I Project was not transmitted from Santo Domingo Tank to Schick Tank. Therefore, there is not sufficient water to supply this area.

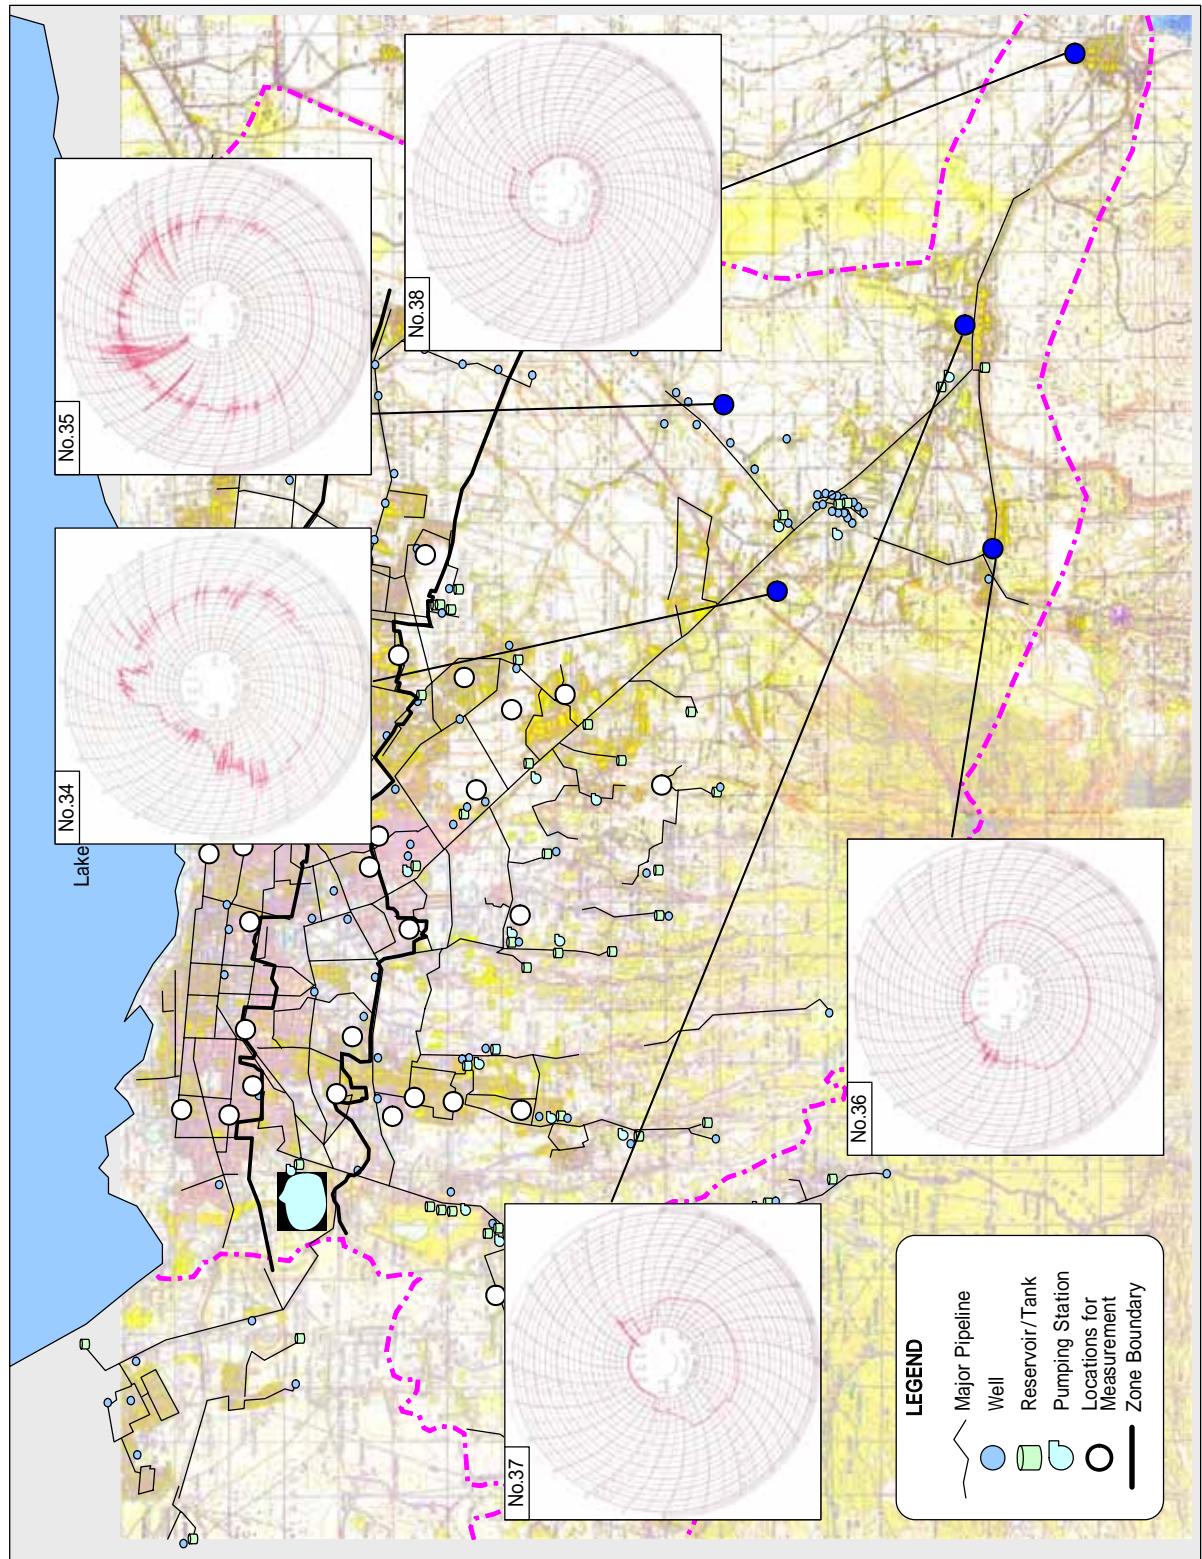
Figure 5.5.20 Results of Pressure Measurement outside Managua

As shown in **Figure 5.5.19** Locations No.34 and No.35 has enough water pressure throughout a day. Especially water pressure at Location No.35 (Veracrus area) was maintained at 0.4 MPa and more. Locations No. 36 (Ticuantepe) and No.37 has no water during day time but has enough water during night time. On the other hand at Location No.38 (Nindiri) enough water with enough water pressure was necessarily supplied.
