5.5 RESULTS OF PRESSURE MEASUREMENT

5.6 FLOW PATTERN IN THE STUDY AREA, EVALUATION OF WATER SUPPLY CONDITIONS AND IDENTIFICATION OF PROBLEMS

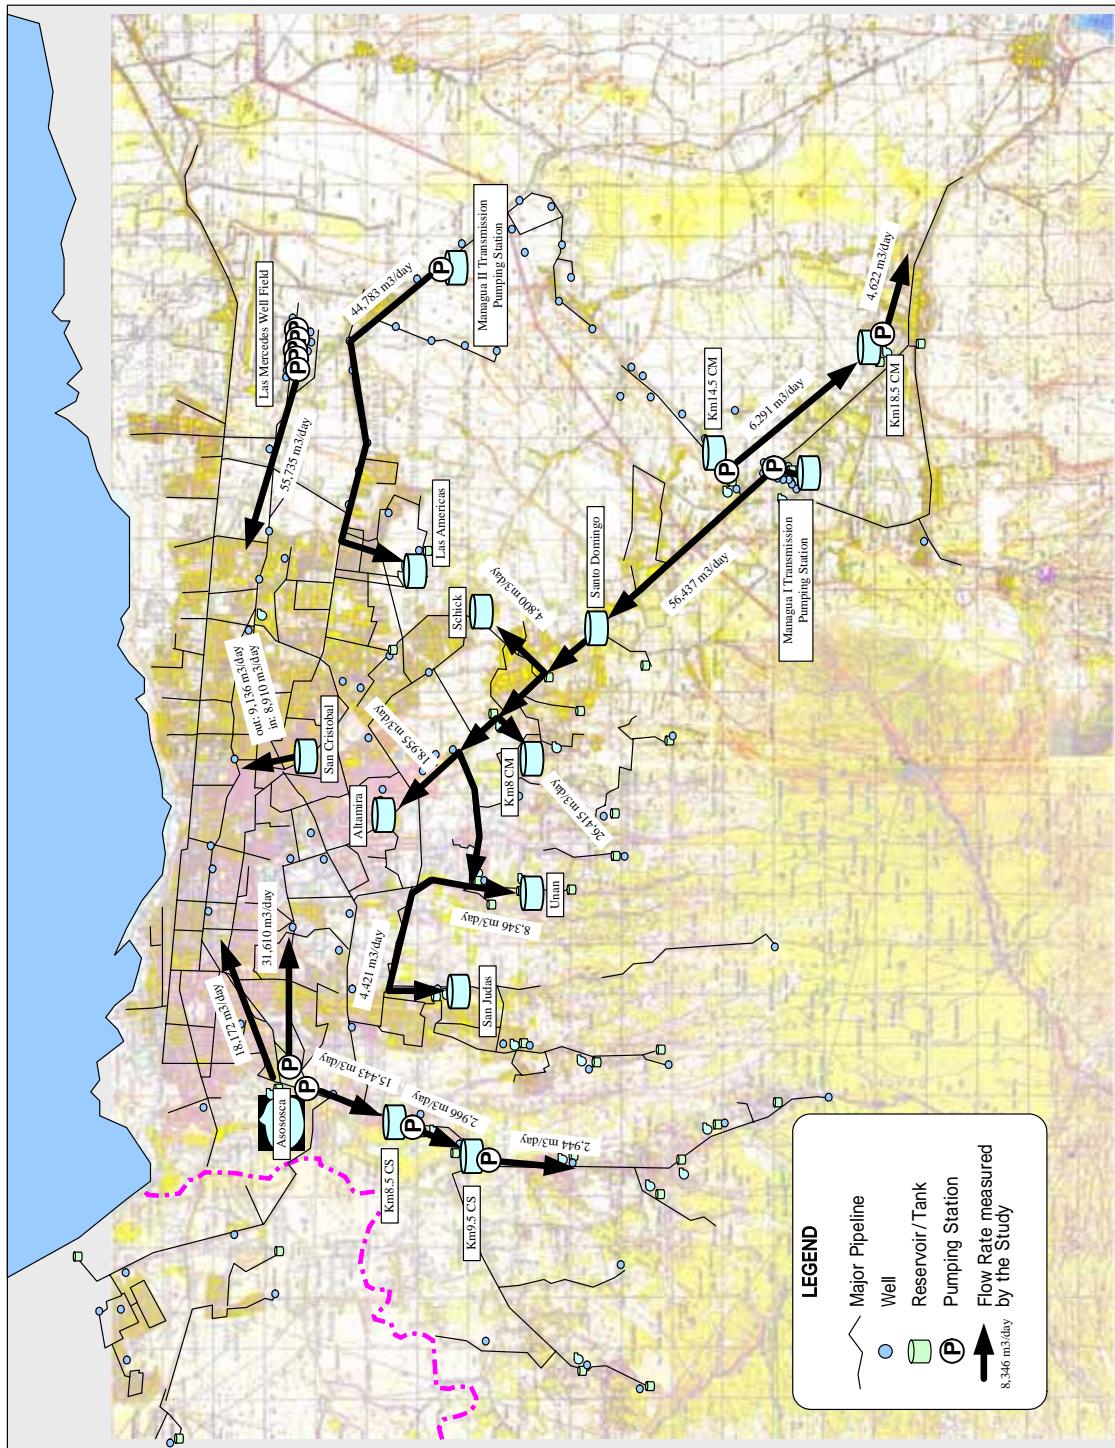
Figure 5.6.1 Flow Patterns in the Study Area

In conclusion of the flow measurement survey in the Study Area, the results are summarized in **Figure 5.6.1**.

At present for the transmission and distribution system along the Masaya Road, for example, water produced at Managua I well field flows to Altamira Tank ($HWL = 157.15$ m) from Santo Domingo Tank ($HWL = 256.25$ m) by gravity. However, water is then supplied to higher areas than Altamira where are located between Altamira and Santo Domingo by pumping. Since in Nicaragua the electricity charge is very high, the energy costs for pump operations are extremely high and it has pressed the management of ENACAL. Such inefficient transmission and distribution system is needed to be improved.

In addition it is identified that some tanks are not filled for 24 hours sometimes even during the night, because the transmission and distribution pipelines are not separated clearly or there may be not enough water for the Managua water supply system.

In order to improve and maintain a stable water supply, the following measures are necessary to consider for the master plan of the Managua water supply system.

- a. separation of small or medium size of distribution zone
- b. improvement water transmission and distribution system
- c. distinction of the transmission and distribution pipelines
