## **Annexe B Rehabilitation Works for Khettaras**

### **Contents**

## B.1 Present Condition of Khettaras

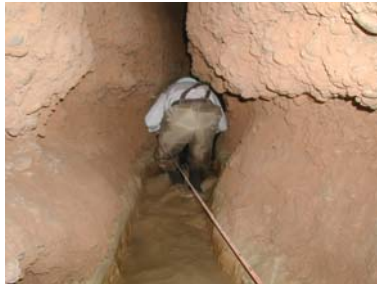
Gallery before rehabilitation work

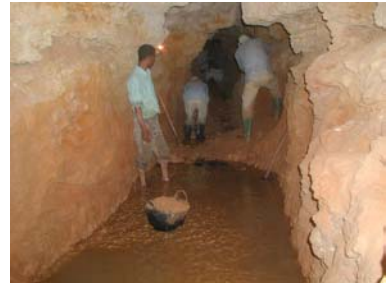
Excavation works in the gallery

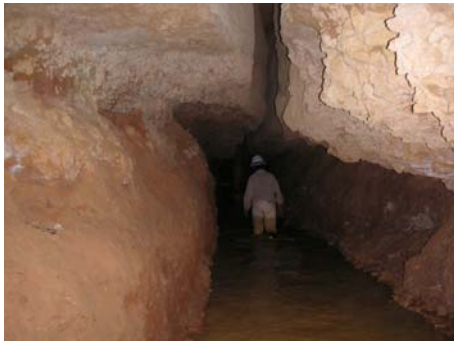
Inside of gallery after widening

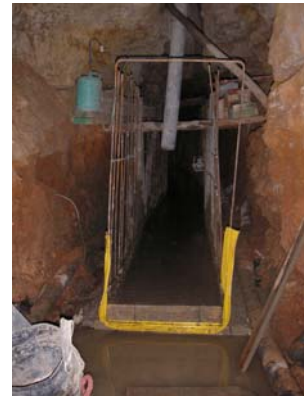
Installation of reinforcing bar and water stop

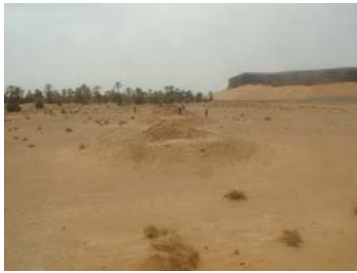
Khettara Lambarkia

View of ground surface before rehabilitation

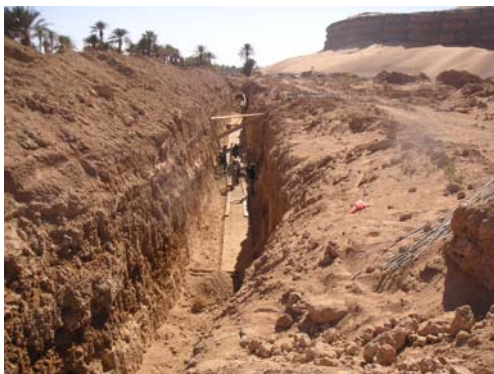
Excavation to the gallery foundation  
Concrete placing was commenced after open excavation works.

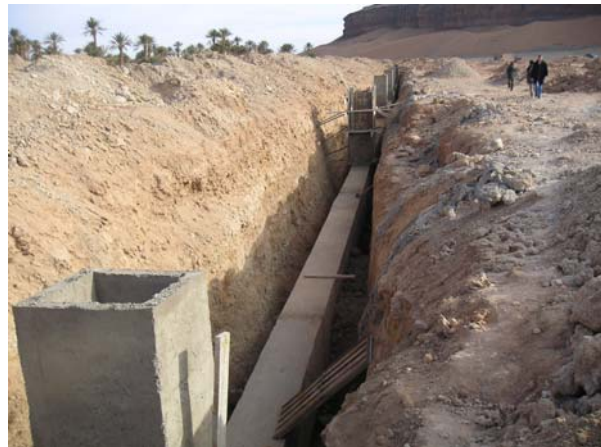
Concrete placing (gallery and vertical shafts)  
Gallery and vertical shafts of its interval of 30m

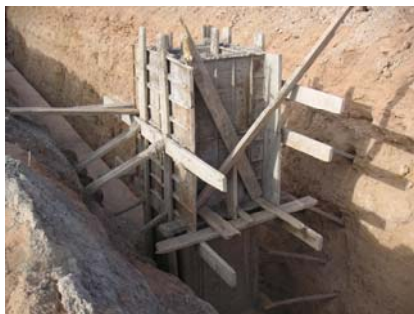
Form assembly for the vertical shafts

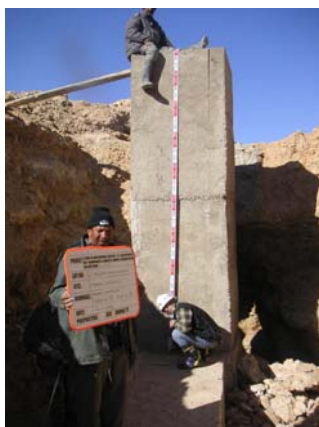
Vertical shaft about 5 m high from the foundation

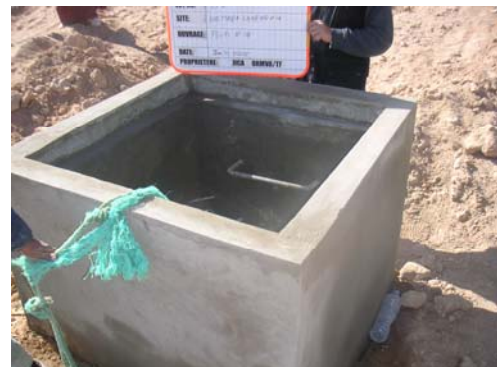
Top of vertical shafts (0.9 m x 0.9 m inside)

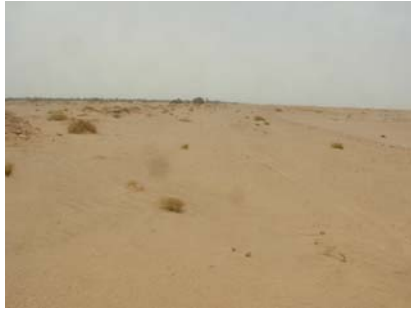
Khettara Oustania

View of ground surface before rehabilitation

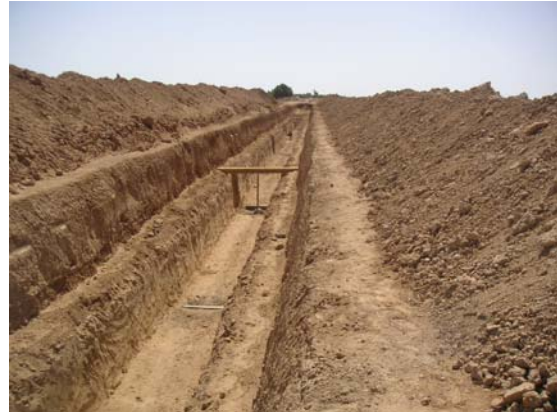
Excavation works along the gallery

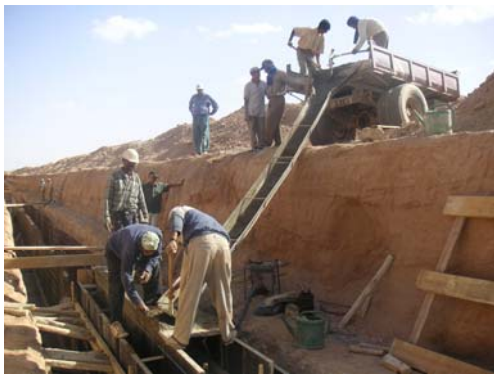
Concrete placing with chute

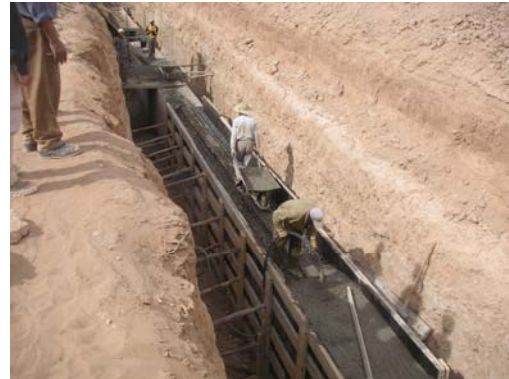
Concrete placing of top slab

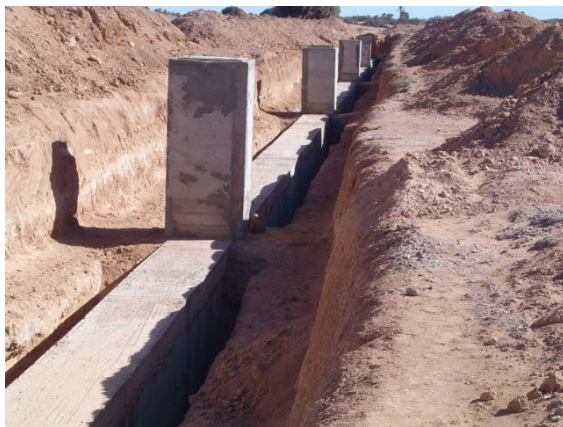
Gallery and vertical shafts of interval 30 m  
( Middle portion of total rehabilitation length of 300m

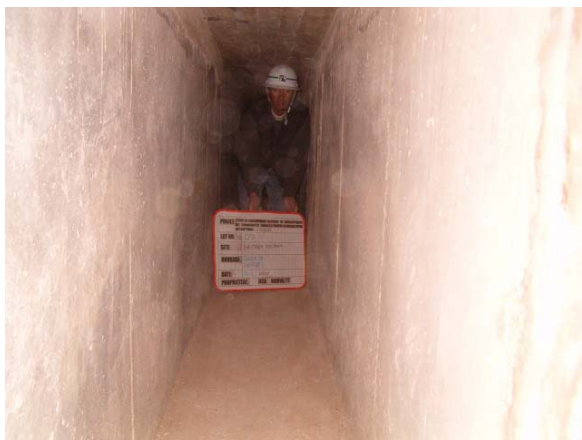
Inside of concrete culvert  
Width: 0.6m, height: 1.5m

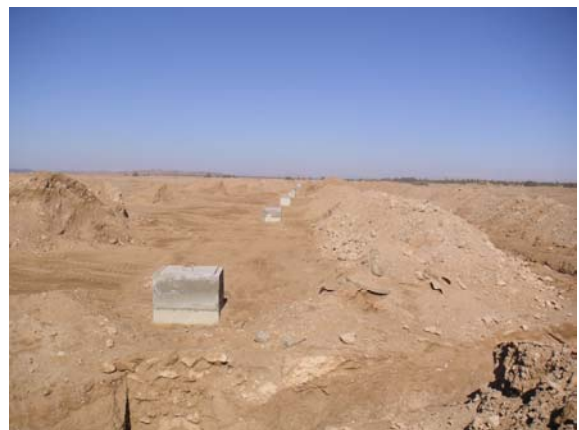
View of ground surface after refilling

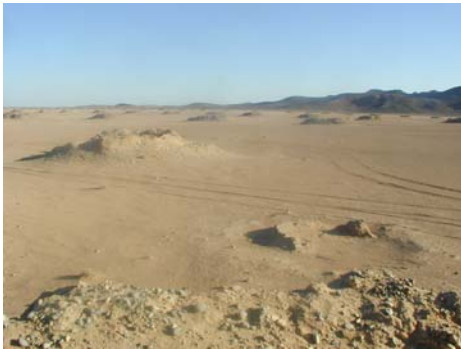
View of ground surface  
Gallery exists about 18 m below from the surface

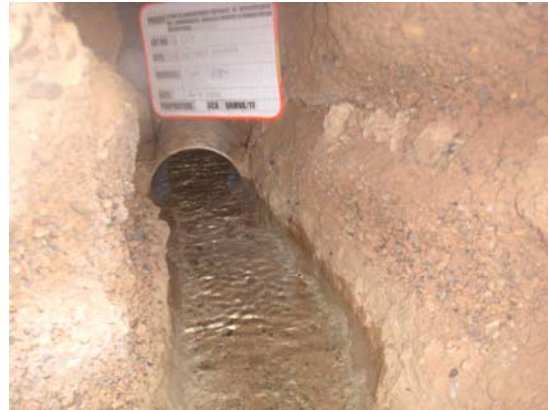
Most upstream of PVC pipe  
Pipe diameter has certain surplus flow capacity for increase of discharge in future.

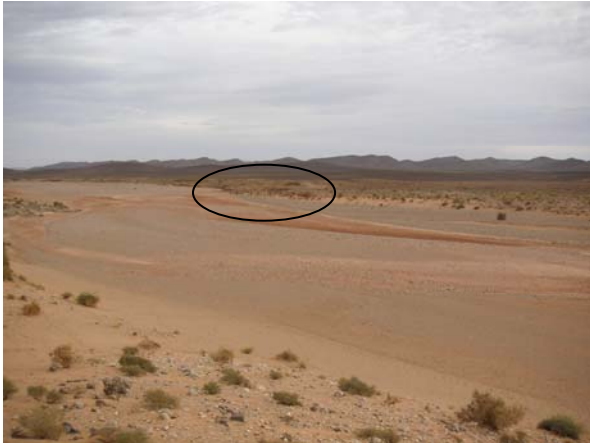
Round portion was subject to the rehabilitation works.

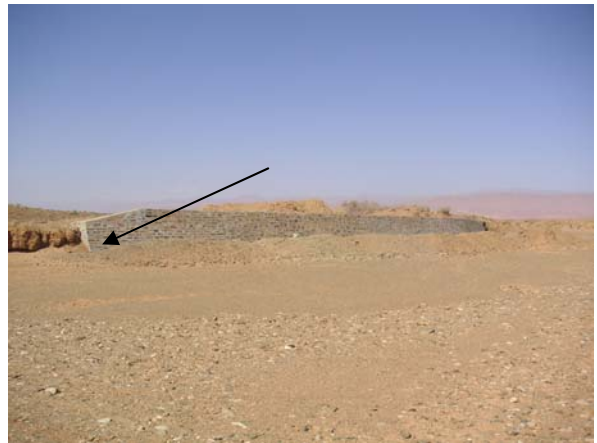
Masonry wall for flood protection (50m length)  
Gallery is located along arrow mark in the photograph.

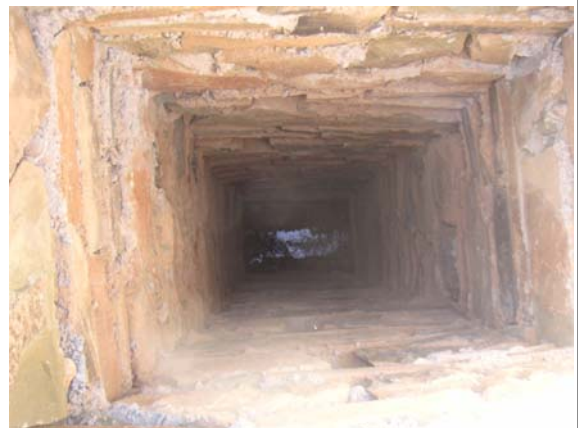
Inside of vertical shaft  
Shaft has its depth of 5.85m.

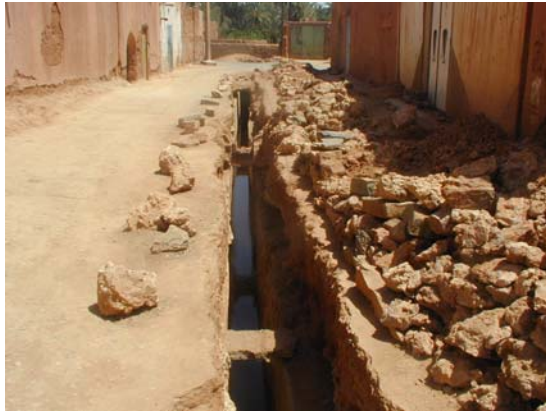
Downstream of the khettara is located in the residential area, so that waste water has caused contamination of the water for potable use.

After excavation along the gallery

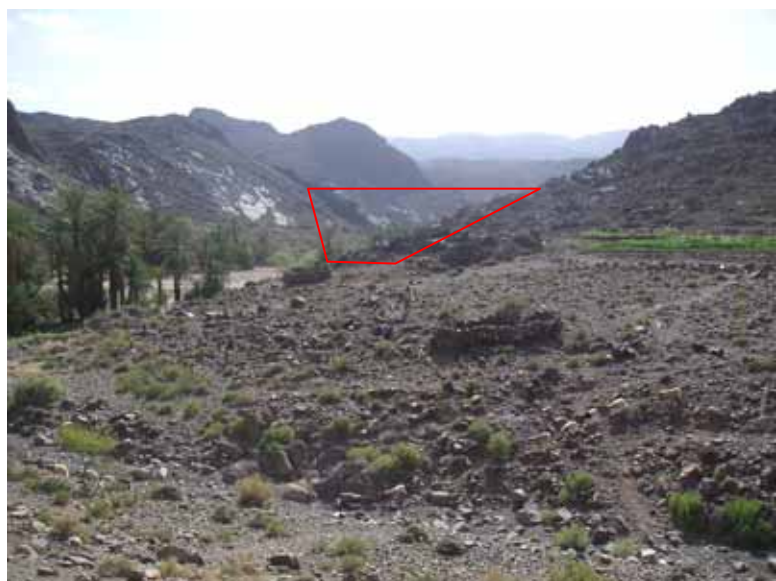
Reservoir toward upstream

Proposed dam site seeing from left side downstream of the dam
