REHABILITATION OF ORPHANAGES

(JROH NAGUNA & NIRMALA)

UNDER JAPAN'S NON-PROJECT TYPE GRANT AID

**APPENDIX-5 REHABILITATION OF ORPHANAGES  
(JROH NAGUNA & NIRMALA)  
UNDER JAPAN’S NON-PROJECT TYPE GRANT AID**

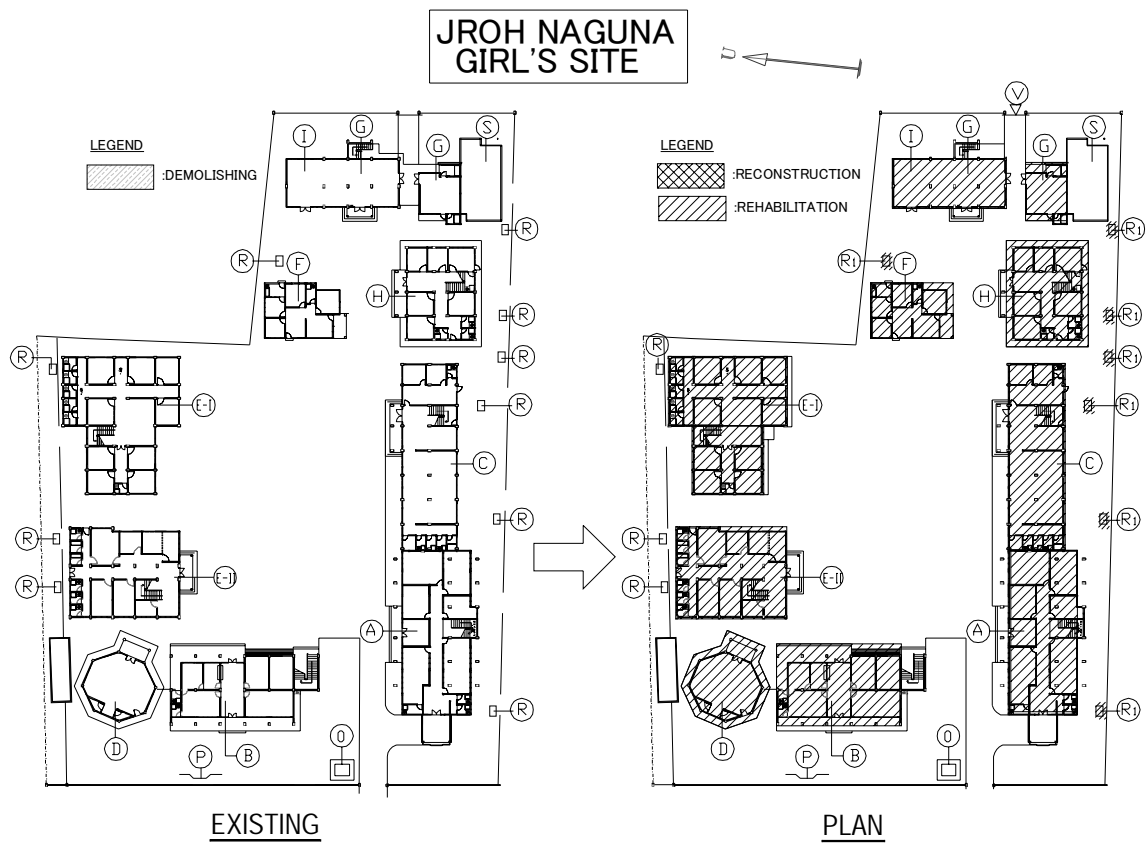
Figure 1.1.4 Site Plan and Rehabilitation Plan for Jroh Naguna Orphanage

Symbol	Facility name		Repair classification (○: Usable X: Unusable ▲: Overall repairs □: Partial repairs)									
			Structure	Exterior walls	Interior walls	Indoor flooring	Halls Stairs	Ceilings	Roofs	Fixtures	Light fixtures	Plumbing fixtures
A/C	Office and Hostel (Boy)1	2 <sup>nd</sup> fl	○	▲	▲	△	△	▲	△	△	△	△
		1 <sup>st</sup> fl		▲	▲	▲	▲	▲		△	△	△
B	Auditorium	2 <sup>nd</sup> fl	○	▲	▲	△	▲	▲	△	△	▲	○
		1 <sup>st</sup> fl		▲	▲	△	N/A	▲		△	▲	○
D	Mosque		○	▲	▲	▲	N/A	▲	▲	△	○	N/A
E-I	Hostel (Girl)1	2 <sup>nd</sup> fl	○	▲	▲	△	△	▲	○	△	△	△
		1 <sup>st</sup> fl		▲	▲	△	△	▲		△	△	○
E-II	Hostel(Girl)2	2 <sup>nd</sup> fl	○	▲	▲	△	○	▲	▲	△	○	○
		1 <sup>st</sup> fl		▲	▲	△	○	▲		△	○	○
F	Office House		○	▲	▲	▲	N/A	△	○	△	○	△
G/I	Kitchen and Mess Room1	2 <sup>nd</sup> fl	○	▲	▲	○	△	▲	△	△	△	○
		1 <sup>st</sup> fl		▲	▲	△	△	▲		△	△	○
H	Hostel(Boy)2	2 <sup>nd</sup> fl	○	▲	▲	△	○	△	△	△	△	○
		1 <sup>st</sup> fl		▲	▲	△	○	△		△	△	○
J	Education Room	2 <sup>nd</sup> fl	○	▲	▲	○	△	▲	△	△	▲	○

1 <sup>st</sup> fl		▲	▲	▲	△	▲		△	▲	○
K/L	Workshop and Boarding House		X	New construction, due to major damage to structure frame.								
M	Polyclinic		○	▲	▲	▲	N/A	▲	▲	△	○	○
N	Auditorium		X	New construction, due to major damage to structure frame.								
Q	Kitchen and Mess Room2		○	▲	▲	▲	N/A	▲	○	△	○	△
T	Toilet		X	New construction, due to tsunami damage.

In addition to the repairs listed in Table 1.1.2, other repair work performed will include the following described repairs to the roads inside the premises, restoration of walls and gates, and repairs to water supply facilities.

- ◆ Roads inside premises: Since the corridor connecting the boys' hostel was severely damaged, repairs will be made using interlocking block material.
- ◆ Grounds work: The roads in vacant land other than the roads inside the premises of the boys' hostel will be repaired with gravel.

- ◆ Walls and gates: Walls on the perimeter of the facilities collapsed due to the tsunami, and will therefore be rebuilt.
- ◆ Water supply facilities: Saltwater damage due to the tsunami rendered the existing well unusable. Therefore, new water supply facilities will be installed.

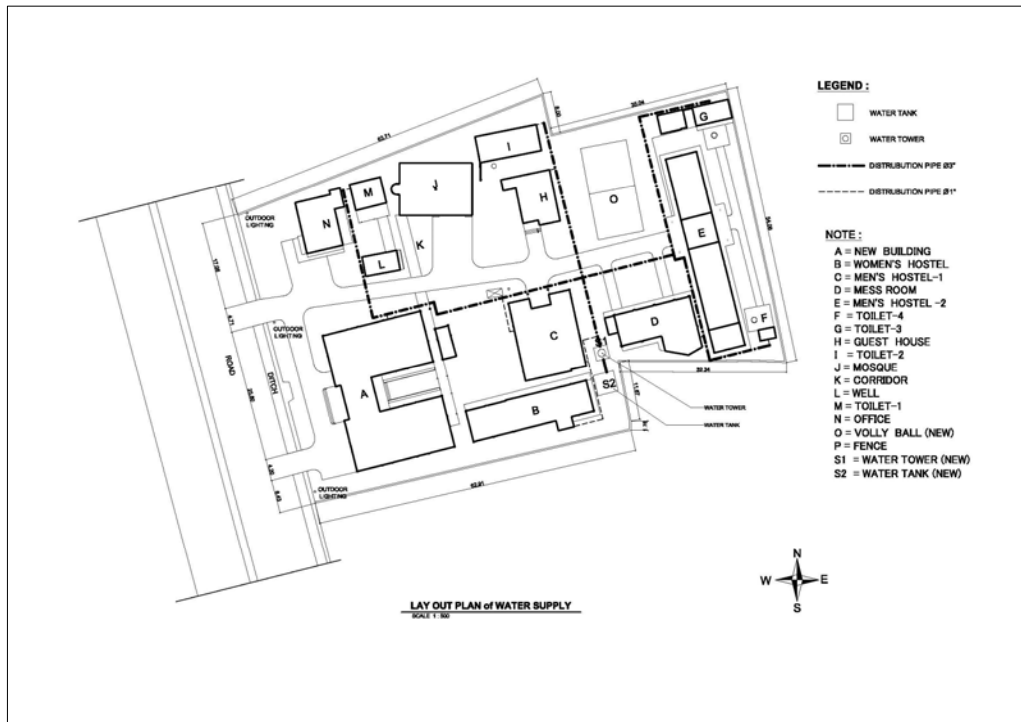
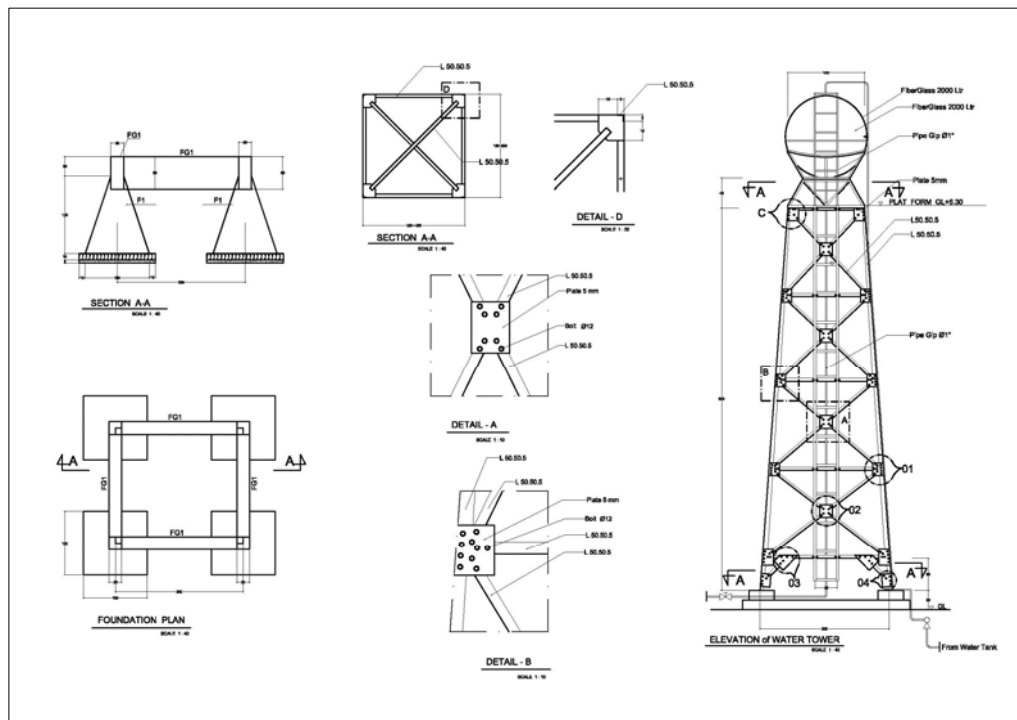
Figure 1.1.6 Nirmala Orphanage Water Supply Plan

- ◆ Since the existing water supply facilities at the Nirmala orphanage are unusable, a deep well will be drilled in the vacant land next to the existing dinning room water will be supplied via water supply facilities including an elevated tank and a pump which will also be installed. Also, as with the boys' hostel at the Jroh Naguna orphanage, it is expected that contamination of running and well water has clogged the faucets with mud, and that they will need to be

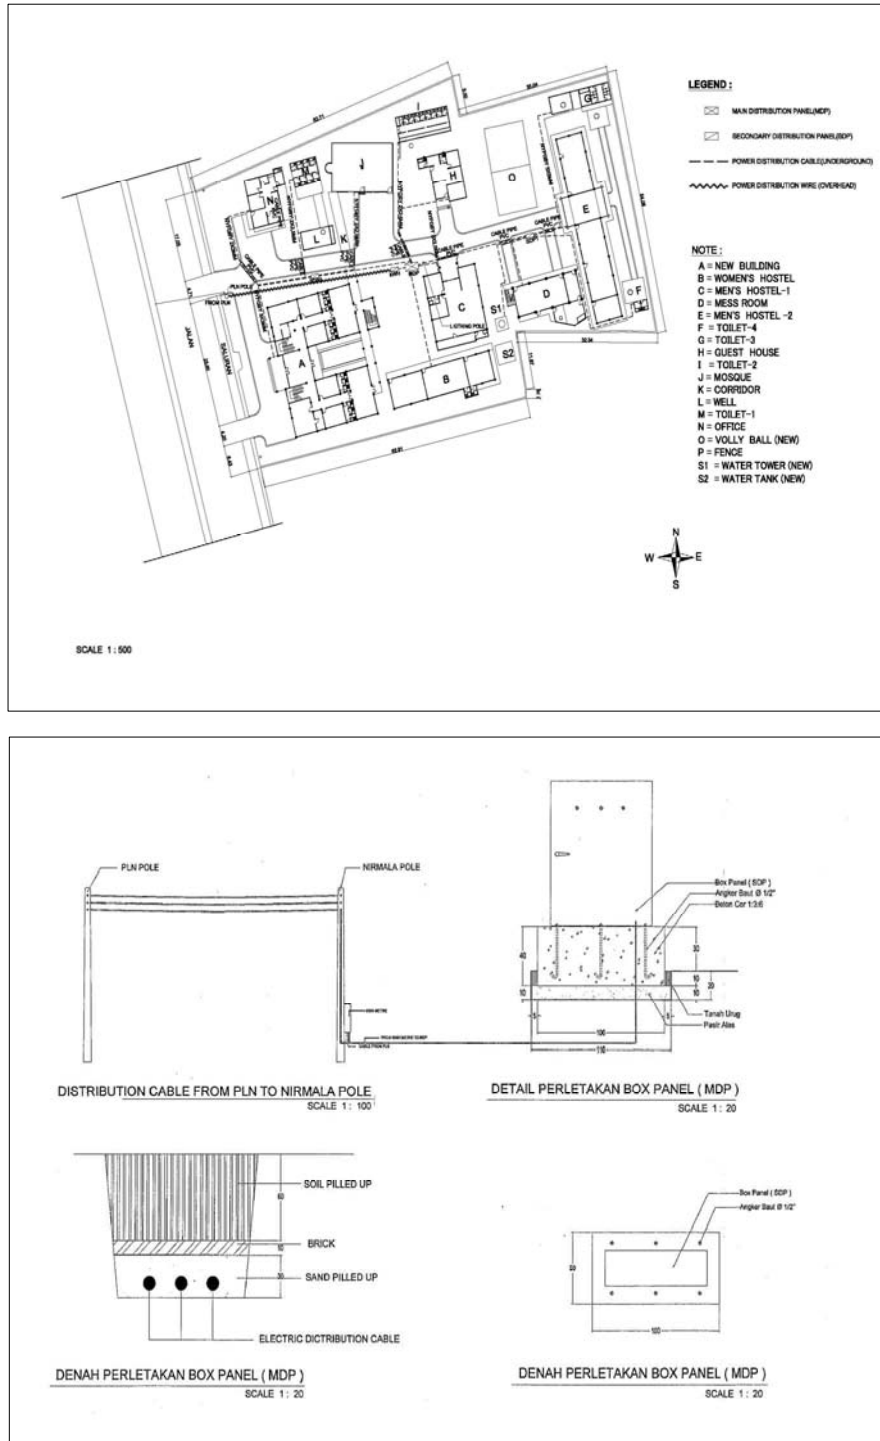
Figure-1.1.7 Nirmla Orphanage Power System Diagram

As is the case with the Jroh Naguna orphanage, lighting fixtures here have also been damaged to the extent that most of them in the facility need to be replaced. In particular, the damage on the first floor is extensive, and most of the light fixtures are unusable as a result of deterioration of parts because of rust, both from age and from the tsunami. The spread of rust will lead to damage such as electrical leaks and earth fault accidents, and therefore necessitates immediate replacement of these parts. In addition, some light fixtures have fallen from the ceilings as a result of vibration from the earthquakes. When the light fixtures fell from the ceilings it exerted an excessive amount of strain on the cables and contact points resulting in damage to the insulating coating on cables and fixtures.

As a result, these parts also require immediate replacement (see photos below).
