**SOLOMON ISLANDS WATER AUTHORITY**

**THE STUDY FOR  
REHABILITATION AND IMPROVEMENT  
OF  
SOLOMON ISLANDS WATER AUTHORITY'S  
WATER SUPPLY AND SEWERAGE SYSTEMS**

**FINAL REPORT  
SUMMARY**

**JUNE 2006**

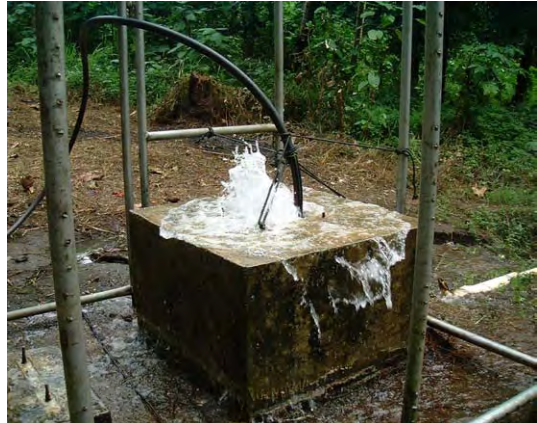
<p>Situation of borehole washing in White river area. Several boreholes were washed to recover production capacity in the Study.</p>	<p>Situation of field work of electric survey. The survey was carried out covering entire Honiara to detect promising aquifer.</p>

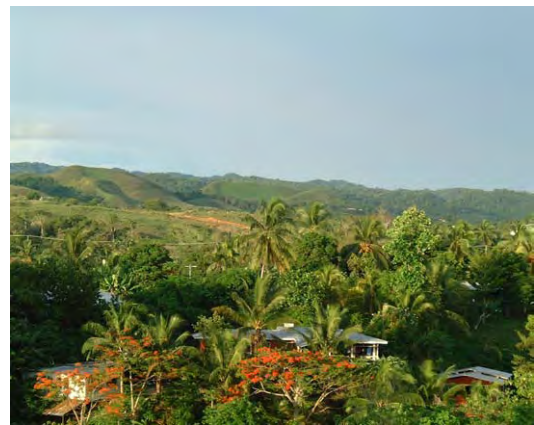
<p>Situation of Konglai Spring in Dec. 2007. Discharge rate from the spring has been reduced since Nov. 2006 as half as the normal condition. Almost all the water is being taken by SIWA results in little over-flow.</p>	<p>Situation of hills in south of Honiara Honiara Reef-limestone is in the front and Honiara beds is in the back. Mbonehi limestone is distributed in the mountains behind hills.</p>

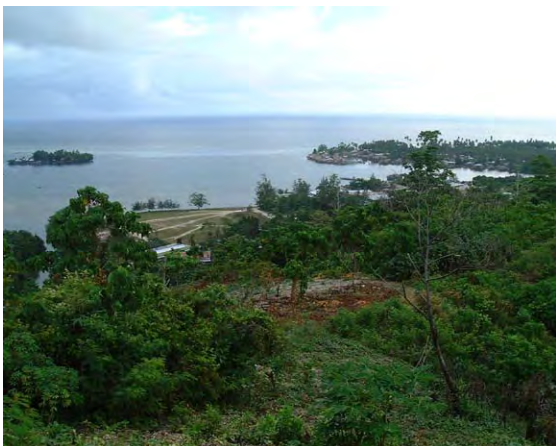
<p>Hill behind Auki town-area. Excellent aquifer by limestone is distributed in this area. Two new boreholes should be developed to meet water demand in 2010.</p>	<p>Situation of water-intake of Ziata river. The river has enough discharge to meet water demand of 2010. There is an existing purification plant 200m north of this intake.</p>

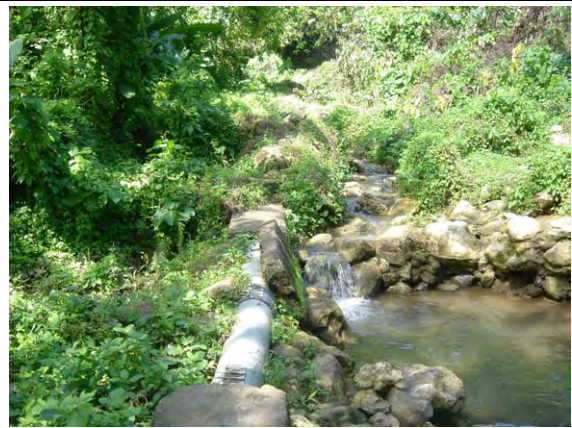
Water conveyance pipe which conveys water from the intake point of Konglai Spring to transmission pump station.

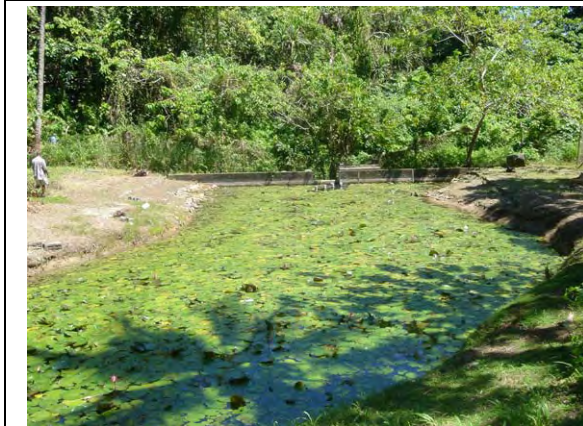
Rove Spring which is one of three springs in Honiara. Intake volume of this spring is as small as one-seventh of Konglai Spring. Water from the spring is distributed mainly to Point Cruz district.

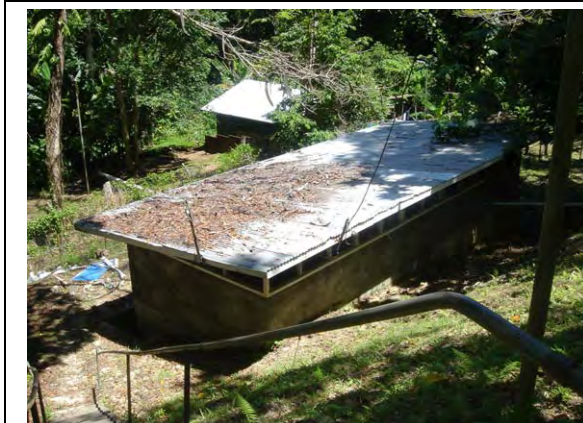
Chlorination injection house located downstream to Rove Spring.

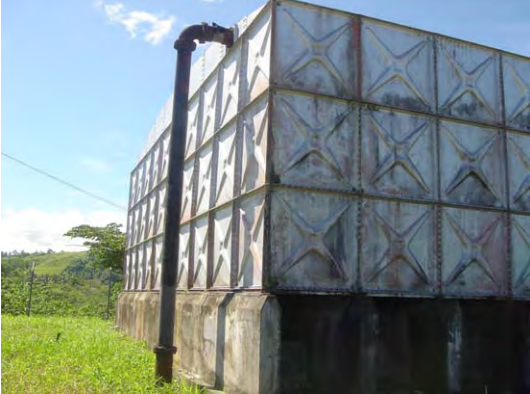
<p>Tasahe Reservoir. Water is transferred from Konglai Spring to this reservoir by pumping.</p>	<p>Titinge Reservoir. Water transferred by pumping from Konglai Spring to Tasahe Reservoir is further transferred to this reservoir. This reservoir is not in use at present due to large leakage.</p>

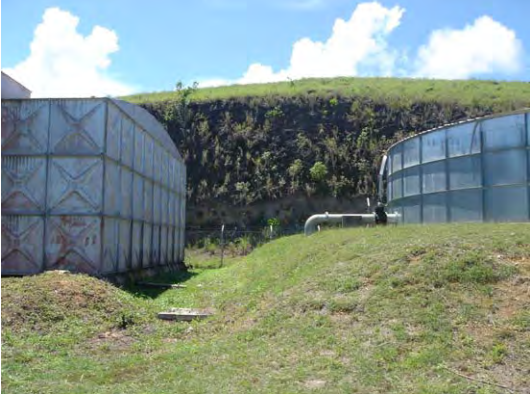
<p>Skyline Reservoir. Water is transferred from Konglai Spring and Mataniko Borefield to this reservoir. The reservoir at the right hand side was constructed in 1998 by the Japan's grant aid.</p>	<p>Low West Kolaa Reservoir. This reservoir is not in use due to deterioration by usage over service life. One of the two reservoirs was demolished for replacement.</p>

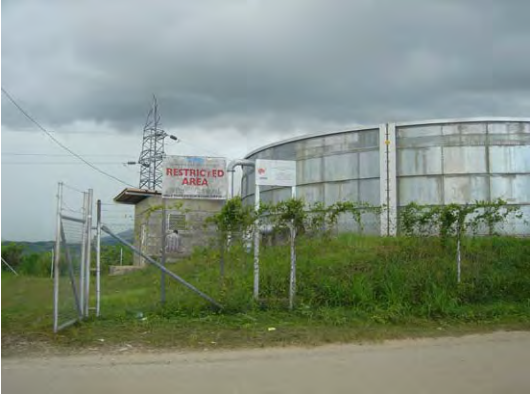
<p>Panatina Reservoir. Water source of this reservoir is Panatina Borefield which was constructed under the Japan's grant aid project in 1998.</p>	<p>White River Reservoir. Old reservoir is not in use at present due to deterioration by usage over service life. New reservoir was constructed under the Japan's grant aid project.</p>

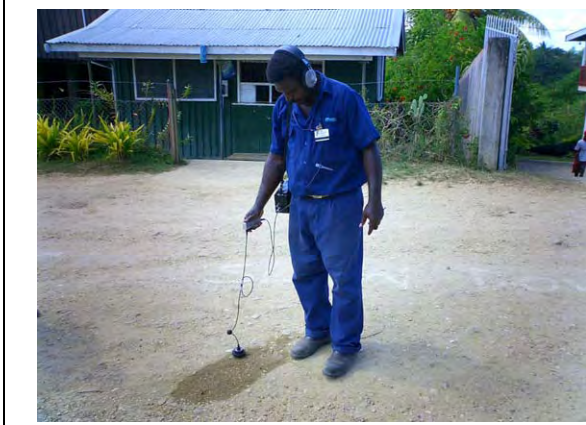
Leakage detection survey done in Phase-1 of this Study  
SIWA staff is doing the detection survey by means of leakage detector.

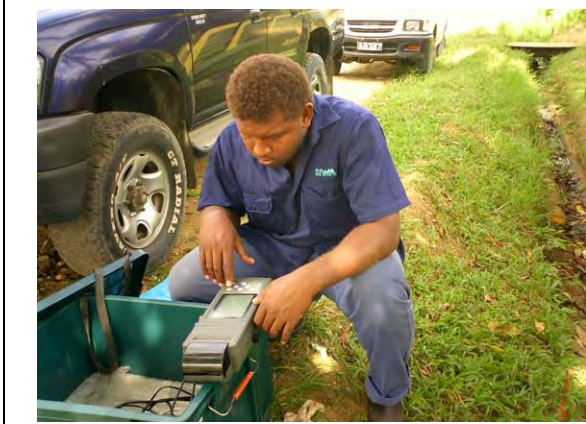
Leakage detection survey done in Phase-1 of this Study  
Water flow for 24 hours was measured by means of portable ultrasonic flow meter in 12 model districts. Through this measurement, minimum night flow (leakage) and distribution pattern were obtained.

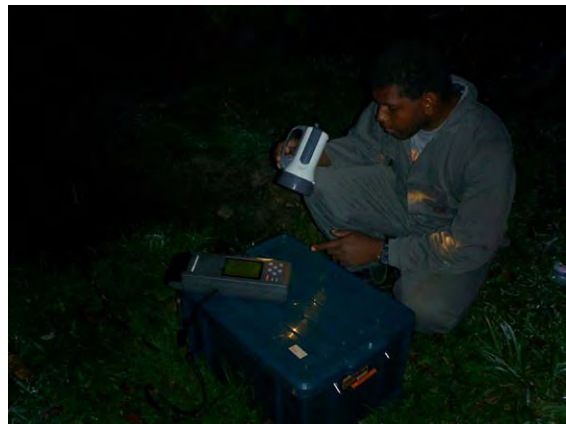
Leakage detection survey done in Phase-1 of this Study  
SIWA staff is measuring the minimum night flow by means of portable ultrasonic flow meter.

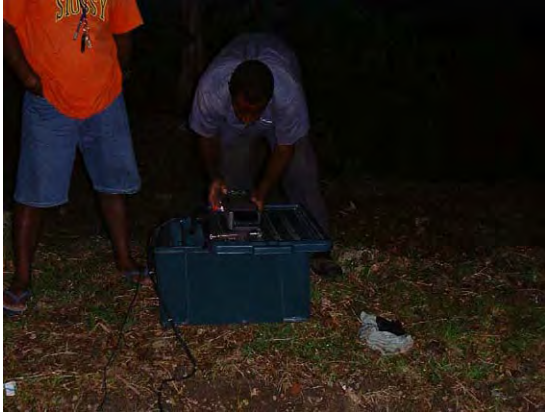
Pilot project for establishing leakage reduction indicator. 12 model sections were selected by the leakage survey. This photo shows the situation of the work at Vavaya Ridge district. Leakage (or minimum night flow) is measured before pipe replacement.

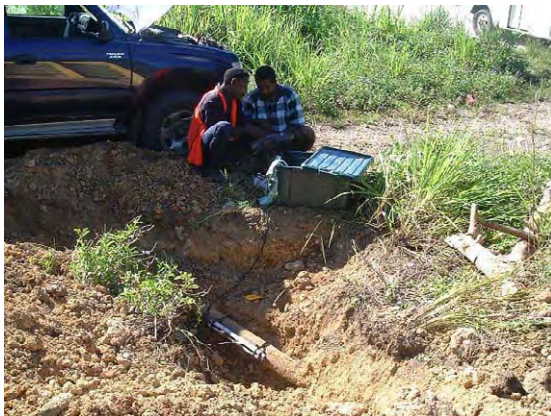
Situation of leakage measurement work before pipe replacement at Kola Ridge district.

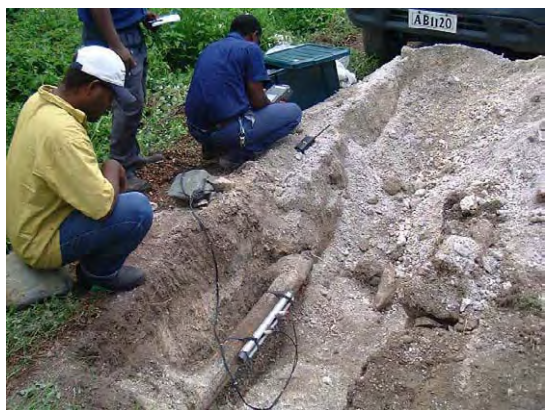
Situation of leakage measurement work before pipe replacement at Kukum Campus.
