**SOLOMON ISLANDS WATER AUTHORITY**

**THE STUDY FOR  
REHABILITATION AND IMPROVEMENT  
OF  
SOLOMON ISLANDS WATER AUTHORITY'S  
WATER SUPPLY AND SEWERAGE SYSTEMS**

**FINAL REPORT  
MAIN REPORT**

**JUNE 2006**

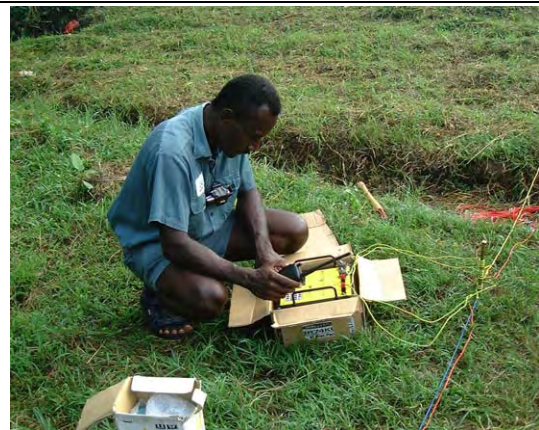
Situation of field work of electric survey. The survey was carried out covering entire Honiara to detect promising aquifer.

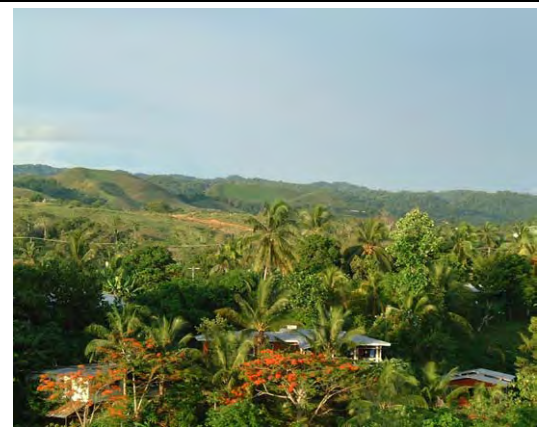
Situation of hills in south of Honiara Honiara Reef-limestone is in the front and Honiara beds is in the back. Mbonehi limestone is distributed in the mountains behind hills.

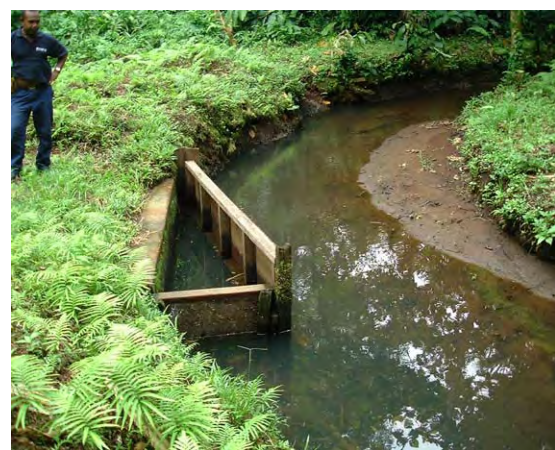
Situation of water-intake of Ziata river. The river has enough discharge to meet water demand of 2010. There is an existing purification plant 200m north of this intake.

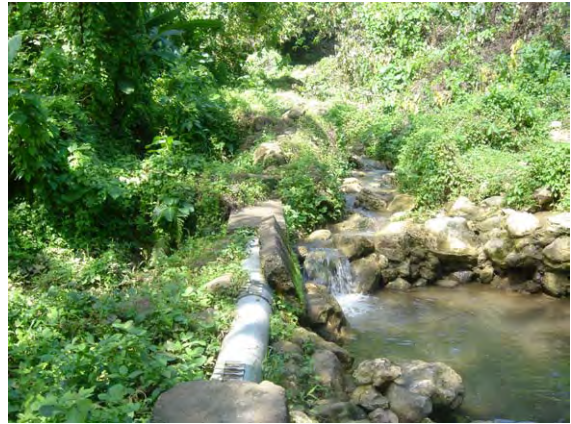
Water conveyance pipe which conveys water from the intake point of Konglai Spring to transmission pump station.

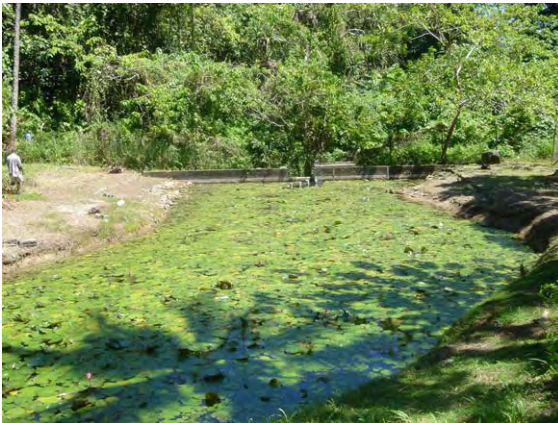
Rove Spring which is one of three springs in Honiara. Intake volume of this spring is as small as one-seventh of Konglai Spring. Water from the spring is distributed mainly to Point Cruz district.

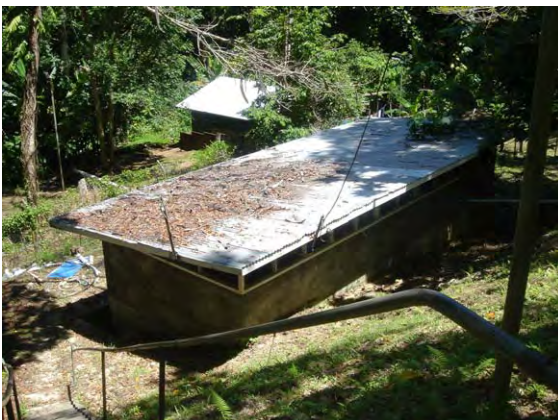
Chlorination injection house located downstream to Rove Spring.

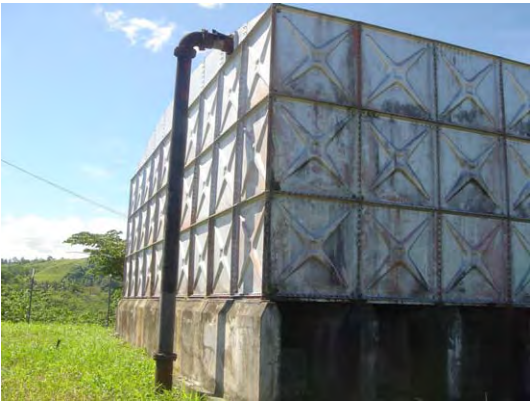
<p>Tasahe Reservoir. Water is transferred from Konglai Spring to this reservoir by pumping.</p>	<p>Titinge Reservoir. Water transferred by pumping from Konglai Spring to Tasahe Reservoir is further transferred to this reservoir. This reservoir is not in use at present due to large leakage.</p>

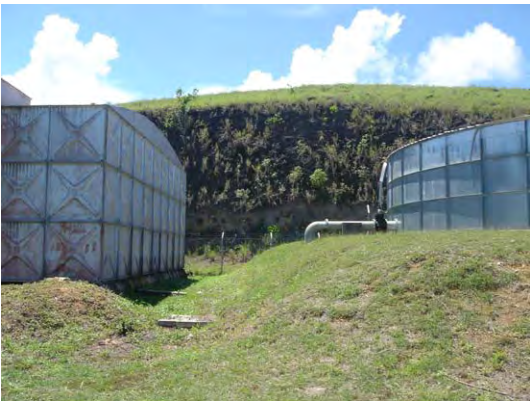
<p>Skyline Reservoir. Water is transferred from Konglai Spring and Mataniko Borefield to this reservoir. The reservoir at the right hand side was constructed in 1998 by the Japan's grant aid.</p>	<p>Low West Kolaa Reservoir. This reservoir is not in use due to deterioration by usage over service life. One of the two reservoirs was demolished for replacement.</p>

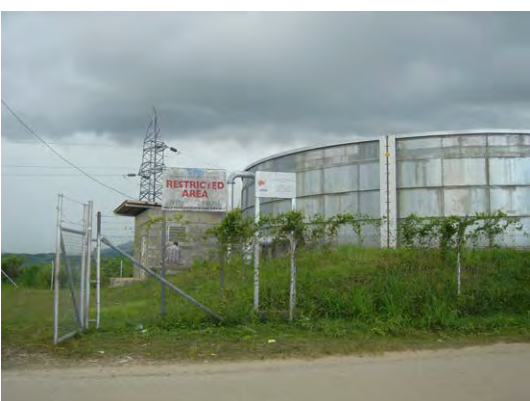
<p>Panatina Reservoir. Water source of this reservoir is Panatina Borefield which was constructed under the Japan's grant aid project in 1998.</p>	<p>White River Reservoir. Old reservoir is not in use at present due to deterioration by usage over service life. New reservoir was constructed under the Japan's grant aid project.</p>

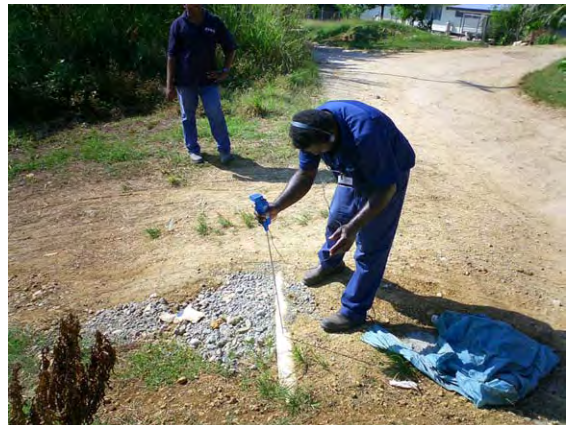
Leakage detection survey done in Phase-1 of this Study  
SIWA staff is surveying the leakage sound by means of digital sound detector.

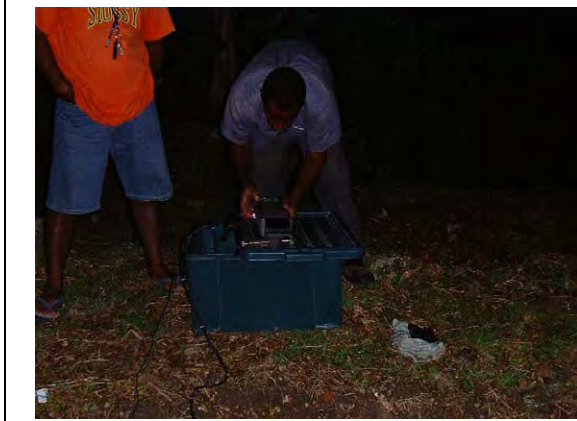
Pilot project for establishing leakage reduction indicator. 12 model sections were selected by the leakage survey. This photo shows the situation of the work at Vavaya Ridge district. Leakage (or minimum night flow) is measured before pipe replacement.

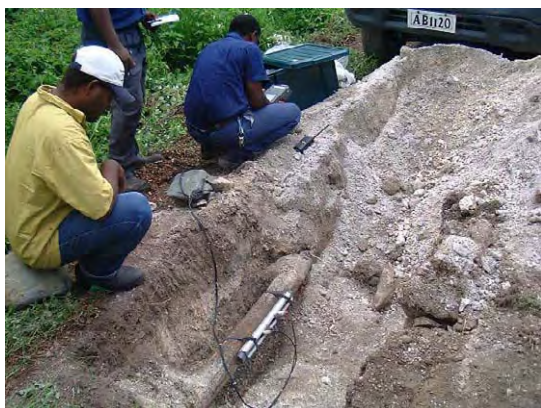
Situation of leakage measurement work before pipe replacement at Kukum Campus.
