S-3-1-6 Observation of Leakage Conditions

Outline of Leakage Situations

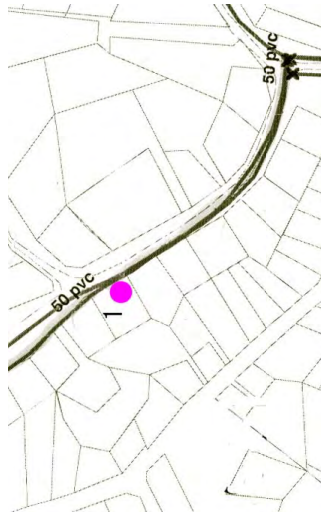
Location map

Date of Survey:	21-Jun-05	
Survey No.:	1 Stop Cock	
System name:	W.R.P, W.R.P, Rove, Mataniko-P, JICA-B, Kombito, Kombito-G, Panatina, Others	
Address:	Orion company NGOSSI	
Main Line	CIP, GP, PVC, POL, Others()	Position Condition Pipe, Connection, Valve, Others Hole, Crack, Brake, Pack kin, Loose, Others
Diameter	"or mm	Cause Corrosion, Water-pressure, Wrong Construction, Traffic load, Others
Service Line	CIP, GP, PVC, POL, Others()	Position Condition Pipe, Connection, Valve, Others Hole, Crack, Brake, Pack kin, Loose, Others
Diameter	1/2 "or 13 mm	Cause Corrosion, Water-pressure, Deterioration, Wrong Construction, Traffic load, Others
Depth	15 cm	Ground Asphalt, Concrete, Gravel, Grass, Others
Leakage Size	Large, Medium, Small	Leakage Quantity (Estimation) 0.5L/min or 0.03 m ³ /h

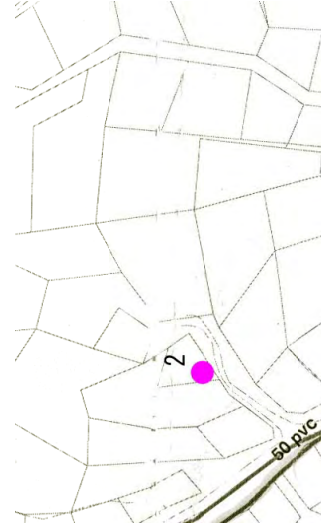
Location map

Date of Survey:	21-Jun-05	
Survey No.:	2 Stop Cock	
System name:	W.R.P, W.R.P, Rove, Mataniko-P, JICA-B, Kombito, Kombito-G, Panatina, Others	
Address:	Mr. David Quan H/No. 41 NGOSSI	
Main Line	CIP, GP, PVC, POL, Others()	Position Condition Pipe, Connection, Valve, Others Hole, Crack, Brake, Pack kin, Loose, Others
Diameter	"or mm	Cause Corrosion, Water-pressure, Wrong Construction, Traffic load, Others
Service Line	CIP, GP, PVC, POL, Others()	Position Condition Pipe, Connection, Valve, Others Hole, Crack, Brake, Pack kin, Loose, Others
Diameter	1/2 "or 13 mm	Cause Corrosion, Water-pressure, Deterioration, Wrong Construction, Traffic load, Others
Depth	10 cm	Ground Asphalt, Concrete, Gravel, Grass, Others
Leakage Size	Large, Medium, Small	Leakage Quantity (Measured) 5L/min or 0.3 m ³ /h

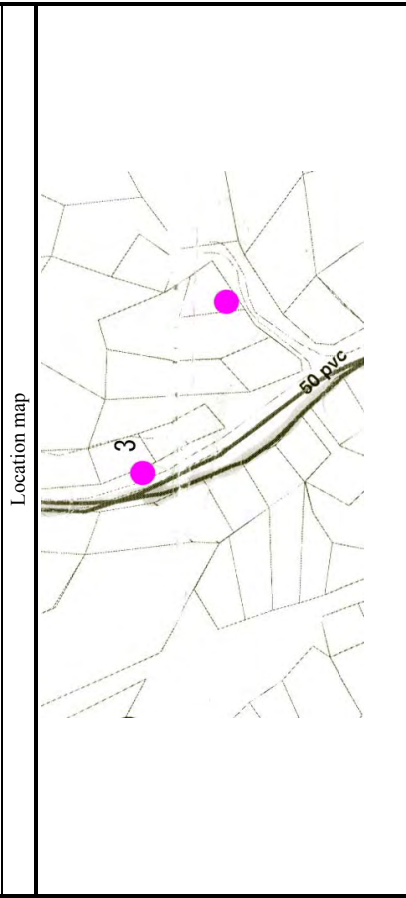
Date of Survey:	21-Jun-05	
Survey No.:	3 Service Pipe	
System name:	W.R.P., W.R.P., Rove, Mataniko-P, JICA-B, Kombito, Kombito-G, Panatina, Others	
Address:	Mr. Luke Eta H/No.25 NGOSSI	
Main Line	CIP, GP, PVC, POL, Others()	Position Pipe, Connection, Valve, Others
Diameter	" or mm	Condition Hole, Crack, Brake, Pack kin, Loose, Others
Service Line	CIP, GP, PVC, POL, Others()	Cause Corrosion, Water-pressure, Wrong Construction, Traffic load, Others
Diameter	1/2 " or 13 mm	Position Pipe, Connection, Valve, Others
Depth	30 cm	Condition Hole, Crack, Brake, Pack kin, Loose, Others
Leakage Size	Large, Medium, Small	Cause Corrosion, Water-pressure, Deterioration Wrong Construction, Traffic load, Others
		Ground Asphalt, Concrete, Gravel, Grass, Others
		Leakage Quantity (Measured)
		20L/min or 1.2 m ³ /h

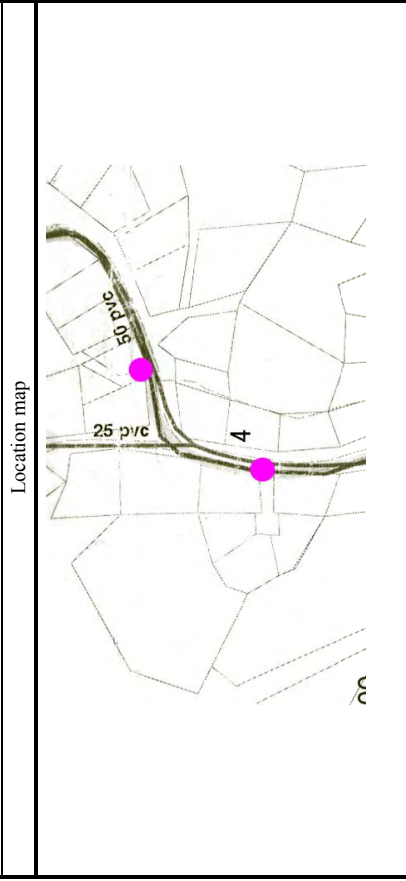
Date of Survey:	21-Jun-05	
Survey No.:	4 Service Pipe	
System name:	W.R.P., W.R.P., Rove, Mataniko-P, JICA-B, Kombito, Kombito-G, Panatina, Others	
Address:	Opposite Welstar Shop NGOSSI	
Main Line	CIP, GP, PVC, POL, Others()	Position Pipe, Connection, Valve, Others
Diameter	" or mm	Condition Hole, Crack, Brake, Pack kin, Loose, Others
Service Line	CIP, GP, PVC, POL, Others()	Cause Corrosion, Water-pressure, Wrong Construction, Traffic load, Others
Diameter	1/2 " or 13 mm	Position Pipe, Connection, Valve, Others
Depth	20 cm	Condition Hole, Crack, Brake, Pack kin, Loose, Others
Leakage Size	Large, Medium, Small	Cause Corrosion, Water-pressure, Deterioration Wrong Construction, Traffic load, Others
		Ground Asphalt, Concrete, Gravel, Grass, Others
		Leakage Quantity (Measured)
		1L/min or 0.06 m ³ /h

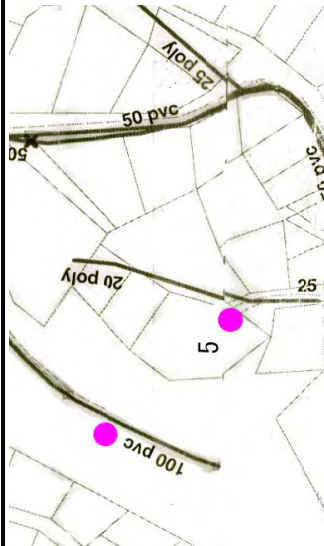
Location map

Date of Survey:	21-Jun-05	
Survey No.:	5	
System name:	W.R.P, W.R.P, Rove, Mataniko-P, JICA-B, Kombito, Kombito-G, Panatina, Others	
Address:	Mr. Antony Makabo NGOSSI	
Main Line	CIP, GP, PVC, POL, Others()	Position Condition Pipe, Connection, Valve, Others Hole, Crack, Brake, Pack kin, Loose, Others
Diameter	"or mm	Cause Corrosion, Water-pressure, Wrong Construction, Traffic load, Others
Service Line	CIP, GP, PVC, POL, Others()	Position Condition Pipe, Connection, Valve, Others Hole, Crack, Brake, Pack kin, Loose, Others
Diameter	1/2 "or 13 mm	Cause Corrosion, Water-pressure, Deterioration Wrong Construction, Traffic load, Others
Depth	20 cm	Ground Asphalt, Concrete, Gravel, Grass, Others
Leakage Size	Large, Middelium, Small	Leakage Ququinty (Estimation) 10L/min or 0.6 m ³ /h

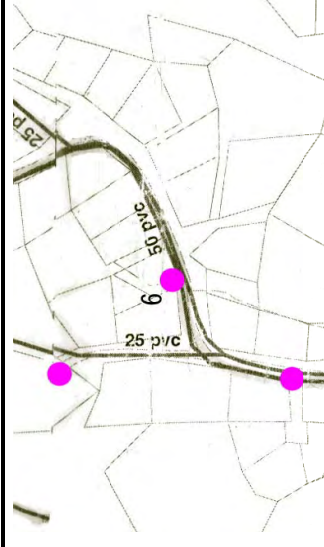
Location map

Date of Survey:	21-Jun-05	
Survey No.:	6	
System name:	W.R.P, W.R.P, Rove, Mataniko-P, JICA-B, Kombito, Kombito-G, Panatina, Others	
Address:	Mr. Y. Sato NGOSSI	
Main Line	CIP, GP, PVC, POL, Others()	Position Condition Pipe, Connection, Valve, Others Hole, Crack, Brake, Pack kin, Loose, Others
Diameter	"or mm	Cause Corrosion, Water-pressure, Wrong Construction, Traffic load, Others
Service Line	CIP, GP, PVC, POL, Others()	Position Condition Pipe, Connection, Valve, Others Hole, Crack, Brake, Pack kin, Loose, Others
Diameter	1/2 "or 13 mm	Cause Corrosion, Water-pressure, Deterioration Wrong Construction, Traffic load, Others
Depth	30 cm	Ground Asphalt, Concrete, Gravel, Grass, Others
Leakage Size	Large, Middelium, Small	Leakage Ququinty (Estimation) 10L/min or 0.6 m ³ /h

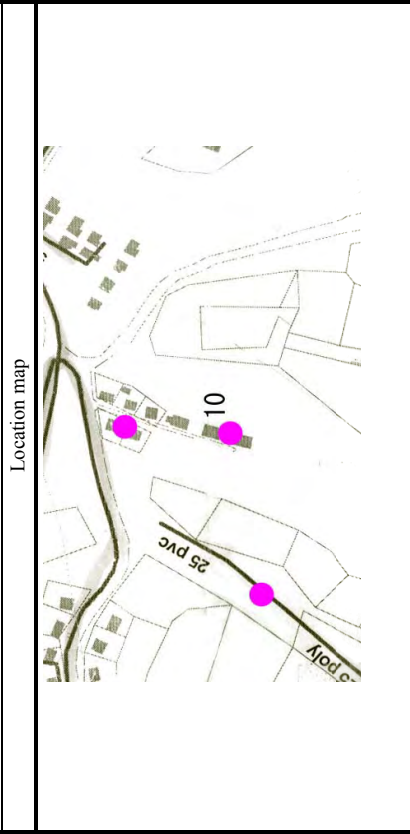
Date of Survey:	22-Jun-05	Service Pipe
Survey No.:	10	
System name:	W.R.G, W.R.P, Rove, Mataniko-P, JICA-B, Kombito, Kombito-G, Panatina, Others	
Address:	Mr. Anderson Marafice M/Qt's H/No, 15 NGOSSI	
Main Line	CIP, GP, PVC, POL, Others()	Position Pipe, Connection, Valve, Others
Diameter	"or mm	Condition Hole, Crack, Brake, Paek kin, Loose, Others
Service Line	CIP, GP, PVC, POL, Others()	Cause Corrosion, Water-pressure, Wrong Construction, Traffic load, Others
Diameter	1/2" or 13 mm	Position Pipe, Connection, Valve, Others
Depth	cm	Condition Hole, Crack, Brake, Paek kin, Loose, Others
Leakage Size	Large, Middium, Small	Cause Corrosion, Water-pressure, Deterioration, Wrong Construction, Traffic load, Others
		Ground Asphalt, Concrete, Gravel, Grass, Others
		Leakage Quantity (Measured) 16L/min or 1.0 m ³ /h

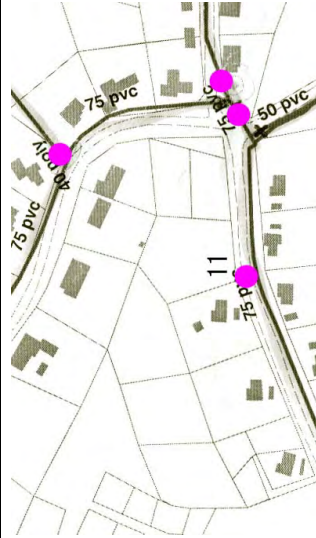
Location map

Date of Survey:	21-Jun-05	Service Pipe
Survey No.:	11	
System name:	W.R.D, W.R.P, Rove, Mataniko-P, JICA-B, Kombito, Kombito-G, Panatina, Others	
Address:	Mr. Joseph Puara H/No, PC15 TAVIO	
Main Line	CIP, GP, PVC, POL, Others()	Position Pipe, Connection, Valve, Others
Diameter	"or mm	Condition Hole, Crack, Brake, Pack kin, Looses, Others
Service Line	CIP, GP, PVC, POL, Others()	Cause Corrosion, Water-pressure, Wrong Construction, Traffic load, Others
Diameter	1/2 "or 13 mm	Position Pipe, Connection, Valve, Others
Depth	30 cm	Condition Hole, Crack, Brake, Pack kin, Looses, Others
Leakage Size	Large, <u>Middium</u> , Small	Cause Corrosion, Water-pressure, Deterioration, Wrong Construction, Traffic load, Others
	Leakage Quantity (Measured)	Ground Asphalt, Concrete, Gravel, Grass, Others
		Leakage Quantity (Estimation) 16L/min or 1.0 m ³ /h

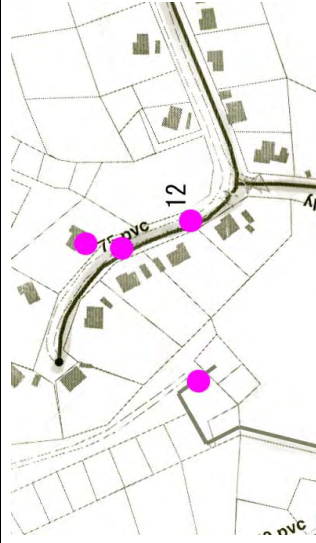
Location map

Date of Survey:	21-Jun-05	Joint
Survey No.:	12	
System name:	W.R.D, W.R.P, Rove, Mataniko-P, JICA-B, Kombito, Kombito-G, Panatina, Others	
Address:	Mr. Robert Sisilo H/No, Q993 TINGE	
Main Line	CIP, GP, PVC, POL, Others()	Position Pipe, Connection, Valve, Others
Diameter	"or mm	Condition Hole, Crack, Brake, Pack kin, Looses, Others
Service Line	CIP, GP, PVC, POL, Others()	Cause Corrosion, Water-pressure, Wrong Construction, Traffic load, Others
Diameter	1/2 "or 13 mm	Position Pipe, Connection, Valve, Others
Depth	20 cm	Condition Hole, Crack, Brake, Pack kin, Looses, Others
Leakage Size	Large, <u>Middium</u> , Small	Cause Corrosion, Water-pressure, Deterioration, Wrong Construction, Traffic load, Others
	Leakage Quantity (Estimation)	Ground Asphalt, Concrete, Gravel, Grass, Others
		Leakage Quantity (Estimation) 10L/min or 0.6 m ³ /h

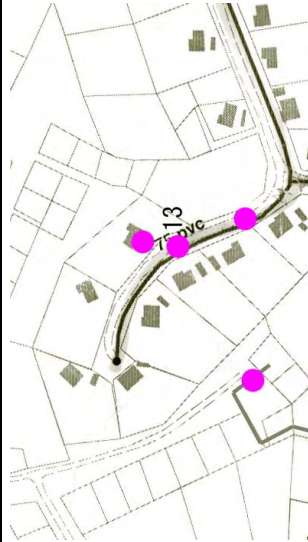
Location map

Date of Survey:	21-Jun-05	
Survey No.:	13	
System name:	Service Pipe	
Address:	W.R.P., W.R.P., Rove, Matamiko-P, JICA-B, Kombito, Kombito-G, Panatina, Others Mr. Allen Rahari Police Rove H/Qtr's TINGE	
Main Line	CIP, GP, PVC, POL, Others()	Pipe, Connection, Valve, Others
Diameter	"or mm	Hole, Crack, Brake, Pack kin, Looses, Others
Service Line	CIP, GP, PVC, POL, Others()	Corrosion, Water-pressure, Wrong Construction, Traffic load, Others
Diameter	1/2 "or 13 mm	Pipe, Connection, Valve, Others
Depth	30 cm	Hole, Crack, Brake, Pack kin, Looses, Others
Leakage Size	Large, Middles, Small	Corrosion, Water-pressure, Deterioration Wrong Construction, Traffic load, Others
	Leakage Quantity (Measured)	10L/min or 0.6m ³ /h

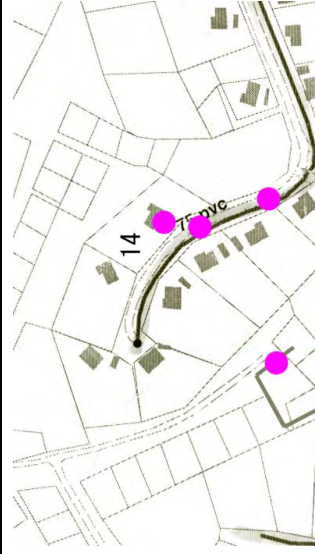
Location map

Date of Survey:	21-Jun-05	
Survey No.:	14	
System name:	Stop Cock	
Address:	W.R.P., W.R.P., Rove, Matamiko-P, JICA-B, Kombito, Kombito-G, Panatina, Others Mr. Allen Rahari Police Rove H/Qtr's TINGE	
Main Line	CIP, GP, PVC, POL, Others()	Pipe, Connection, Valve, Others
Diameter	"or mm	Hole, Crack, Brake, Pack kin, Looses, Others
Service Line	CIP, GP, PVC, POL, Others()	Corrosion, Water-pressure, Wrong Construction, Traffic load, Others
Diameter	1/2 "or 13 mm	Pipe, Connection, Valve, Others
Depth	20 cm	Hole, Crack, Brake, Pack kin, Looses, Others
Leakage Size	Large, Middles, Small	Corrosion, Water-pressure, Deterioration Wrong Construction, Traffic load, Others
	Leakage Quantity (Measured)	25L/min or 1.5m ³ /h

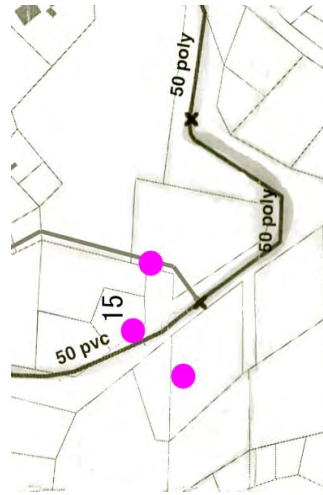
Location map

Date of Survey:	21-Jun-05	
Survey No.:	15	
System name:	Stop Cock	
Address:	W.R.P, W.R.P, Rove, Mataniko-P, JICA-B, Kombito, Kombito-G, Panatina, Others	
Main Line	CIP, GP, PVC, POL, Others()	Mr, Tony Misions police Rove TINGE
Diameter	" or mm	Pipe, Connection, Valve, Others
Service Line	CIP, GP, PVC, POL, Others()	Hole, Crack, Brake, Pack kin, Looes, Others
Diameter	1/2 " or 13 mm	Corrosion, Water-pressure, WrongConstruction, Traffic load, Others
Depth	20 cm	Pipe, Connection, Valve, Others
Leakage Size	Large, Medium, Small	Hole, Crack, Brake, Pack kin, Looes, Others
		Corrosion, Water-pressure, WrongConstruction, Traffic load, Others
		Pipe, Connection, Valve, Others
		Hole, Crack, Brake, Pack kin, Looes, Others
		Corrosion, Water-pressure, Deterioration
		WrongConstruction, Traffic load, Others
		Asphalt, Concrete, Gravel, Grass, Others
		Leakage Quantity (Estimation)

1.6L/min or 0.1 m ³ /h

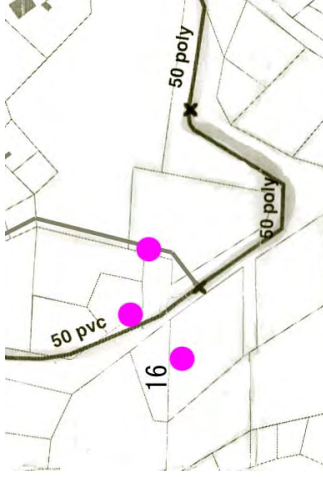
Location map

Date of Survey:	21-Jun-05	
Survey No.:	16	
System name:	Service Pipe	
Address:	W.R.P, W.R.P, Rove, Mataniko-P, JICA-B, Kombito, Kombito-G, Panatina, Others	
Main Line	CIP, GP, PVC, POL, Others()	Mr, Johnson Siapy Police Rove TINGE
Diameter	" or mm	Pipe, Connection, Valve, Others
Service Line	CIP, GP, PVC, POL, Others()	Hole, Crack, Brake, Pack kin, Looes, Others
Diameter	1/2 " or 13 mm	Corrosion, Water-pressure, WrongConstruction, Traffic load, Others
Depth	cm	Pipe, Connection, Valve, Others
Leakage Size	Large, Medium, Small	Hole, Crack, Brake, Pack kin, Looes, Others
		Corrosion, Water-pressure, WrongConstruction, Traffic load, Others
		Pipe, Connection, Valve, Others
		Hole, Crack, Brake, Pack kin, Looes, Others
		Corrosion, Water-pressure, Deterioration
		WrongConstruction, Traffic load, Others
		Asphalt, Concrete, Gravel, Grass, Others
		Leakage Quantity (Measured)
		10L/min or 0.6 m ³ /h

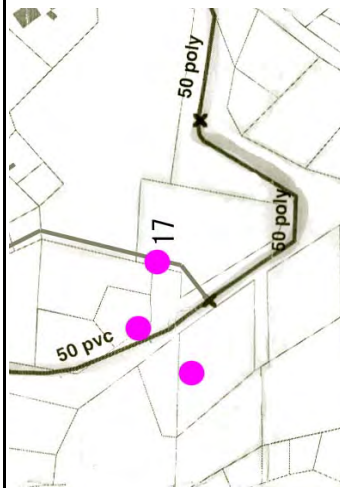
Location map

Date of Survey:	21-Jun-05	
Survey No.:	17	
System name:	W.R.C, W.R.P, Rove, Matamiko-P, JICA-B, Kombito, Kombito-G, Panatina, Others	
Address:	Mr, Beneth Roau Police Rove, TINGE	
Main Line	CIP, GP, PVC, POL, Others()	Position Condition Pipe, Connection, Valve, Others Hole, Crack, Brake, Pack kin, Looes, Others
Diameter	"or mm	Cause Corrosion, Water-pressure, Wrong Constructuon, Traffic load, Others
Service Line	CIP, GP, PVC, POL, Others()	Position Condition Pipe, Connection, Valve, Others Hole, Crack, Brake, Pack kin, Looes, Others
Diameter	1" or 25 mm	Cause Corrosion, Water-pressure, Deterioration Wrong Constructuon, Traffic load, Others
Depth	cm	Ground Asphalt, Concrete, Gravel, Grass, Others
Leakage Size	Large, Medium, Small	Leakage QuANTITY (Measured) 3L/min or 0.2 m ³ /h

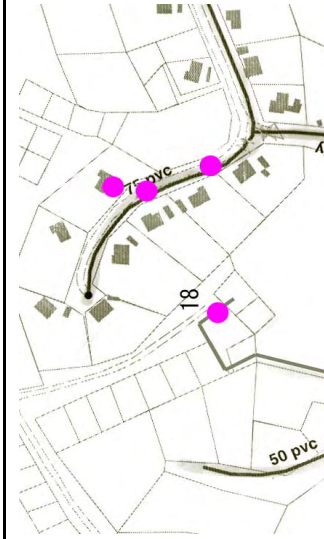
Location map

Date of Survey:	21-Jun-05	
Survey No.:	18	
System name:	W.R.C, W.R.P, Rove, Matamiko-P, JICA-B, Kombito, Kombito-G, Panatina, Others	
Address:	Mr, Laiza Rodi G, province GC7 TINGE	
Main Line	CIP, GP, PVC, POL, Others()	Position Condition Pipe, Connection, Valve, Others Hole, Crack, Brake, Pack kin, Looes, Others
Diameter	"or mm	Cause Corrosion, Water-pressure, Wrong Constructuon, Traffic load, Others
Service Line	CIP, GP, PVC, POL, Others()	Position Condition Pipe, Connection, Valve, Others Hole, Crack, Brake, Pack kin, Looes, Others
Diameter	3/4" or 20 mm	Cause Corrosion, Water-pressure, Deterioration Wrong Constructuon, Traffic load, Others
Depth	30 cm	Ground Asphalt, Concrete, Gravel, Grass, Others
Leakage Size	Large, Medium, Small	Leakage QuANTITY (Measured) 33L/min or 2.0m ³ /h

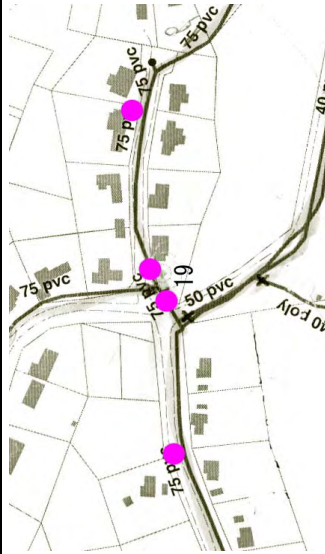
Location map

Date of Survey:	22-Jun-05	
Survey No.:	19 Valve	
System name:	W.R.P, W.R.P, Rove, Mataniko-P, JICA-B, Kombito, Kombito-G, Panatina, Others	
Address:	Redio Technich Neer High Tank TAVIO	
Main Line	CIP, GP, PVC, POL, Others()	Position Condition
Diameter	" or mm	Pipe, Connection, Valve, Others Hole, Crack, Brake, Pack kin, Looses, Others
Service Line	CIP, GP, PVC, POL, Others()	Cause Position Condition
Diameter	1/2 " or 13 mm	Corrosion, Water-pressure, Deterioration Wrong Construction, Traffic load, Others
Depth	50 cm	Ground
Leakage Size	Large, Middium, Small	Leakage Quantity (Estimation) 10L/min or 0.6 m ³ /h

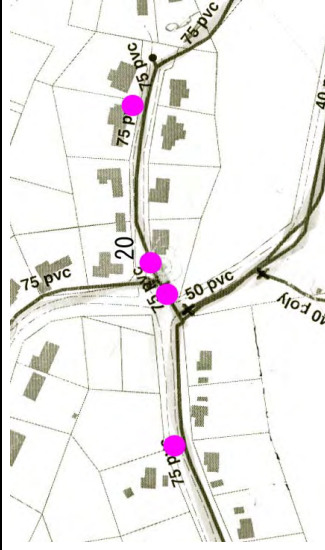
Location map

Date of Survey:	22-Jun-05	
Survey No.:	20 Valve	
System name:	W.R.P, W.R.P, Rove, Mataniko-P, JICA-B, Kombito, Kombito-G, Panatina, Others	
Address:	Redio Technich Neer High Tank TAVIO	
Main Line	CIP, GP, PVC, POL, Others()	Position Condition
Diameter	" or mm	Pipe, Connection, Valve, Others Hole, Crack, Brake, Pack kin, Looses, Others
Service Line	CIP, GP, PVC, POL, Others()	Cause Position Condition
Diameter	1/2 " or 13 mm	Corrosion, Water-pressure, Deterioration Wrong Construction, Traffic load, Others
Depth	50 cm	Ground
Leakage Size	Large, Middium, Small	Leakage Quantity (Measured) 16L/min or 1.0 m ³ /h
