## 5.2 Port of Lobito

### 5.2.1 Overview

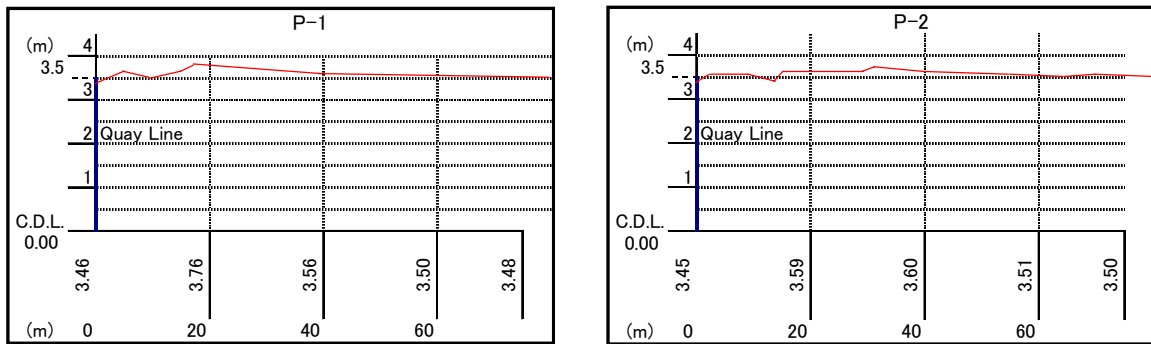
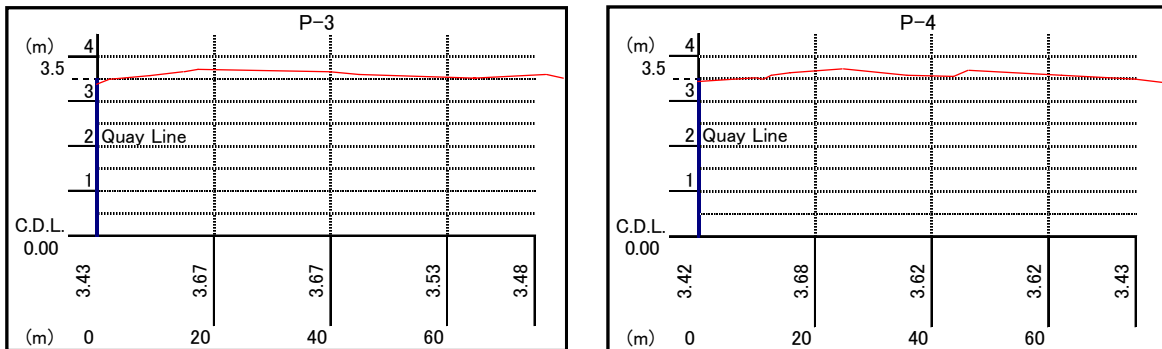
Figure 5-9 Cross Section of P-1 & P-2 at North Quay

Figure 5-10 Cross Section of P-3 & P-4 at North Quay

Height of North quay wall line shown in P-1 to P-4 is 4 cm to 8 cm lower than planned height. It is considered that some tolerable errors could be happened when quay wall was constructed. Most level of apron is over 3.5 m with the setting up transversal gradient due consideration to the rainfall intensity. Height of South quay wall line from P-5 to P-7 is 6 cm to 17 cm lower than planned height; it appears at P-7 apparently. Apron height is about 3.5m at west side area of South quay; however ground level where is located at backside of apron in west side of South quay is lower than 3.5 m. Lower ground level is not paved. East side of South quay is lower than planned level because, no pavement was done and earth retaining wall was collapsed.

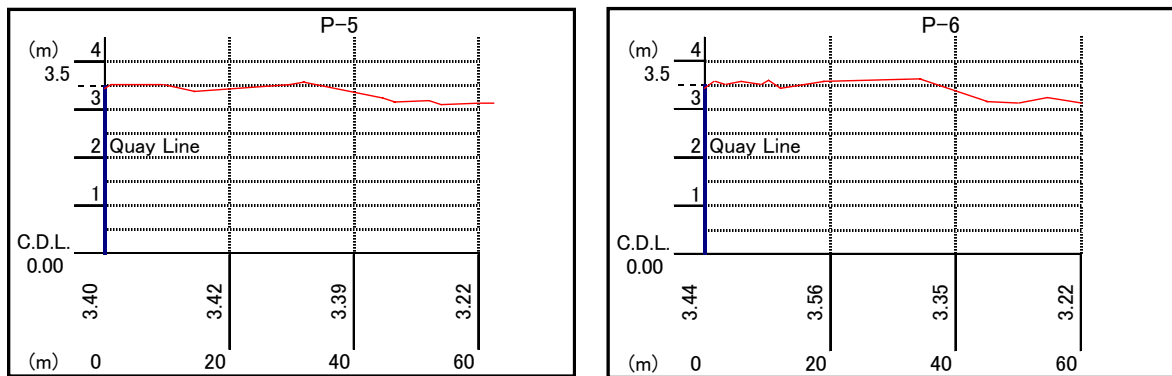
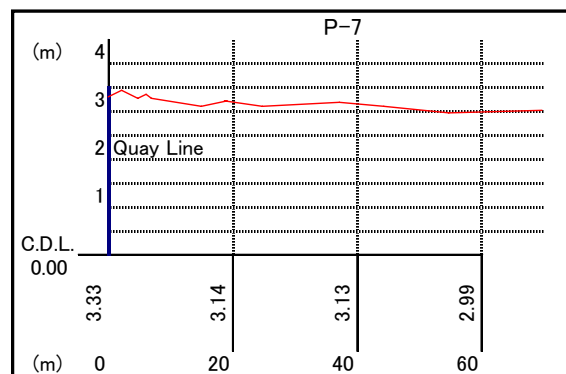
Figure 5-11 Cross Section of P-5 & P-6 at South Quay

Figure 5-12 Cross Section of P-7 at South Quay

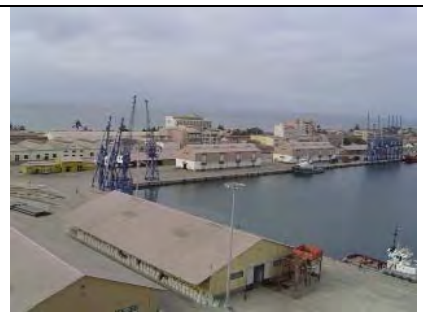
Warehouse closed to the quay front

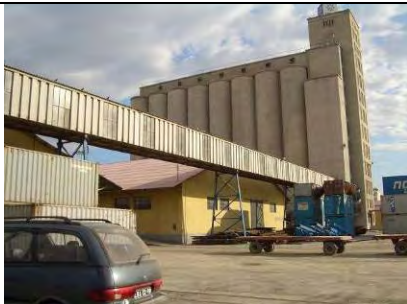
A silo, the belt conveyor which do not operate anymore for dozens of years

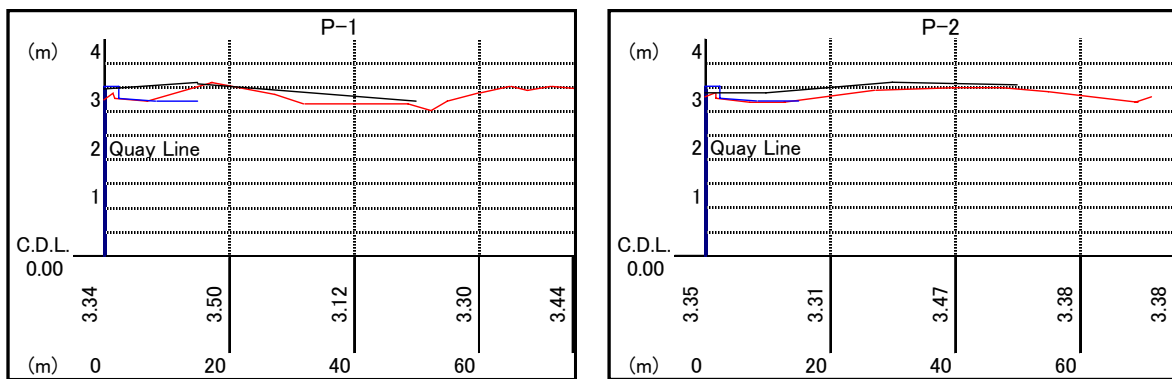
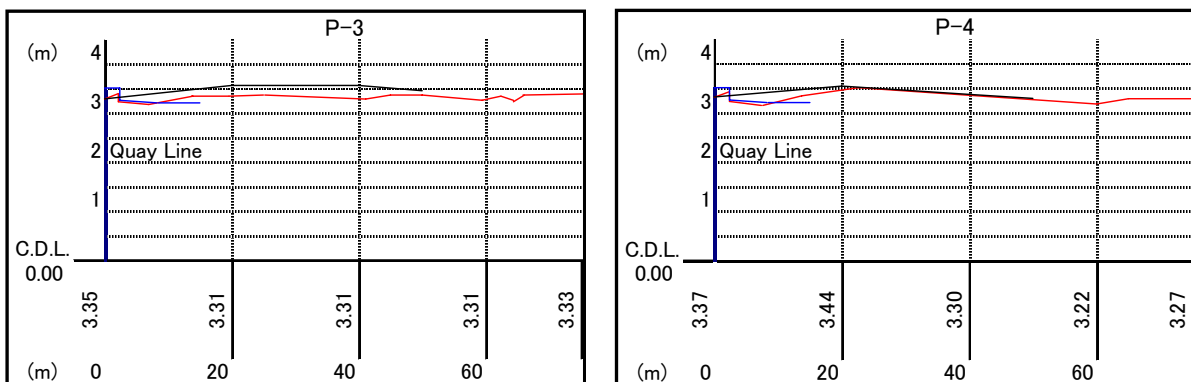
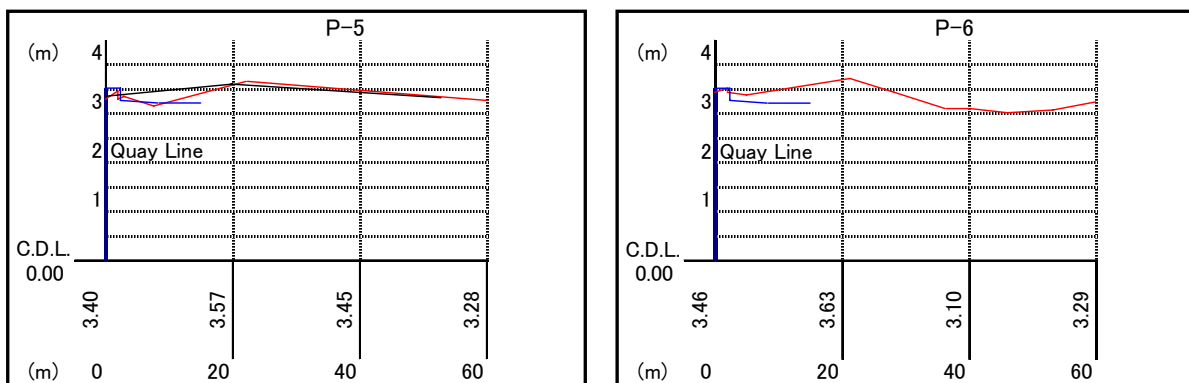
Figure 5-20 Cross Section of P-1 & P-2

Figure 5-21 Cross Section of P-3 & P-4

Figure 5-22 Cross Section of P-5 & P-6

According to the survey result, wharf front is depressed than original design since the coping concrete is lost here and there. Red and black lines in the above are elevated than planned height except wharf front. It is considered that wharf became uneven due to possible heavy cargo transportation like container and granite.

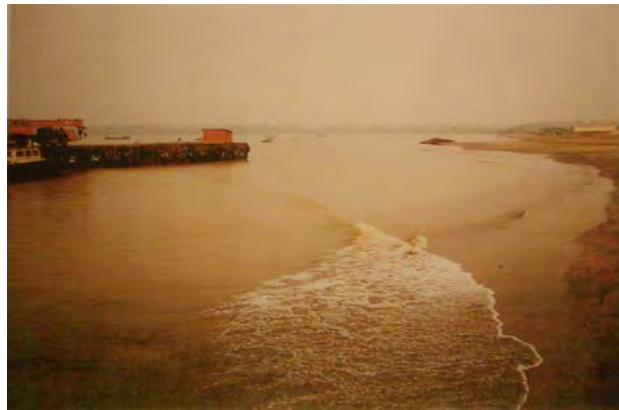
**Photo 5-22 Port of Cabinda in 1998**

Flat land less than 200 meters ASL stretches out in Cabinda province except north-east area. Pictures given below are Port of Cabinda in 1998 and 2005. There was a boat mooring behind the jetty in 1998 (see Photo 5-22). However, the depth around here is now CDL 0.4 meters only, and no boat is able to moor behind the jetty (see Photo 5-23). Bottom of flat barge is touched to sea bed because, it is very shallow at east end of jetty.

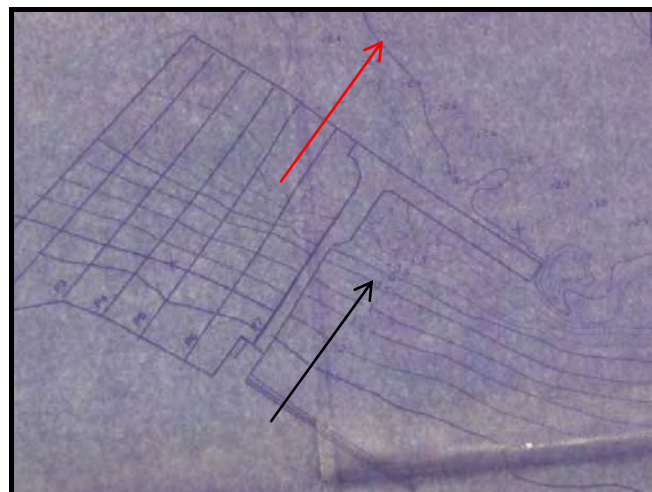
**Figure 5-31 Sounding Chart at Port of Cabinda in 1998**

Red arrow indicates -2.5 meters contour line in sounding chart of 1998 as shown in Figure 5-31, also it became shallower at east end of jetty. Therefore, Port of Cabinda carried out dredging in this area. We found that it keeps in certain depth at middle part of the jetty, however sand had accumulated behind the jetty and east end of the jetty. According to the findings of sounding survey carried out together with staff of Port of Cabinda, this time, +0.5 meters contour line which is indicated by black arrow had moved 20 meters to offshore (see Figure 5-32).

It is conceivable that there is typical littoral drift around shore of Cabinda because tidal current direction is south-east and Port of Cabinda is located north of the Congo River.

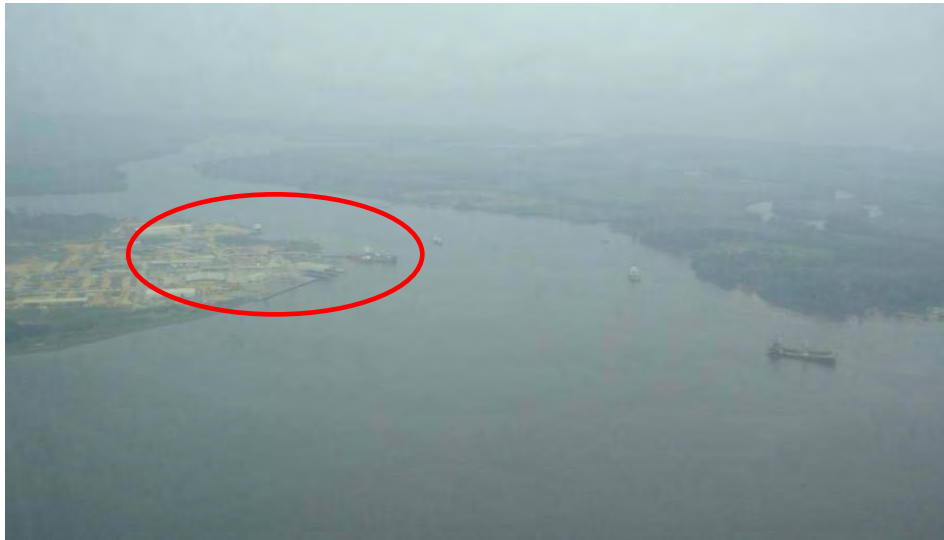
**Photo 5-24 The Port of Soyo (in red circle)**

According to the Soyo Port Authority, tidal change at Soyo port is about 1.5m. Huge volume of earth and sand flowing from Congo River creates problems for the Soyo Port Authority.

Through the review of present status and issues of the port of Soyo, following 2 points are summarized as findings of this study. Due to the settlement of sand from the Congo River, maintenance dredging is needed continuously. Due to lack of loading equipment like quay crane, shippers cannot use public berth when they want.

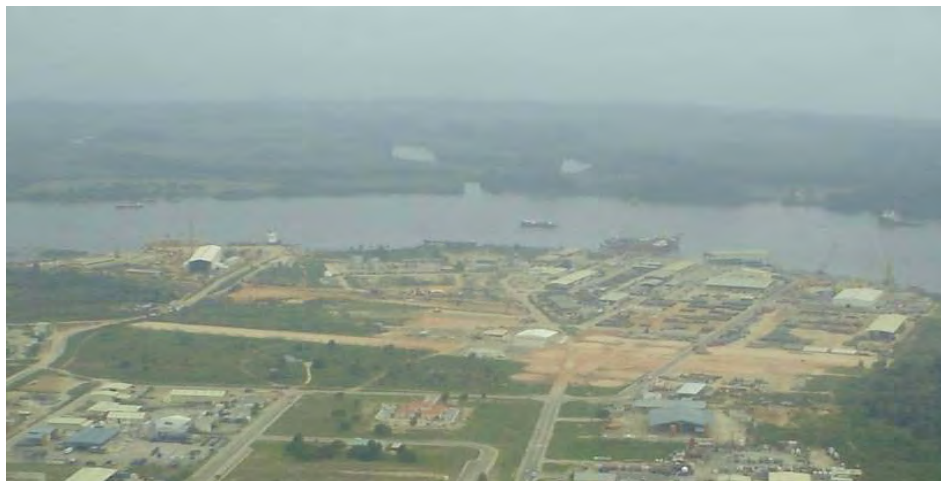
**Photo 5-25 Public Berth (left) and Kwanda's Berth**

In 1980, when the port authority was established, there were no facilities in the port. When the Kwanda oil company constructed their private facilities, they constructed berth and provided it to the port authority. The length of the berth is 200 m and its depth is 6.5 m. There is an old jetty on the Congo River. There is no superstructure, so it is not in use. Due to the earth and sand flowing from the Congo River, continual dredging is required to keep the depth of waterways and mooring basin. (see Photo 5-25, Photo 5-26 and Photo 5-27).

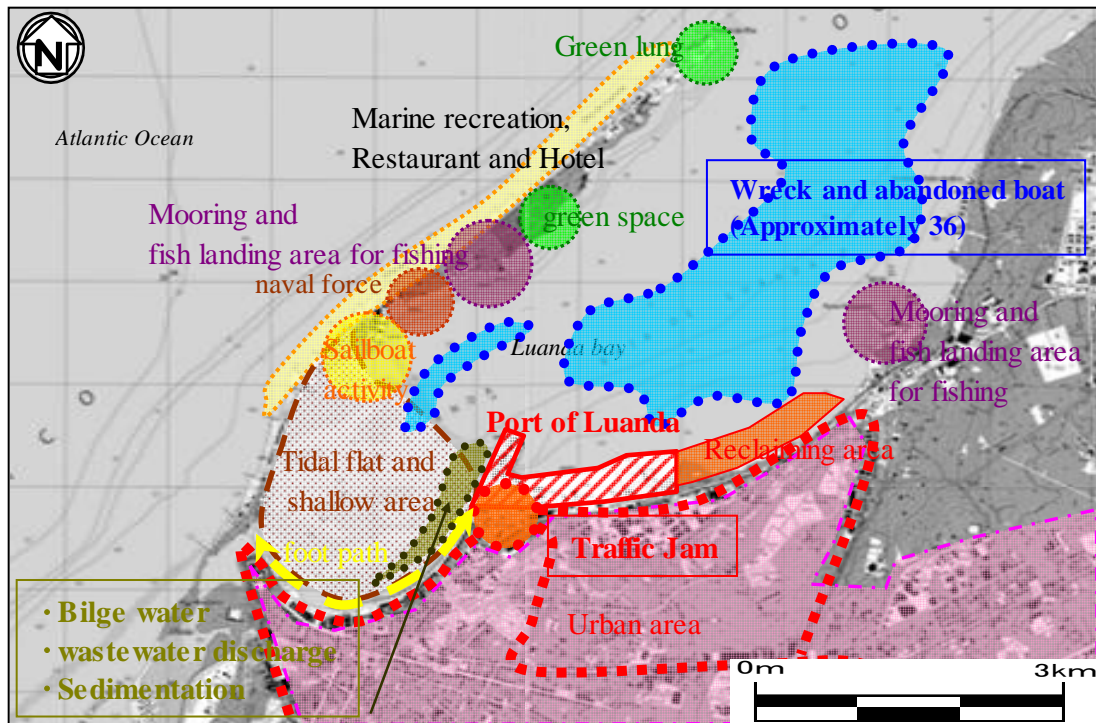
Figure 7-4 Environmental characteristics around Luanda Port

There are no rubber fenders on the domestic trade wharf which results in damage to ships' hull and the wharf itself. The port area is managed by a private company under a concession contract but most of the yard is not paved and fugitive dust is dispersed by port vehicles. The port has many unusable wharf cranes in the port concession area that are kept as remembrances of the civil war.

Since the civil war, the container yard has been very busy with increasing cargoes. The road in the yard is not wide enough and is becoming an obstacle not only to cargo handling works but also taking long time to take cargoes as well as administration and it leads to the hike of cargo handling fee. There is a suggestion that long kept empty container become corrupt and lead to soil pollution.
