## THE STUDY ON URGENT REHABILITATION PROGRAM OF PORTS IN THE REPUBLIC OF ANGOLA

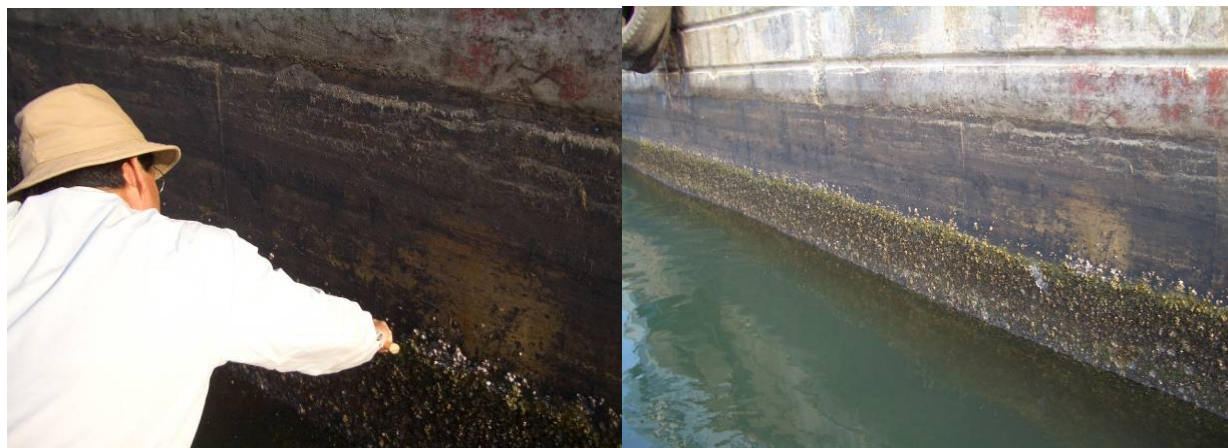
<b>Facility ID</b>	Lo -03 -003	<b>Survey Date</b>	2005/06/01
<b>Port Name</b>	Lobito	<b>Category</b>	Quaywall
<b>Year Constructed</b>	1934		
<b>Maintenance Record</b>	unknown		
<b>Facility Description</b>	Berth No.1 From Bollard No.2 to No.3		
<b>Existing Condition</b>	There can not be seen any damages to be pointed out.		
<b>Structural Condition Assessment</b>	<p style="text-align: center;"><b>Grade 0</b></p> <p>The facility is in sound condition. Detailed survey is not required.</p>		
<b>Location</b>

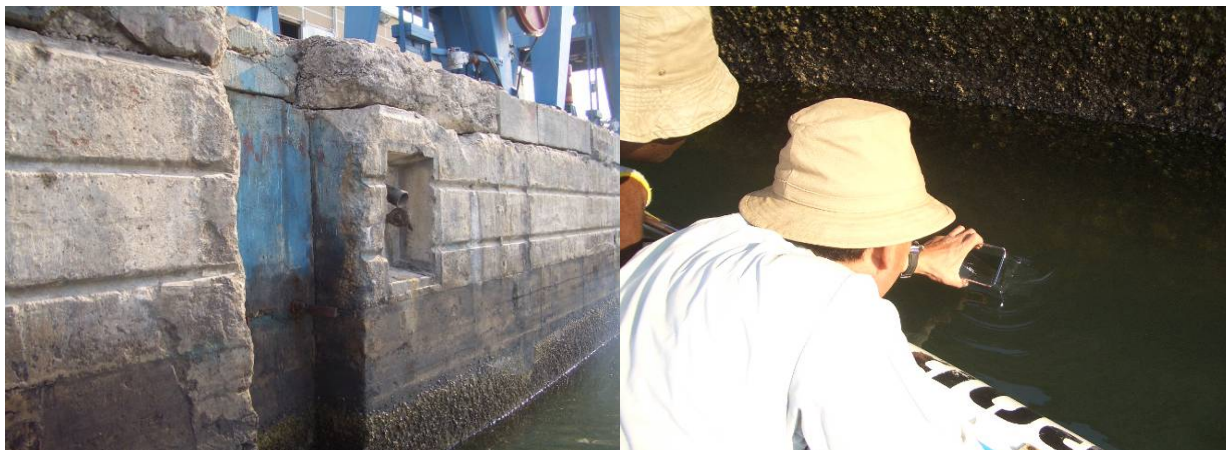
<b>Facility ID</b>	Lo -03 -004	<b>Survey Date</b>	2005/06/01
<b>Port Name</b>	Lobito	<b>Category</b>	Quaywall
<b>Year Constructed</b>	1934		
<b>Maintenance Record</b>	unknown		
<b>Facility Description</b>	Berth No.1 From Bollard No.3 to No.4		
<b>Existing Condition</b>	There can not be seen any damages to be pointed out.		
<b>Structural Condition Assessment</b>	<p style="text-align: center;"><b>Grade 0</b></p> <p>The facility is in sound condition. Detailed survey is not required.</p>		
<b>Location</b>

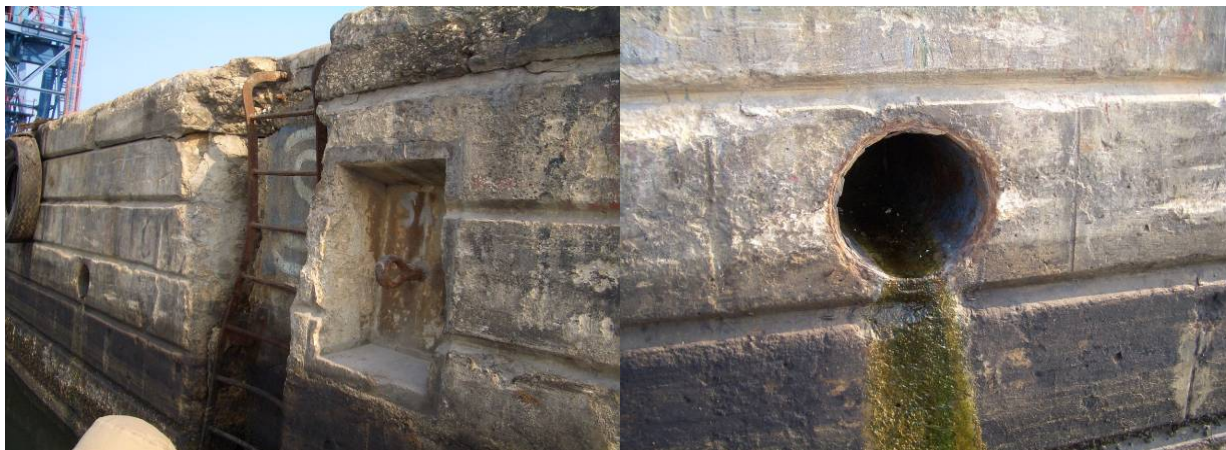
<b>Facility ID</b>	Lo -03 -005	<b>Survey Date</b>	2005/06/01
<b>Port Name</b>	Lobito	<b>Category</b>	Quaywall
<b>Year Constructed</b>	1934		
<b>Maintenance Record</b>	unknown		
<b>Facility Description</b>	Berth No.1 From Bollard No.4 to No.5		
<b>Existing Condition</b>	There can not be seen any damages to be pointed out.		
<b>Structural Condition Assessment</b>	<p style="text-align: center;"><b>Grade 0</b></p> <p>The facility is in sound condition. Detailed survey is not required.</p>		
<b>Location</b>

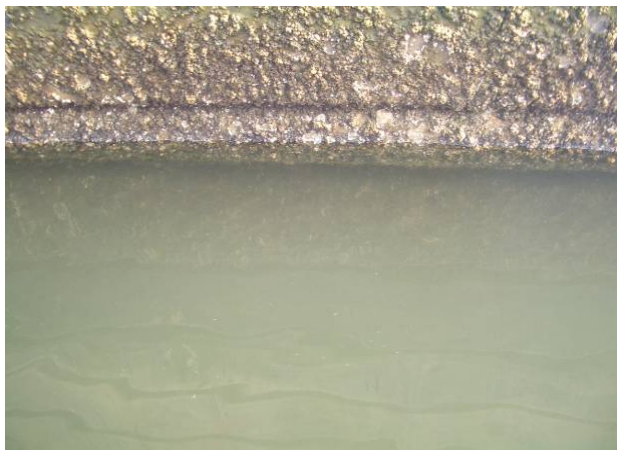
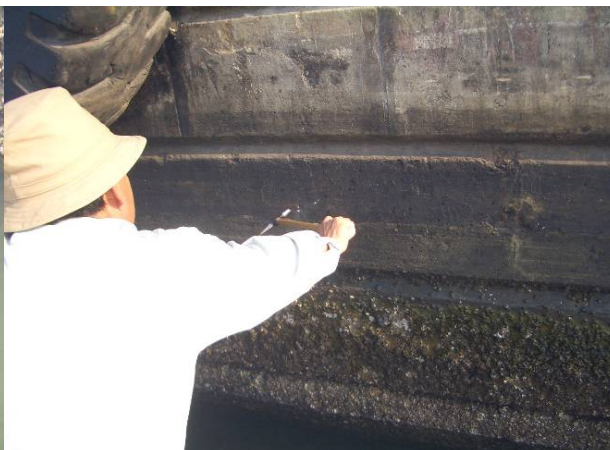
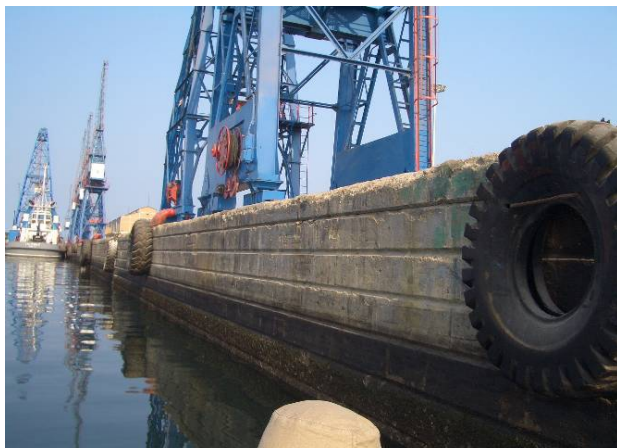
<b>Facility ID</b>	Lo -03 -006	<b>Survey Date</b>	2005/06/01
<b>Port Name</b>	Lobito	<b>Category</b>	Quaywall
<b>Year Constructed</b>	1934		
<b>Maintenance Record</b>	unknown		
<b>Facility Description</b>	Berth No.1 From Bollard No.5 to No.6		
<b>Existing Condition</b>	There can not be seen any damages to be pointed out.		
<b>Structural Condition Assessment</b>	<p style="text-align: center;"><b>Grade 0</b></p> <p>The facility is in sound condition. Detailed survey is not required.</p>		
<b>Location</b>

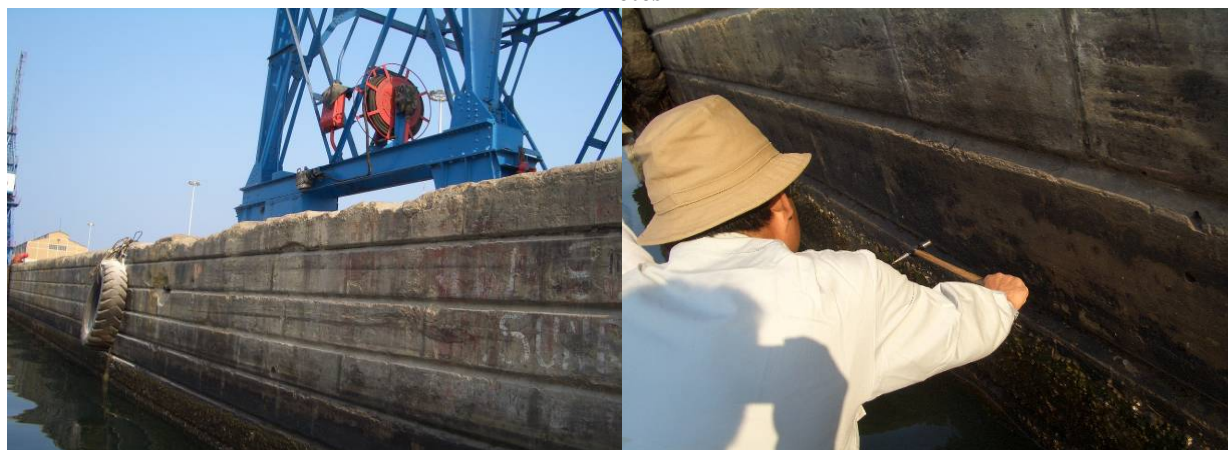
<b>Facility ID</b>	Lo -03 -007	<b>Survey Date</b>	2005/06/01
<b>Port Name</b>	Lobito	<b>Category</b>	Quaywall
<b>Year Constructed</b>	1928		
<b>Maintenance Record</b>	unknown		
<b>Facility Description</b>	Berth No.2 From Bollard No.6 to No.7		
<b>Existing Condition</b>	There can not be seen any damages to be pointed out.		
<b>Structural Condition Assessment</b>	<p style="text-align: center;"><b>Grade 0</b></p> <p>The facility is in sound condition. Detailed survey is not required.</p>		
<b>Location</b>

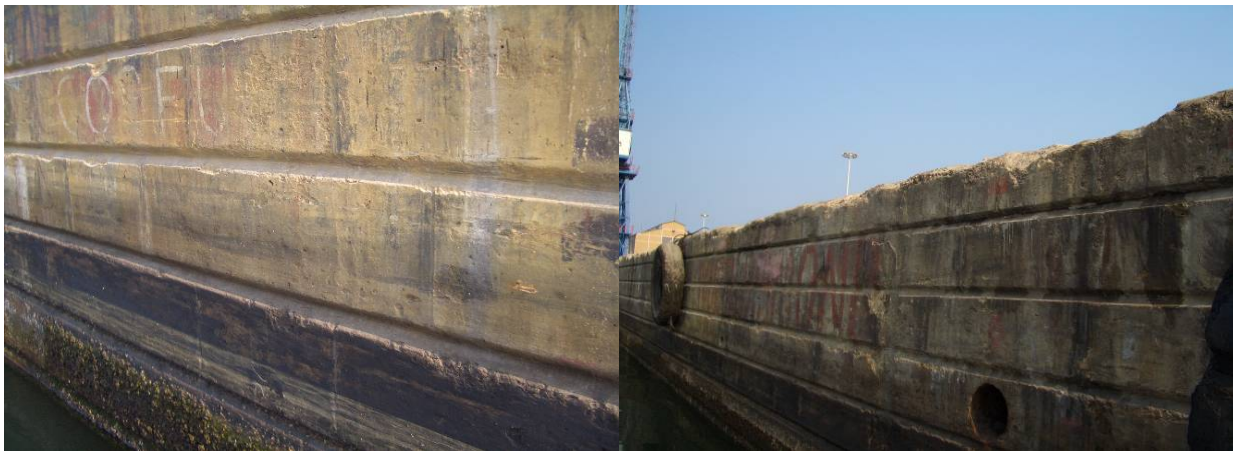
<b>Facility ID</b>	Lo -03 -008	<b>Survey Date</b>	2005/06/01			
<b>Port Name</b>	Lobito	<b>Category</b>	Quaywall			
<b>Year Constructed</b>	1928					
<b>Maintenance Record</b>	unknown					
<b>Facility Description</b>	Berth No.2 From Bollard No.7 to No.8					
<b>Existing Condition</b>	There can not be seen any damages to be pointed out.					
<b>Structural Condition Assessment</b>	<p style="text-align: center;"><b>Grade 0</b></p> <p>The facility is in sound condition. Detailed survey is not required.</p>					
<b>Location</b>

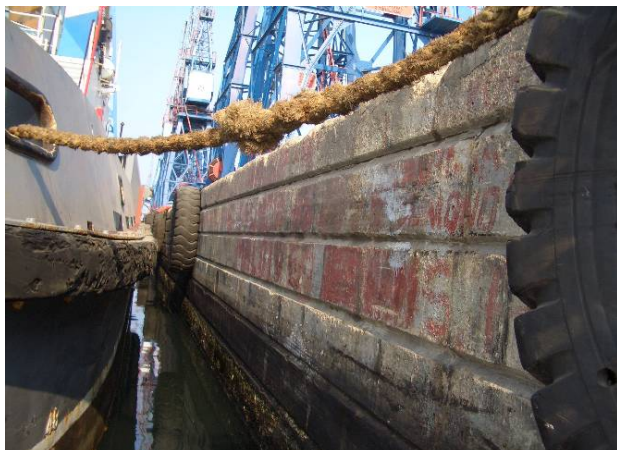
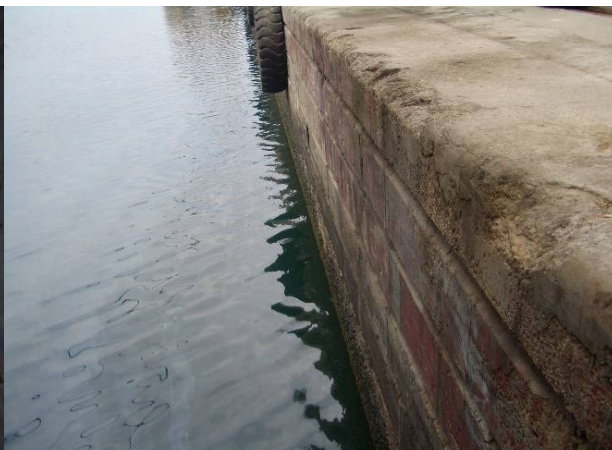
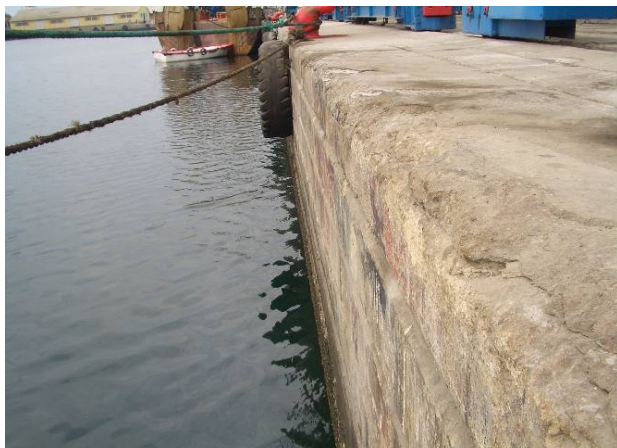
<b>Facility ID</b>	Lo -03 -010	<b>Survey Date</b>	2005/06/01, 10/04
<b>Port Name</b>	Lobito	<b>Category</b>	Quaywall
<b>Year Constructed</b>	1928		
<b>Maintenance Record</b>	unknown		
<b>Facility Description</b>	Berth No.2 From Bollard No.9 to No.10		
<b>Existing Condition</b>	There can not be seen any damages to be pointed out.		
<b>Structural Condition Assessment</b>	<p style="text-align: center;"><b>Grade 0</b></p> <p>The facility is in sound condition. Detailed survey is not required.</p>		
<b>Location</b>

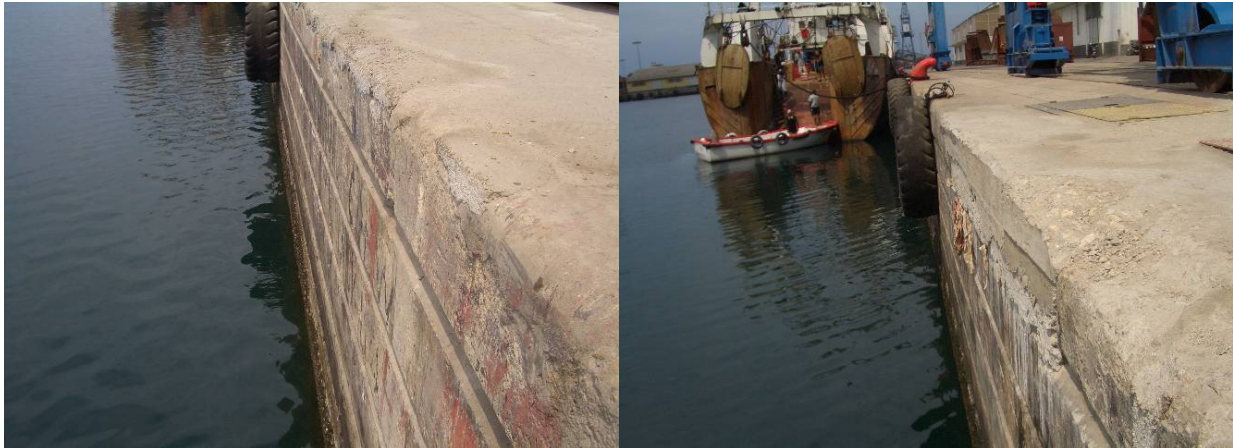
<b>Facility ID</b>	Lo -03 -011	<b>Survey Date</b>	2005/10/04			
<b>Port Name</b>	Lobito	<b>Category</b>	Quaywall			
<b>Year Constructed</b>	1928					
<b>Maintenance Record</b>	unknown					
<b>Facility Description</b>	Berth No.2 From Bollard No.10 to No.11					
<b>Existing Condition</b>	There can not be seen any damages to be pointed out.					
<b>Structural Condition Assessment</b>	<p style="text-align: center;"><b>Grade 0</b></p> <p>The facility is in sound condition. Detailed survey is not required.</p>					
<b>Location</b>

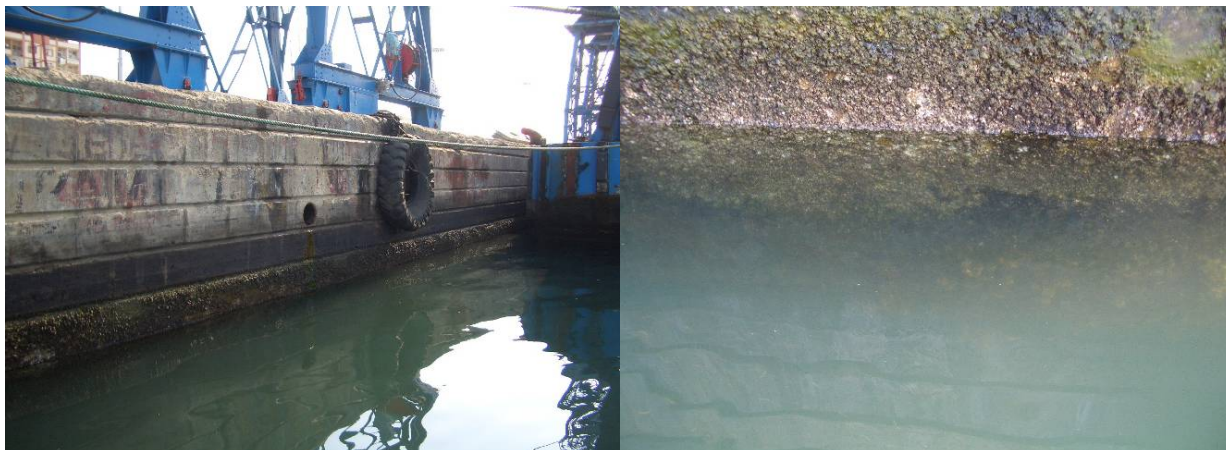
<b>Facility ID</b>	Lo -03 -013	<b>Survey Date</b>	2005/06/01
<b>Port Name</b>	Lobito	<b>Category</b>	Quaywall
<b>Year Constructed</b>	1934		
<b>Maintenance Record</b>	unknown		
<b>Facility Description</b>	Berth No.3 From Bollard No.12 to No.13		
<b>Existing Condition</b>	There can not be seen any damages to be pointed out.		
<b>Structural Condition Assessment</b>	<p style="text-align: center;"><b>Grade 0</b></p> <p>The facility is in sound condition. Detailed survey is not required.</p>		
<b>Location</b>

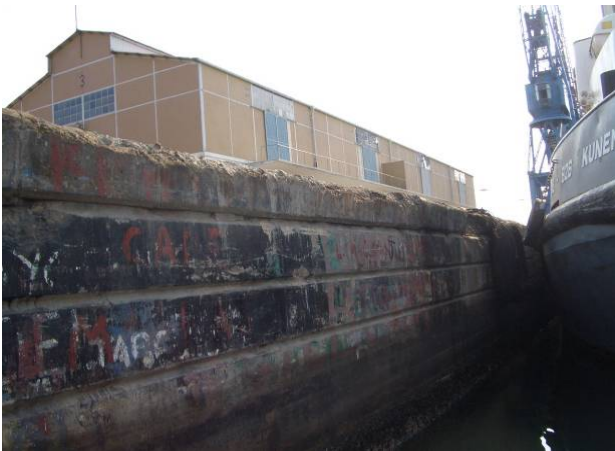
Facility ID	Lo -03 -015	Survey Date	2005/06/01
Port Name	Lobito	Category	Quaywall
Year Constructed	1934		
Maintenance Record	unknown		
Facility Description	Berth No.3 From Bollard No.14 to No.15		
Existing Condition	There can not be seen any damages to be pointed out.		
Structural Condition Assessment	<div>Grade 0</div> <div>The facility is in sound condition. Detailed survey is not required.</div>		
Location

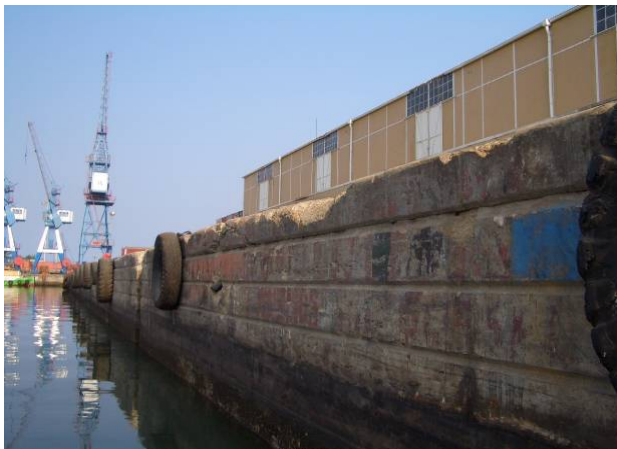
Facility ID	Lo -03 -016	Survey Date	2005/06/01
Port Name	Lobito	Category	Quaywall
Year Constructed	1934		
Maintenance Record	unknown		
Facility Description	Berth No.4 From Bollard No.15 to No.16		
Existing Condition	There can not be seen any damages to be pointed out.		
Structural Condition Assessment	<div>Grade 0</div> <div>The facility is in sound condition. Detailed survey is not rquired.</div>		
Location
