**THE STUDY ON URGENT REHABILITATION PROGRAM OF PORTS IN THE REPUBLIC OF ANGOLA**

<b>Facility ID</b>	Na -02 -012	<b>Survey Date</b>	2005/05/17, 10/12
<b>Port Name</b>	Namibe	<b>Category</b>	Coping Concrete
<b>Year Constructed</b>	1953-1957		
<b>Maintenance Record</b>	unknown		
<b>Facility Description</b>	Berth No.3 From Bollard No.11 to No.12 A crane socket is found.		
<b>Existing Condition</b>	The edges of the coping concrete are chipped off throughout the length of interval.		
<b>Structural Condition Assessment</b>	<b>Grade 2</b>		
	The facility is in structurally bad condition. It will become the object of rehabilitation plan.		
<b>Location</b>

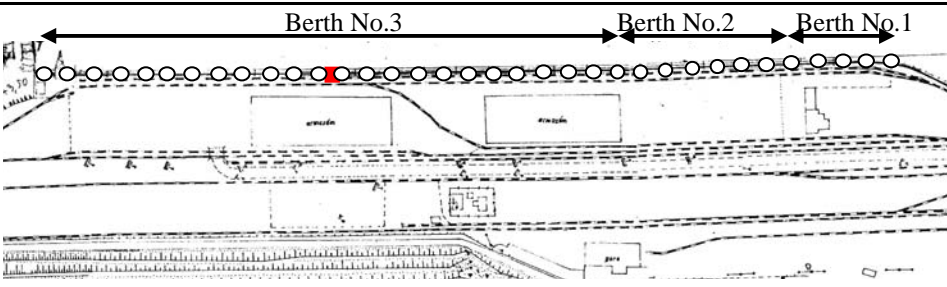
<b>Facility ID</b>	Na -02 -013	<b>Survey Date</b>	2005/05/17, 10/12
<b>Port Name</b>	Namibe	<b>Category</b>	Coping Concrete
<b>Year Constructed</b>	1953-1957		
<b>Maintenance Record</b>	unknown		
<b>Facility Description</b>	Berth No.3 From Bollard No.12 to No.13 A sewage discharge point is found.		
<b>Existing Condition</b>	The edges of the coping concrete are chipped off throughout the length of interval.		
<b>Structural Condition Assessment</b>	<b>Grade 2</b>		
	The facility is in structurally bad condition. It will become the object of rehabilitation plan.		
<b>Location</b>

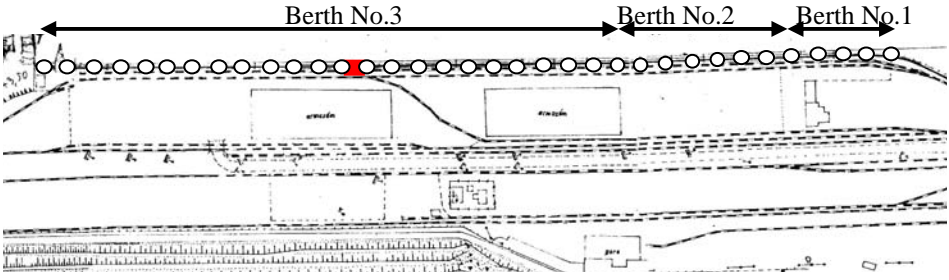
<b>Facility ID</b>	Na -02 -014	<b>Survey Date</b>	2005/05/17, 10/12
<b>Port Name</b>	Namibe	<b>Category</b>	Coping Concrete
<b>Year Constructed</b>	1953-1957		
<b>Maintenance Record</b>	unknown		
<b>Facility Description</b>	Berth No.3 From Bollard No.13 to No.14 An water supply bulb is found.		
<b>Existing Condition</b>	The edges of the coping concrete are chipped off throughout the length of interval.		
<b>Structural Condition Assessment</b>	<b>Grade 2</b>		
	The facility is in structurally bad condition. It will become the object of rehabilitation plan.		
<b>Location</b>

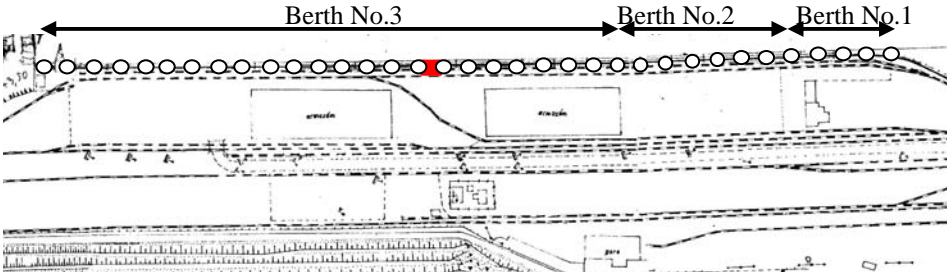
<b>Facility ID</b>	Na -02 -017	<b>Survey Date</b>	2005/05/17, 10/12
<b>Port Name</b>	Namibe	<b>Category</b>	Coping Concrete
<b>Year Constructed</b>	1953-1957		
<b>Maintenance Record</b>	unknown		
<b>Facility Description</b>	Berth No.3 From Bollard No.16 to No.17 A sewage discharge point, an water supply bulb and crane socket are found.		
<b>Existing Condition</b>	The edges of the coping concrete are chipped off throughout the length of interval.		
<b>Structural Condition Assessment</b>	<b>Grade 2</b>		
	The facility is in structurally bad condition. It will become the object of rehabilitation plan.		
<b>Location</b>

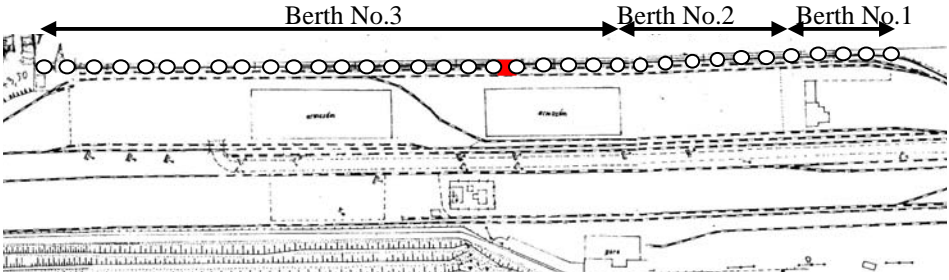
<b>Facility ID</b>	Na -02 -020	<b>Survey Date</b>	2005/05/17, 10/12
<b>Port Name</b>	Namibe	<b>Category</b>	Coping Concrete
<b>Year Constructed</b>	1953-1957		
<b>Maintenance Record</b>	unknown		
<b>Facility Description</b>	Berth No.3 From Bollard No.19 to No.20		
<b>Existing Condition</b>	The edges of the coping concrete are chipped off throughout the length of interval. There can be seen lack of the coping concrete (encircled part in the photo hereunder).		
<b>Structural Condition Assessment</b>	<b>Grade 2</b>		
	The facility is in structurally bad condition. It will become the object of rehabilitation plan.		
<b>Location</b>

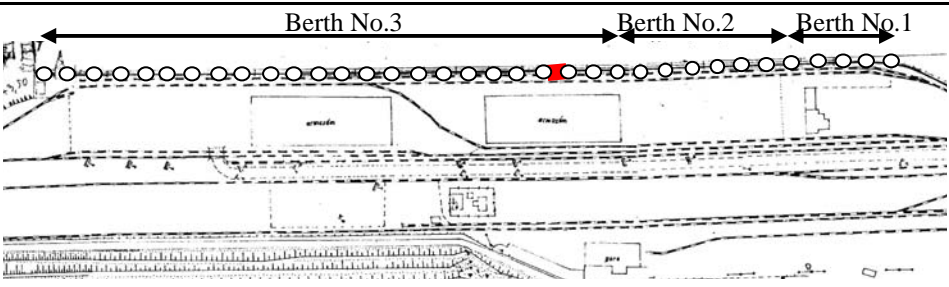
<b>Facility ID</b>	Na -02 -022	<b>Survey Date</b>	2005/05/17, 10/12
<b>Port Name</b>	Namibe	<b>Category</b>	Coping Concrete
<b>Year Constructed</b>	1953-1957		
<b>Maintenance Record</b>	unknown		
<b>Facility Description</b>	Berth No.3 From Bollard No.21 to No.22 A crane socket is found.		
<b>Existing Condition</b>	The edges of the coping concrete are chipped off throughout the length of interval.		
<b>Structural Condition Assessment</b>	<b>Grade 2</b>		
	The facility is in structurally bad condition. It will become the object of rehabilitation plan.		
<b>Location</b>

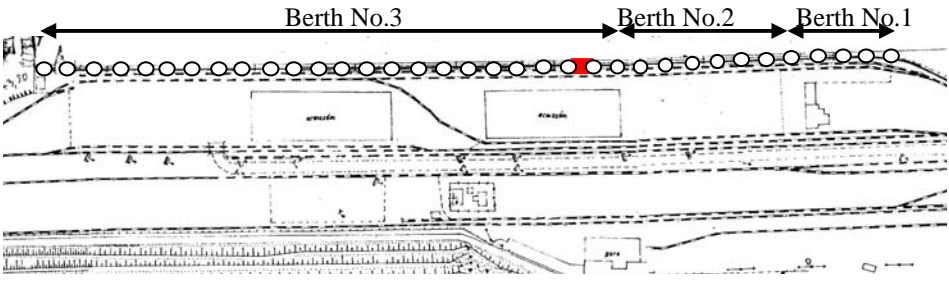
<b>Facility ID</b>	Na -02 -023	<b>Survey Date</b>	2005/05/17, 10/12
<b>Port Name</b>	Namibe	<b>Category</b>	Coping Concrete
<b>Year Constructed</b>	1953-1957		
<b>Maintenance Record</b>	unknown		
<b>Facility Description</b>	Berth No.3 From Bollard No.22 to No.23 A sewage discharge point and a crane socket are found.		
<b>Existing Condition</b>	The edges of the coping concrete are chipped off throughout the length of interval.		
<b>Structural Condition Assessment</b>	<b>Grade 2</b>		
	The facility is in structurally bad condition. It will become the object of rehabilitation plan.		
<b>Location</b>

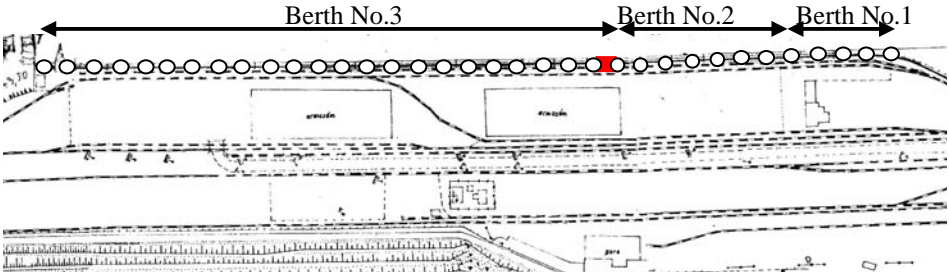
<b>Facility ID</b>	Na -02 -024	<b>Survey Date</b>	2005/05/17, 10/12
<b>Port Name</b>	Namibe	<b>Category</b>	Coping Concrete
<b>Year Constructed</b>	1953-1957		
<b>Maintenance Record</b>	unknown		
<b>Facility Description</b>	Berth No.3 From Bollard No.23 to No.24 A crane socket is found.		
<b>Existing Condition</b>	The edges of the coping concrete are chipped off throughout the length of interval.		
<b>Structural Condition Assessment</b>	<b>Grade 2</b>		
	The facility is in structurally bad condition. It will become the object of rehabilitation plan.		
<b>Location</b>
