# **EXISTING CONDITION OF THE WATER SUPPLY AND SANITATION / SEWERAGE SYSTEMS**

### 3.1      Water Supply System

### 3.1.2 Salaulim Water Supply Scheme

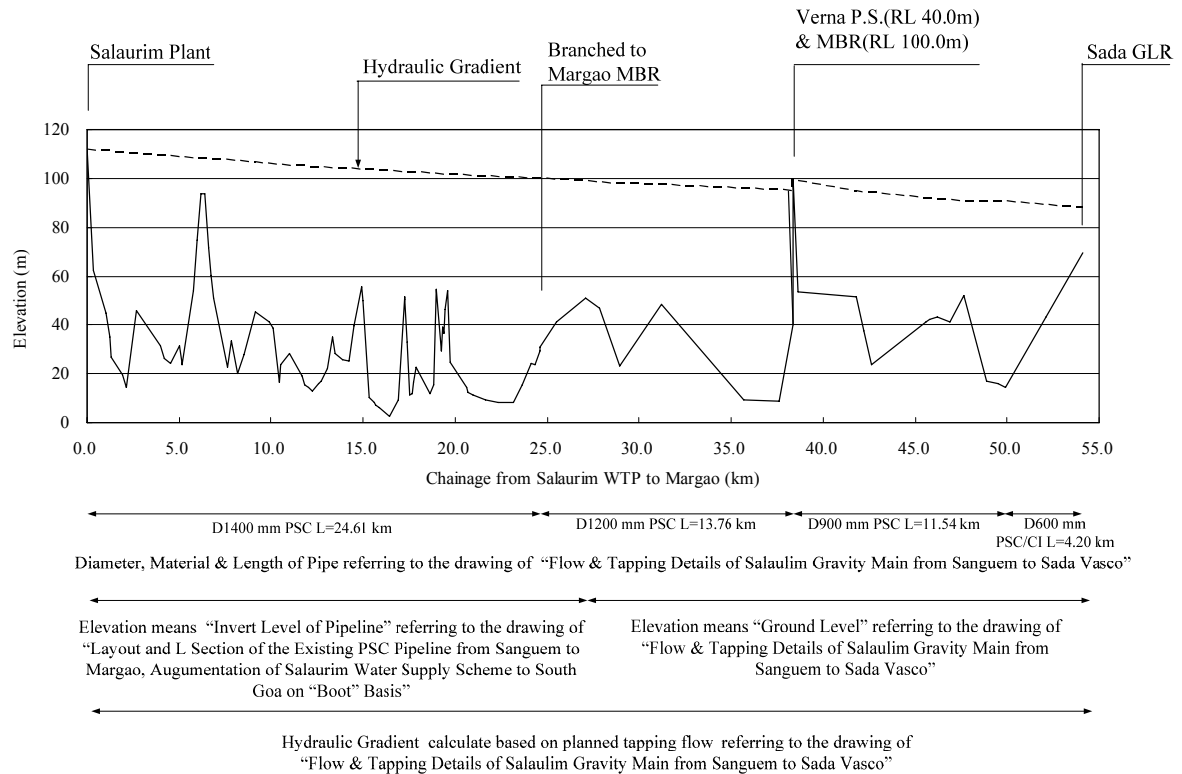
**Figure 31.5 Longitudinal Section along the Transmission Mains from Salaulim WTP**

Figure 31.5 shows the longitudinal section along the main route of transmission mains, between the Salaulim WTP and Vasco da Gama City. The PWD has replaced the first 10 kilometres of

the old PSC pipes with mild steel pipes. This was necessary because the existing pipes were corroding and there was a lack of re-bars for the PSC pipes.

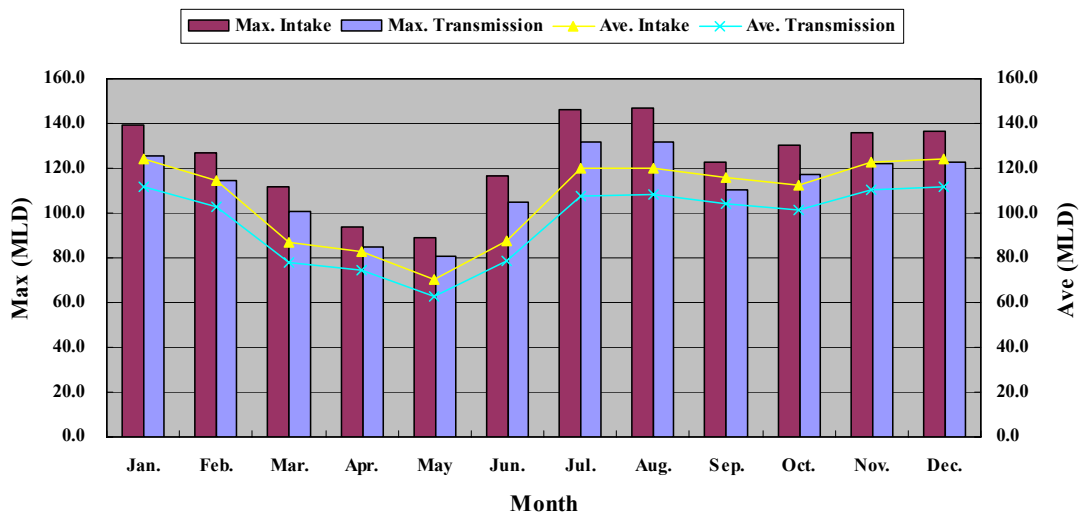
**Figure 31.12 Intake and Transmission Flow Rates**

The total intake flow rates for Plant I, Plant II and Plant III (having a combined total capacity of 92 MLD) was calculated from pump capacity and pump operation hours. These flow rates are shown in Figure 31.12. Figure 31.12 indicates that the plants are overloaded.

Since Plant IV was only commissioned in 2004 there are no accumulated records. When the flow meter was checked during the site visit, the intake flow was 60,700 m<sup>3</sup>/day which is 1.5 times above the design capacity.
