4.2 Damage Estimation for Facilities and Equipment

4.2.1 Preliminary Seismic Diagnosis

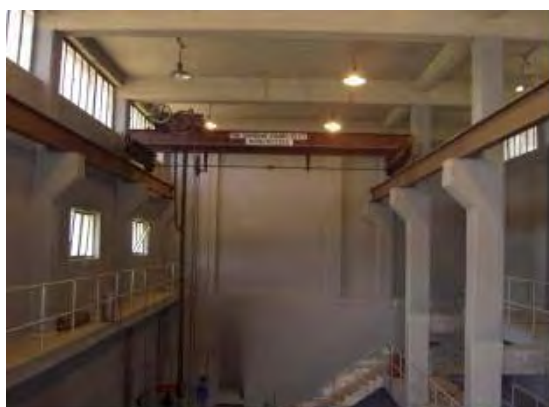
**Picture 4-2-4 Early design of No.2 Pump House
Designed by English (1955)**

The cross section of the design by subsequent Iranians is larger than the early design by the English. Old structure is classified into two categories (early design and subsequent Iranian design), and detailed earthquake-resistant diagnosis shall be performed based on structural analysis.

TWWC has not analyzed the early design. Structural analysis is performed for pump house No.2 as a typical model of early design in this Study.

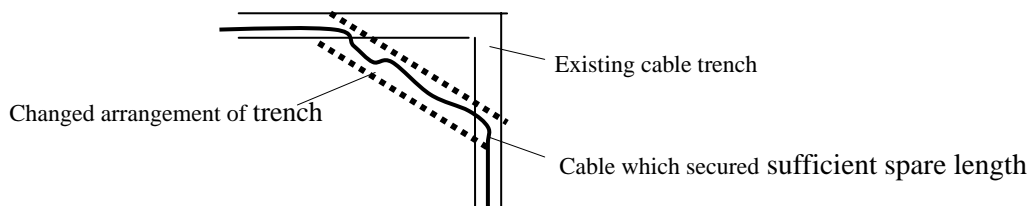
Figure 4.2.2 Plan of Cable Trench

It seems that there is not enough spare length of cable at most of the facilities. If possible, rewiring with enough spare length of the cable would be proposed for the important equipments. Otherwise right-angled trench might be changed as shown in the following figure, and length of cable needs to have enough allowance.

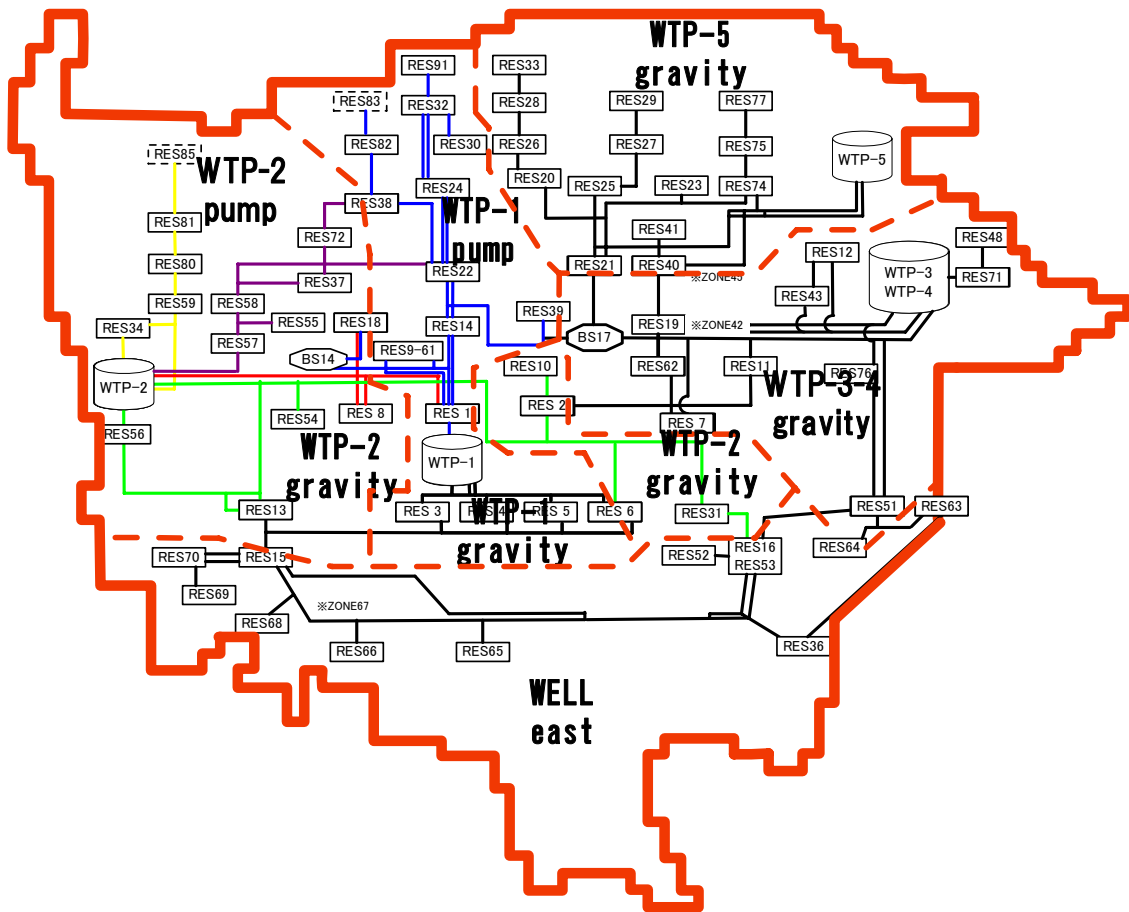
Figure 4.3.2 Approximate Service Area of Treatment Plants

Figure 4.3.2 shows service area of each water treatment plant as of July 2005. Speculation of water suspension area is shown in the figure, in case of no operation change in pumps, valves and pipes. Thus, wide area would suffer from water shortage by stoppage of each one of the five treatment plants.

As shown in the figure and table, damage level (represented in number of reservoirs with insufficient inflow) in each case diminishes except for Case 2 and 5, both of which have several reservoirs of insufficient flow. However, a lot of changes in operation must be made in these cases. It is ideal but not realistic to alter so many operating conditions manually in a short period after earthquake disaster.

By these analyses, it is recognized that 2,000mm concrete raw water mains to plant No.2 and 1,850 mm concrete pipelines are very important and need proper earthquake resistant measures.
