## CHAPTER 9 SELECTION OF 10 BRIDGES FOR REHABILITATION, REINFORCEMENT

### 10.1 Identification of Deterioration in 10 Bridges

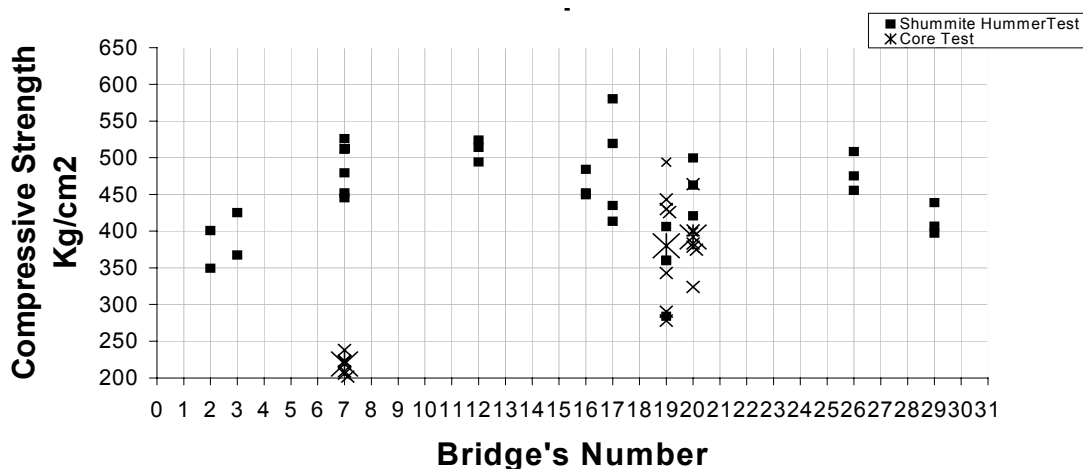
Figure 10.1.5. Result of Compression Test

Those results of both compression tests ensure that actual compressive strength meets the strength specified in General Notes of original drawing, and that there are thoroughly no problems regarding concrete strength in 10 bridges.

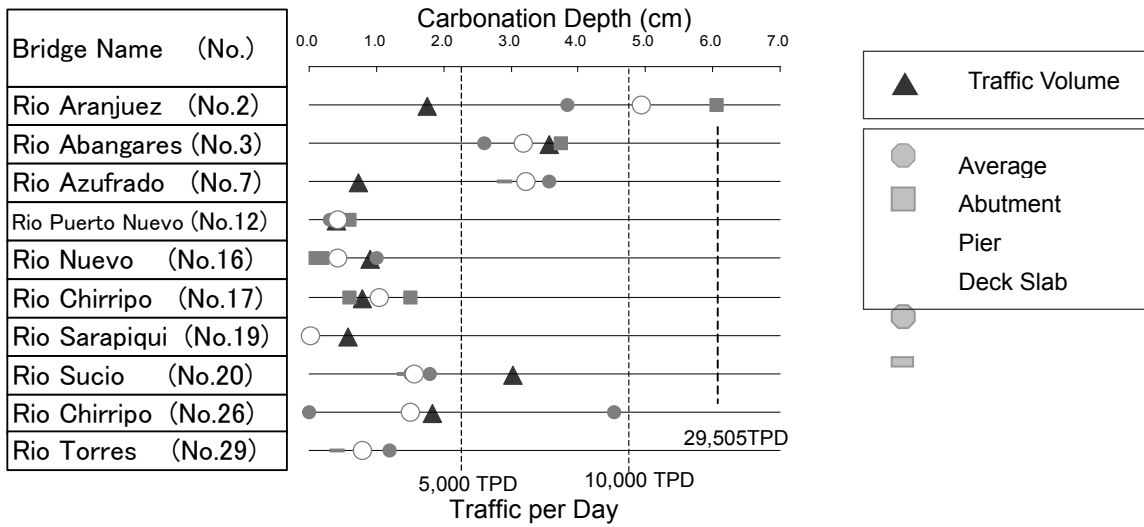
Figure 10.1.6. Result of Carbonation Test

Route	Bridge		Place	Depth (cm)	Average (cm)
	No.	Name			
1	2	Rio Aranjuez	Abutment No.1	6.06	4.945
			Pier No.1	3.83	
	3	Rio Abangares	Abutment No.2	3.75	3.175
			Pier No.2	2.6	
	7	Rio Azufrado	Pier No.2	3.57	3.230
			Girder	2.89	
2	12	Rio Puerto Nuevo	Abutment No.2	0.6	0.433
			Pier No.1	0.4	
			Pier No.4	0.3	
	16	Rio Nuevo	Abutment No.1	0.1	0.433
			Abutment No.2	0.2	
			Pier No.1	1	
4	17	Rio Chirripo	Abutment No.1	1.5	1.050
			Abutment No.2	0.6	
	19	Rio Sarapiqui	Abutment No.1	0.1	0.100
			Abutment No.2	0.1	
32	20	Rio Sucio	Pier No.1	1.5	1.567
			Pier No.2	1.8	
			Box Girder	1.4	
	26	Rio Chirripo	Pier No.2	4.53	1.510
			Pier No.5	0	
			Pier No.6	0	
218	29	Rio Torres	Pier No.2	1.2	0.800
			Girder	0.4

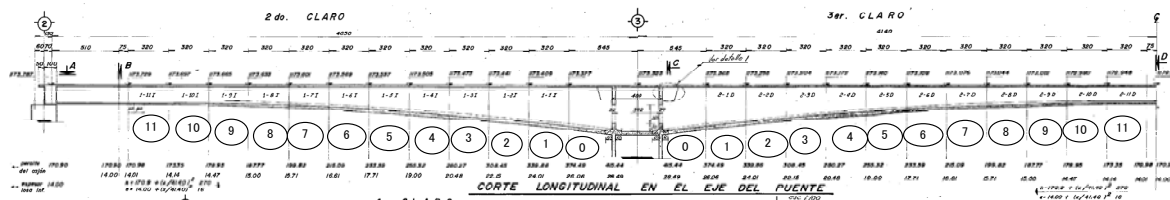
Allowable compression stress 140 kg/cm<sup>2</sup>  
 Allowable tension stress -30 kg/cm<sup>2</sup>
